Existing window
elevation, dating from
1990's
East wall, Hall.

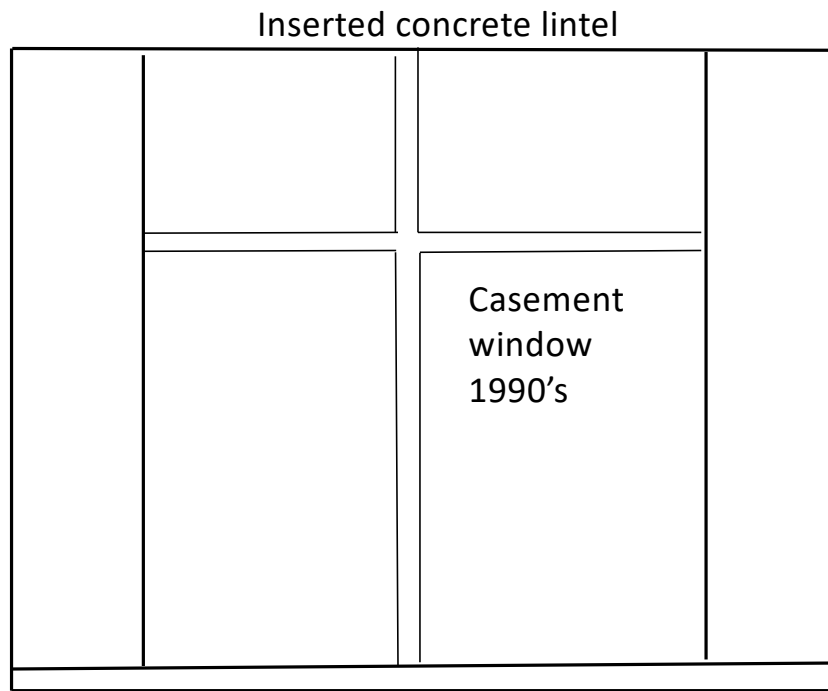
Wooden window sill
Modern blockwork infill

Water level during winter months

Wooden floor

Concrete subfloor (?1970's)
