# Drakes House, Gatcombe, Blakeney

## Proposed Scheme of Works requiring Listed Building Consent

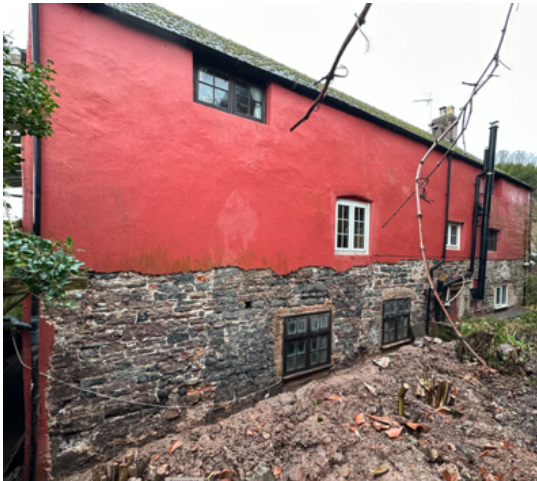
### 1.1 East Wall

**Justification:** *Cement render likely to be main reason for internal damp and needs to be replaced by lime system. Drain repair to allow water flow.*

Remove external concrete render on the east wall and allow wall to dry out. Re-render external wall with three coats of lime render. Dig out existing drain which has failed and replace with open drain which can be kept clean, to allow water to flow freely. Render surface in NHL5.

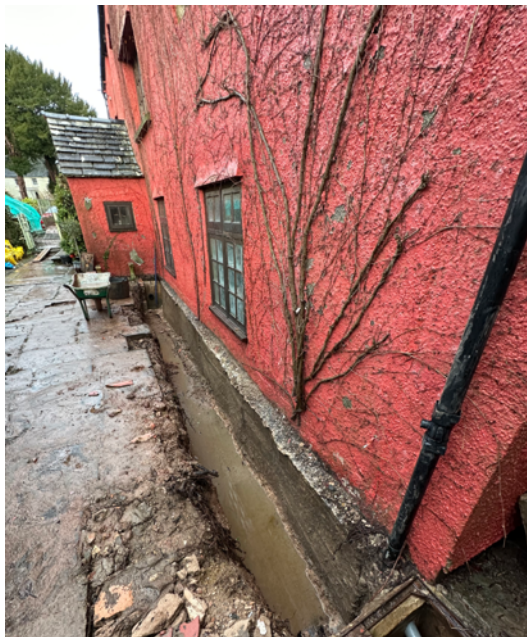
### 1.2 West Wall

**Justification:** *At present the render appears to be sound, and pre-dates 1972. There is also a significant bulge in the side of the house, noted in 1972, and with no recent signs of movement, and we are reluctant to expose this. The present drain along the west wall has collapsed and is a cause of water ingress. An open drain will allow us to keep it clean of river silt, as estuary water often backs up during a high tide into this drain.*

Investigate pebble-dash render on the West elevation which dates to the 1960's.

Hack-off to 500mm above ground level and replace with lime system. Dig out existing drain that runs along the wall and replace with open drain, capped by flagstones.

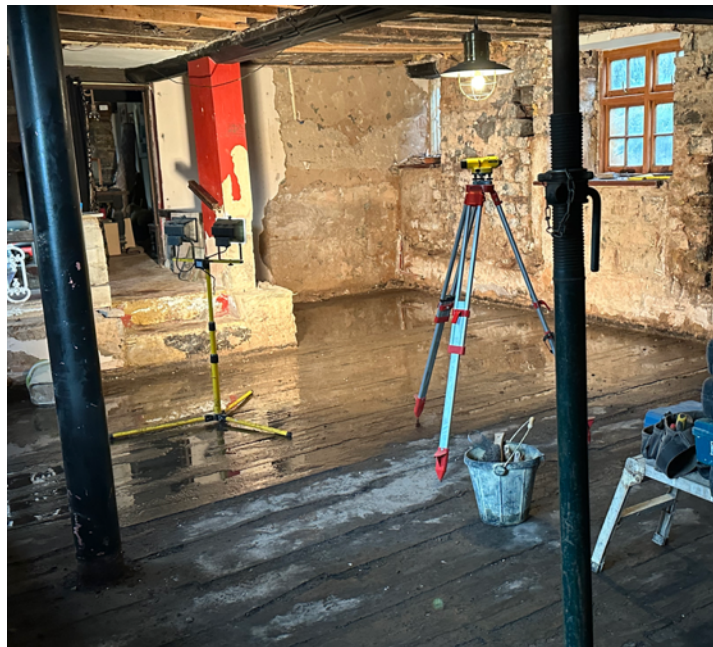
### 2.1 Internal Floor level

**Justification:** The original 16<sup>th</sup> century floor was at this level (as is apparent with the fireplace hearthstone) and was dug out in the 19<sup>th</sup> century. Paving stones will be in keeping with the period nature of the room (replacing the present modern wooden floor), and underfloor heating will help keep this room and the rest of the house dry and warm. If the room is external flooded, it will be possible to recover in a resilient way. The sump will keep the ground floor internal rooms dry and free of damp.

We propose to raise the internal floor level by 420mm from the concrete base, inserted in c. 1972 (+250mm above present timber floor). This will help to keep the floor dry (see flooding over the slab). The system, as suggested by Ty Mawr, will be as follows:

1. Permeable geotextile
2. Glapor recycled foamed glass 150mm
3. Geotextile
4. Heatmat system forming underfloor heating
5. Limecrete sub-base, encasing heatmat 200mm
6. Screed 45mm
7. Stone Slab 25mm

Ground water that accumulates at the base of the floor will be able to pass through the glapor, while channels have been cut into the base slab. In the SW corner, a covered sump will collect the water, and be pumped out, via an automatic switch, into the external drain.

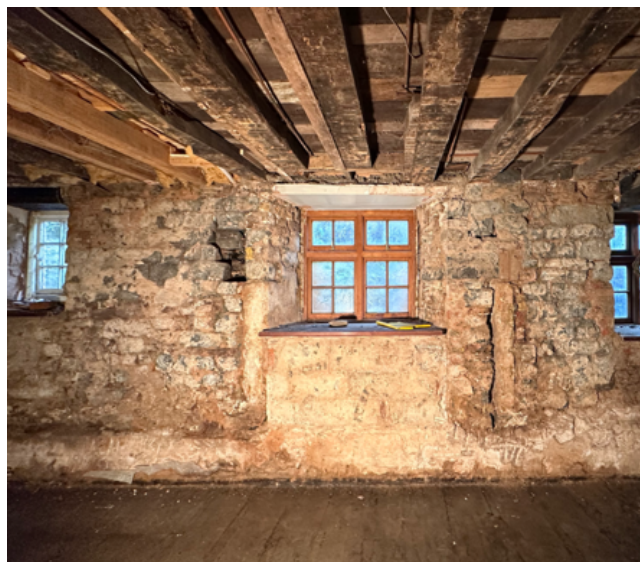
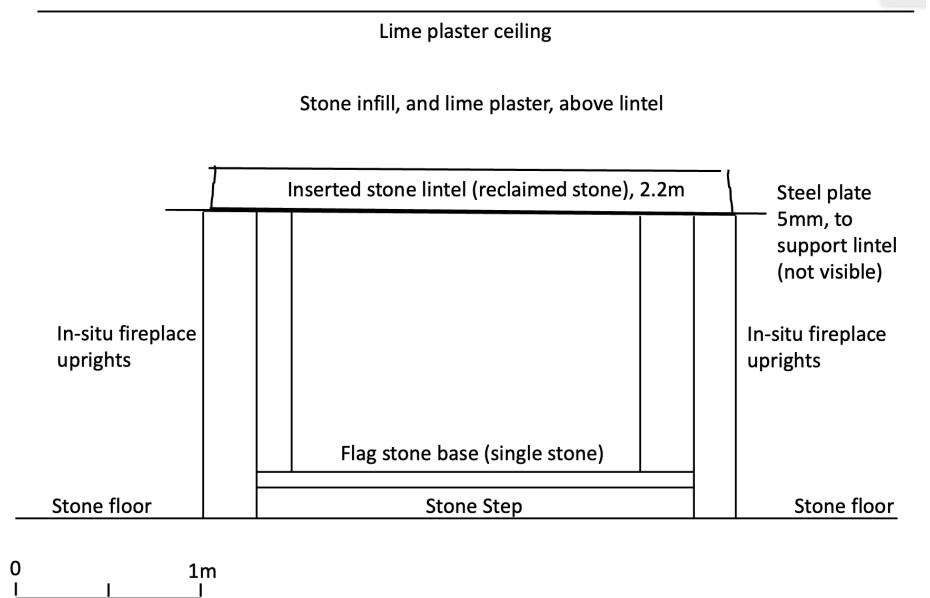
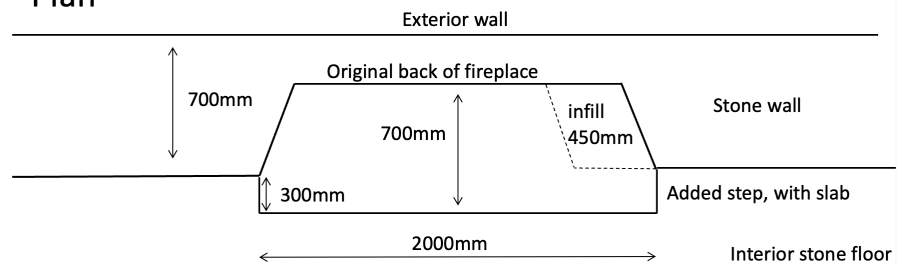
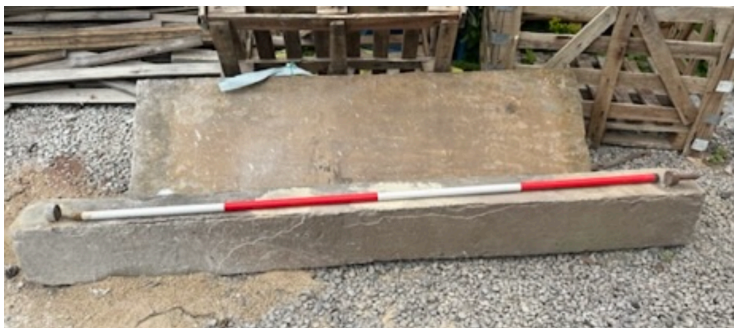
## 2.2 East Wall fireplace

While removing the concrete render, we uncovered the uprights of the original fireplace in the hall, which was blocked in the 19<sup>th</sup> century. These are of limestone, and similar to the fireplace on the first floor. The overall width is 1.8m, needing a mantel of 2.30m. We propose to open up this fireplace, which involves removing concrete and stone blockwork infill. We have been able to source an appropriate stone lintel that will span the full 2.3m and propose to infill above with blue lias stone. At this stage, we do not intend to have a working fire, so there will be no alterations to the external elevation.

***Justification:*** *This is one of the original features of the house, and its position in the centre of the hall considerably adds to the special architectural character of the building. Reinstating the fireplace will involve blocking a window that dates to the 19<sup>th</sup> century, although not removing any significant historic fabric in the process. This window has a poured concrete lintel which is failing, supporting the floor beams – one of which is scorched and unattached. Infilling the window will help resolve this issue.*

## Elevation of Proposed Reinstated Fireplace

## Proposed lintel and hearth for fireplace

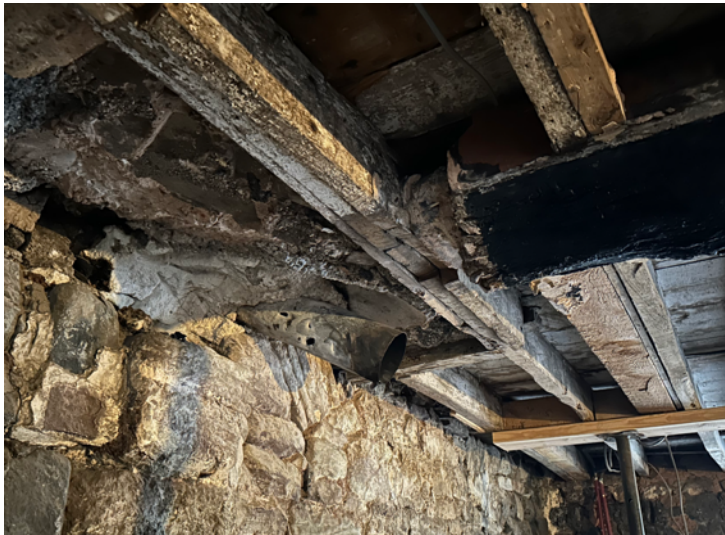
**2.3 South Wall Fireplace**  
We have removed the existing fireplace which was placed there in the 1970's. It was built of cinder blockwork and poured cement. It was freestanding and not keyed into the primary wall behind. It covered up the primary river entrance, which we would like to leave exposed. We will place fitch plates on either side of the unsupported longitudinal

**Justification:** *The present fireplace is modern and does not support the main longitudinal beam of the house, with the sawn-off end hanging. Removing the 1970's fireplace enables a solution to support the beam.*

beam and tie it back onto the S wall, where there is a surviving corbel. The beam will be extended with oak and stained to match existing.

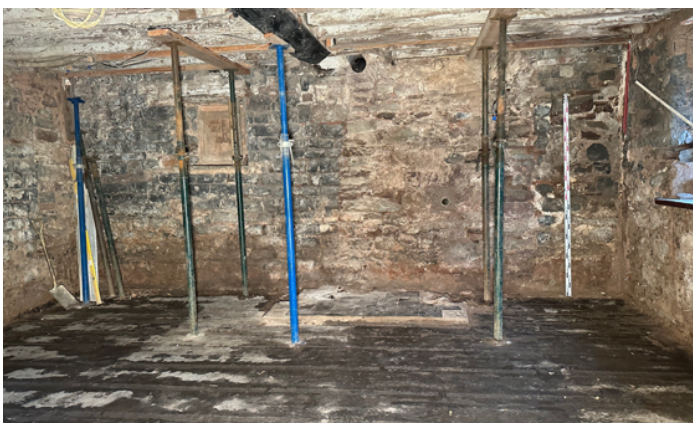
#### 2.4 Internal Wall Coverings

**Justification:** *Lime plaster is the most appropriate wall covering for a building of this period, and we can see some evidence for it in the surviving fabric. This will allow the building to breathe and stay dry.*

When the walls have fully dried, we will cover with three coats of NHL3.5 lime render, and six coats of ochre-coloured limewash. We will repoint and leave the south and parts of the east wall exposed. Before applying render, we will take detailed photographs, and a detailed laser scan of the room.

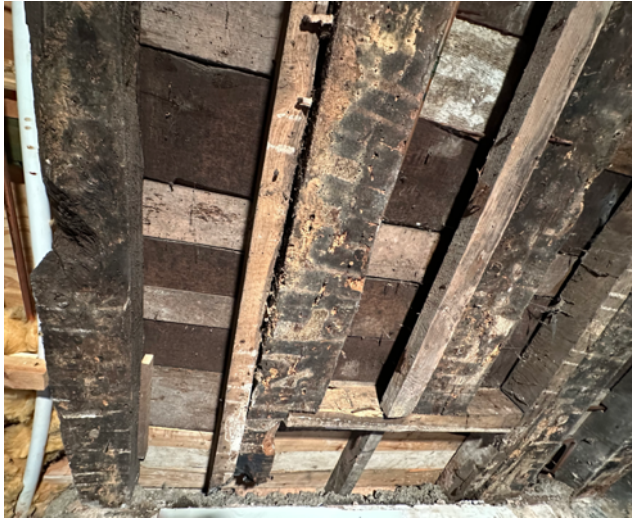
## 2.5 Ceilings.

The present ceiling coverings all date to the 1970's and are currently failing. We will remove and treat the timber joists with woodworm treatment and replace. In the north east quadrant, we will clean the original oak beams, and infill the gaps with lime plaster board. We will also leave the timbers around the stair exposed.

**Justification:** *Original beams survive in one of the four areas. The remainder are replacement floor joists that date to 1972. The timbers around the stair are of particular architectural interest.*

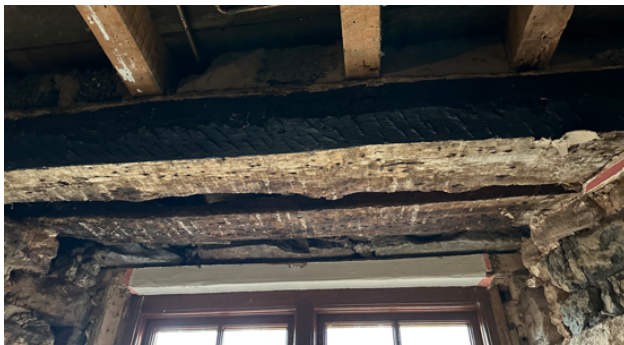
## 2.6 Window lintels and sills

Some of the original window lintels survive (but have been covered over). We will expose these and repair where necessary. The existing sills date to the mid 1980's and are made from an imported hardwood. We will replace these with stone sills, in keeping with the one surviving stone sill.

**Justification:** *While the original mullioned windows have been lost, the lintels retain historic interest, and we would like them to be exposed as they were originally meant to be seen.*

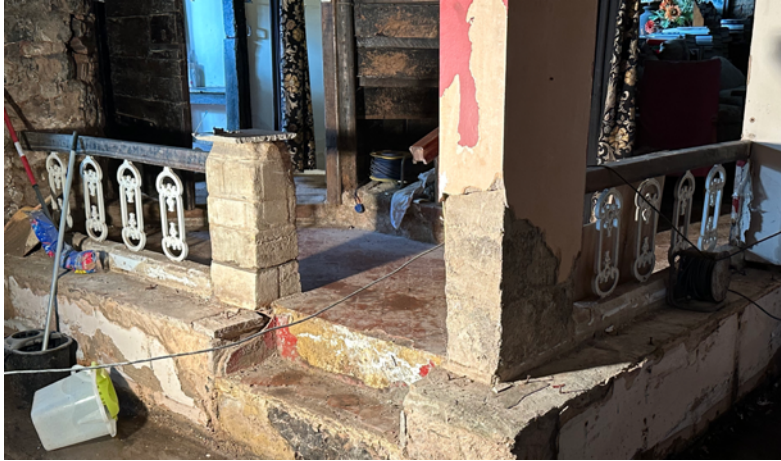
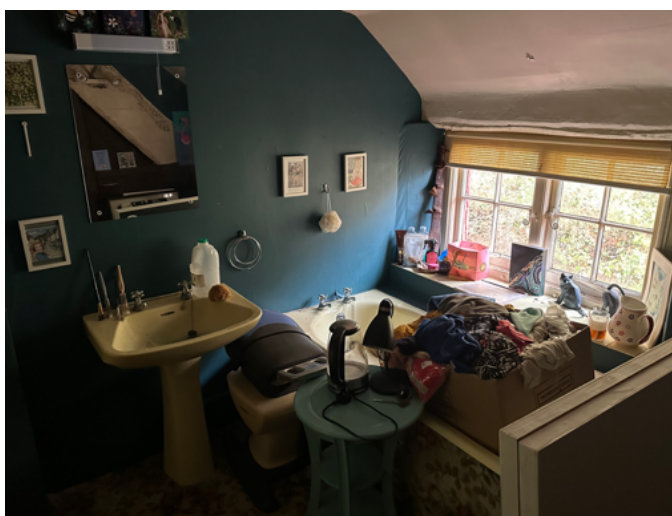
## 2.7 Passage Rails

We would like to remove the passage rails that were placed there when the floor was lowered in the 19<sup>th</sup> century. The rails are reused timber from panelling in the house, with cast iron decorative pieces, set into a limestone base that is now heavily

decayed. We will re-use the timbers as stair handrails and retain the cast iron pieces within the property. The longitudinal beam is supported on a pillar made from breeze blocks. We will replace this by a timber post made from oak sourced at Lydney

**Justification:** *As the floor will now be level, there is no purpose for these rails which break up the floor span. They are significantly decayed, and not part of the original fabric of the building. The wall is also holding back the ground water causing significant damp issues in the northern part of the house and its removal will allow the house to dry out.*

Park and worked as a jowl-post in a style appropriate to the 16<sup>th</sup> century. The timber will rest on a stone plinth, currently reused in the passage rails, but which probably was used for this purpose originally.
