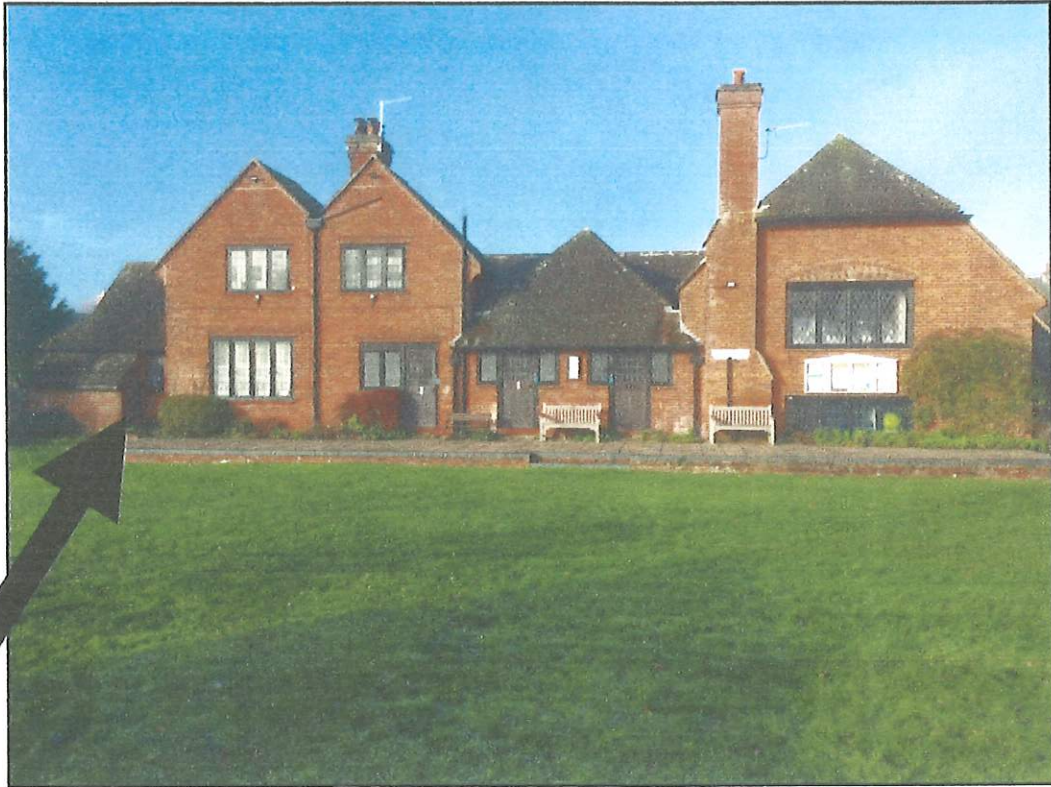
Rear of club, east facing, four windows on left of the building to be replaced. Two upper floor and two ground floor (one set back).

Two upper floor and  
two ground floor (one  
set back).
