RYBURN VALLEY HIGH SCHOOL

ARBORICULTURAL IMPACT ASSESSMENT

JSL4956_770
Ryburn Valley High School
Arboricultural Impact
Assessment
V1
Oct 2023

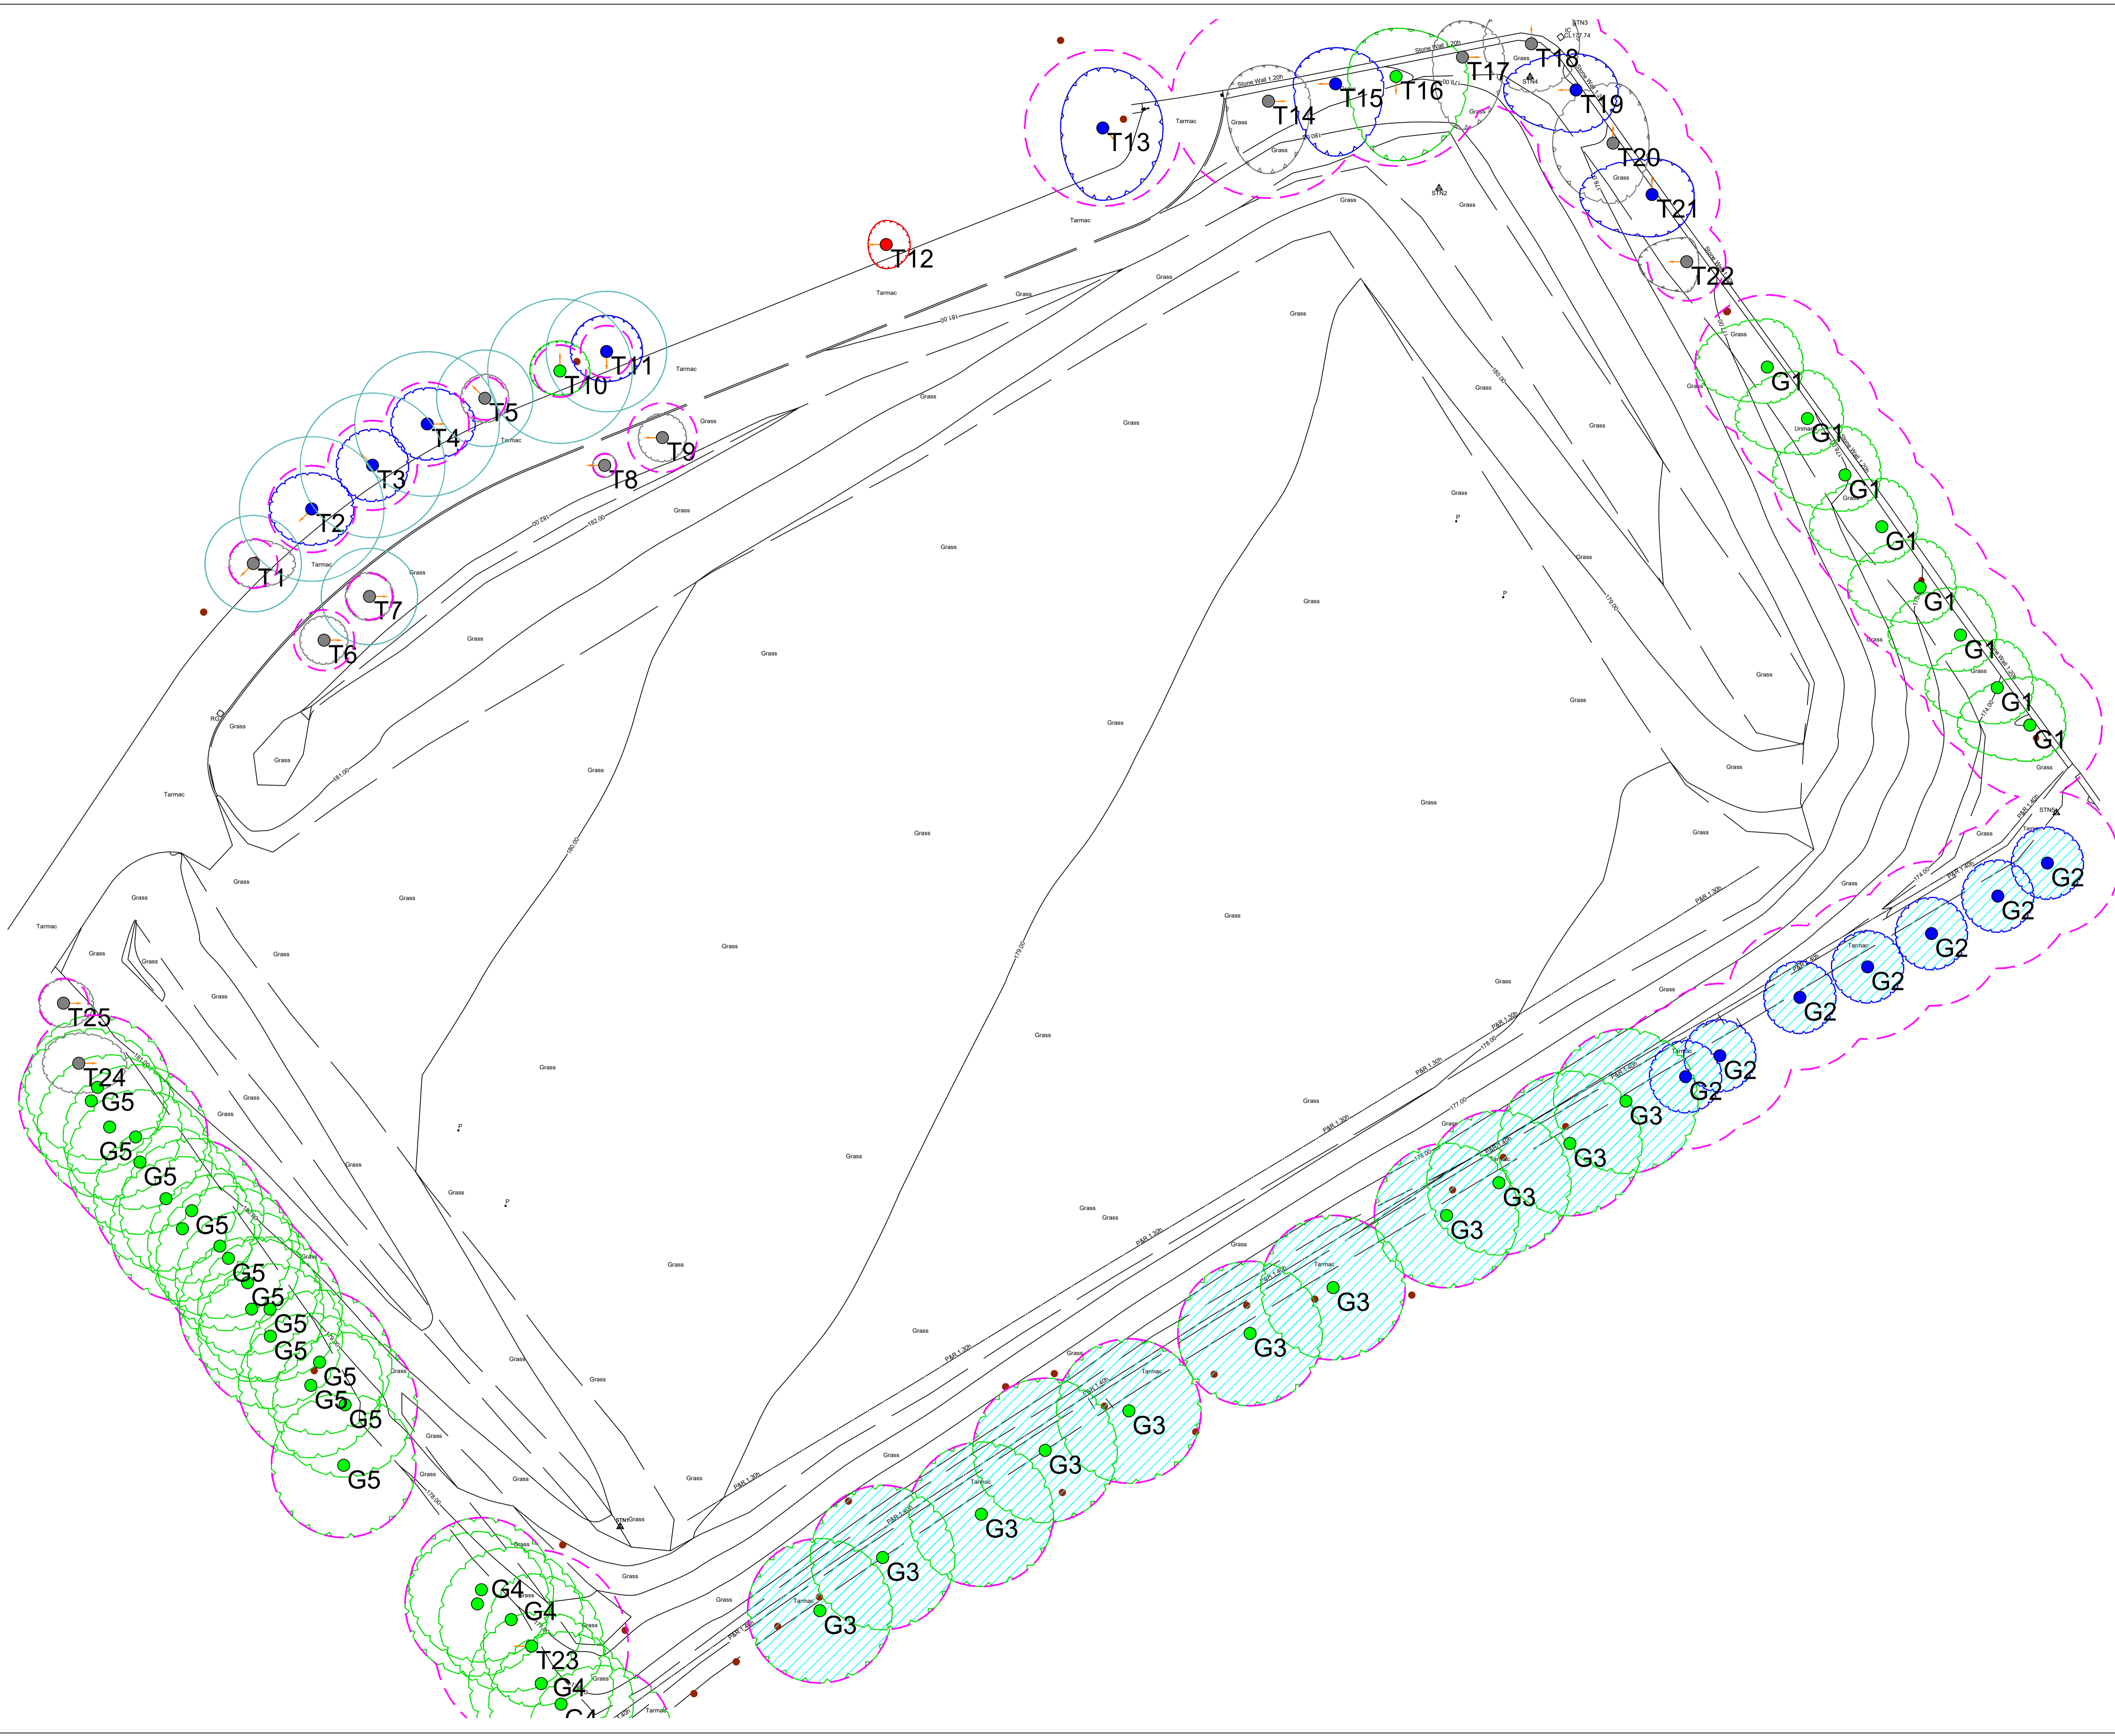
JSL4956_700: TREE CONSTRAINTS PLAN

The purpose of the survey was to gather data on the trees present within the site and to prepare a Tree Constraints Plan (see drawing 700) that could be used to assess any potential impacts of the development.

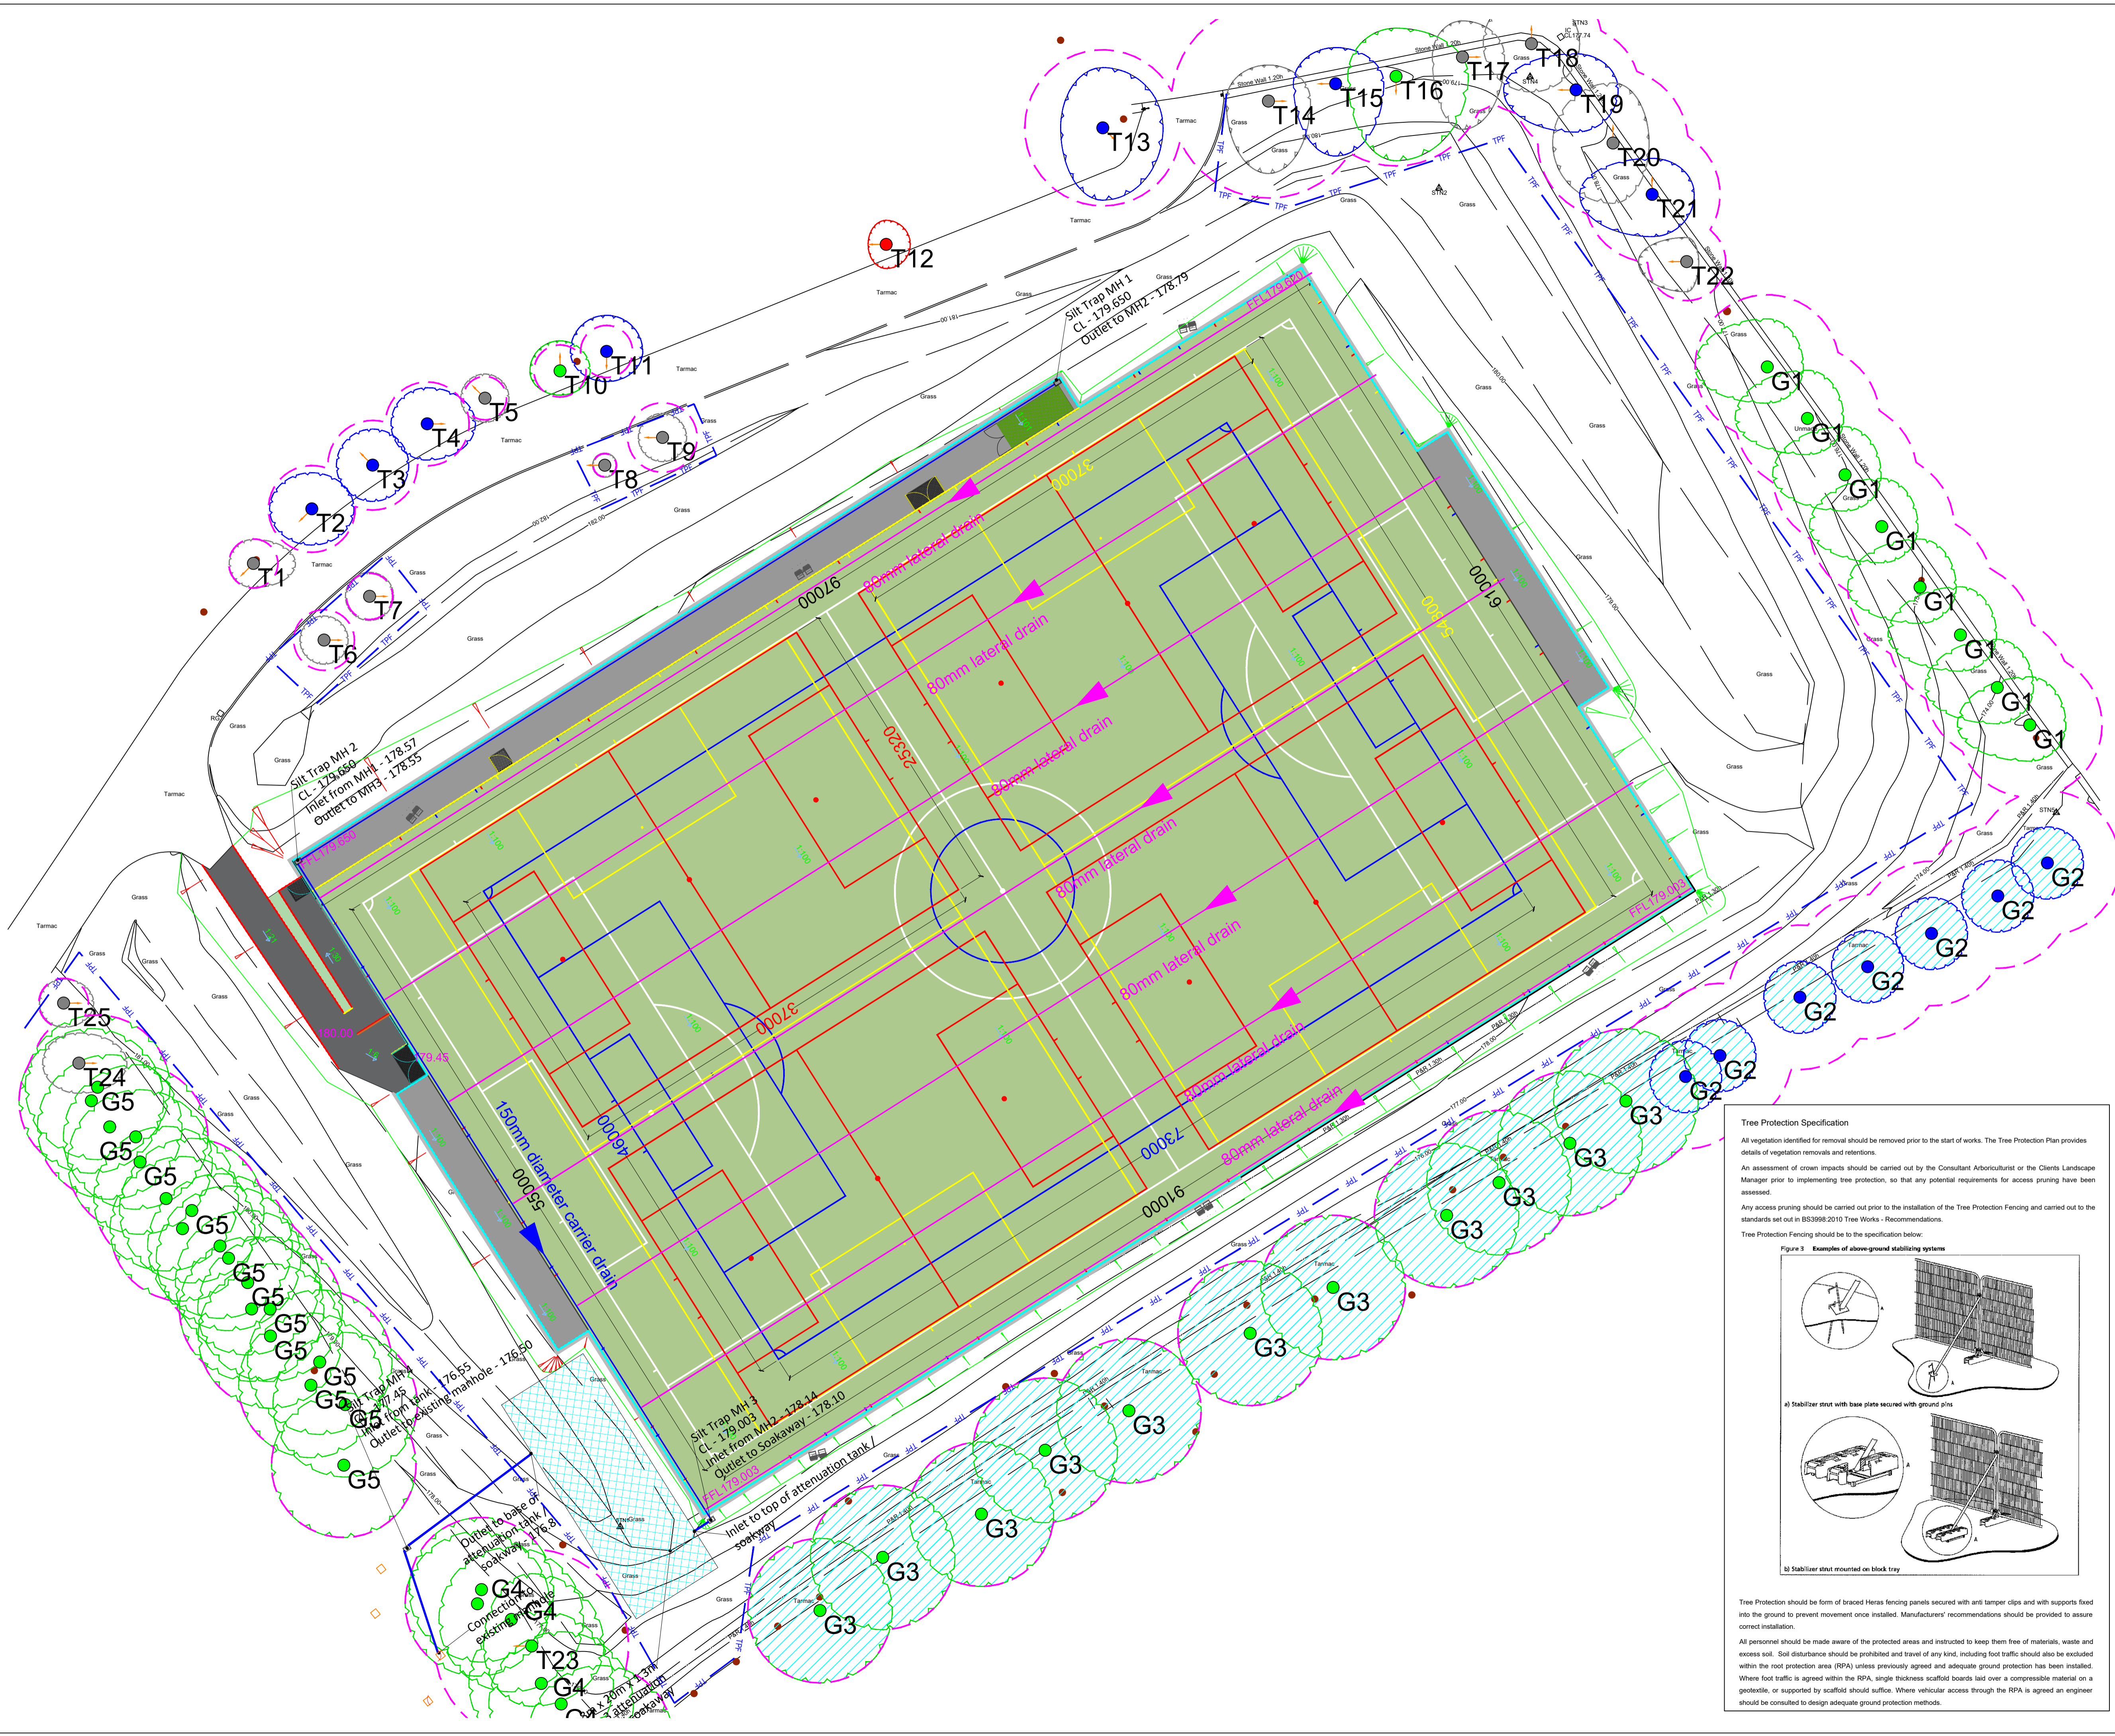
JSL4956_710: TREE PROTECTION PLAN

There is one instance where an encroachment of an RPA has been identified and this relates to the required connection between the proposed soakaway at the south-west corner of the site to an existing manhole to the west. It will require installation through the periphery of the RPA of the north-westernmost tree in the Category A group G4 (amounting to an incursion of approximately 9% of the RPA). This appears unavoidable, however it should be well within the tolerances of the tree to withstand given the species, age and condition of the tree. The connection should allow for working methods that will minimise damage to trees. For example, reference to documents such as NJUG Volume 4 - Guidelines for the planning, installation and maintenance of drainage in proximity to trees. (National Joint Utilities Group 2007) may be suitable.
