Box Hedge Farm, Coalpit Heath

Proposed redevelopment

Preliminary Ecological Appraisal

Survey date: 22nd May 2020

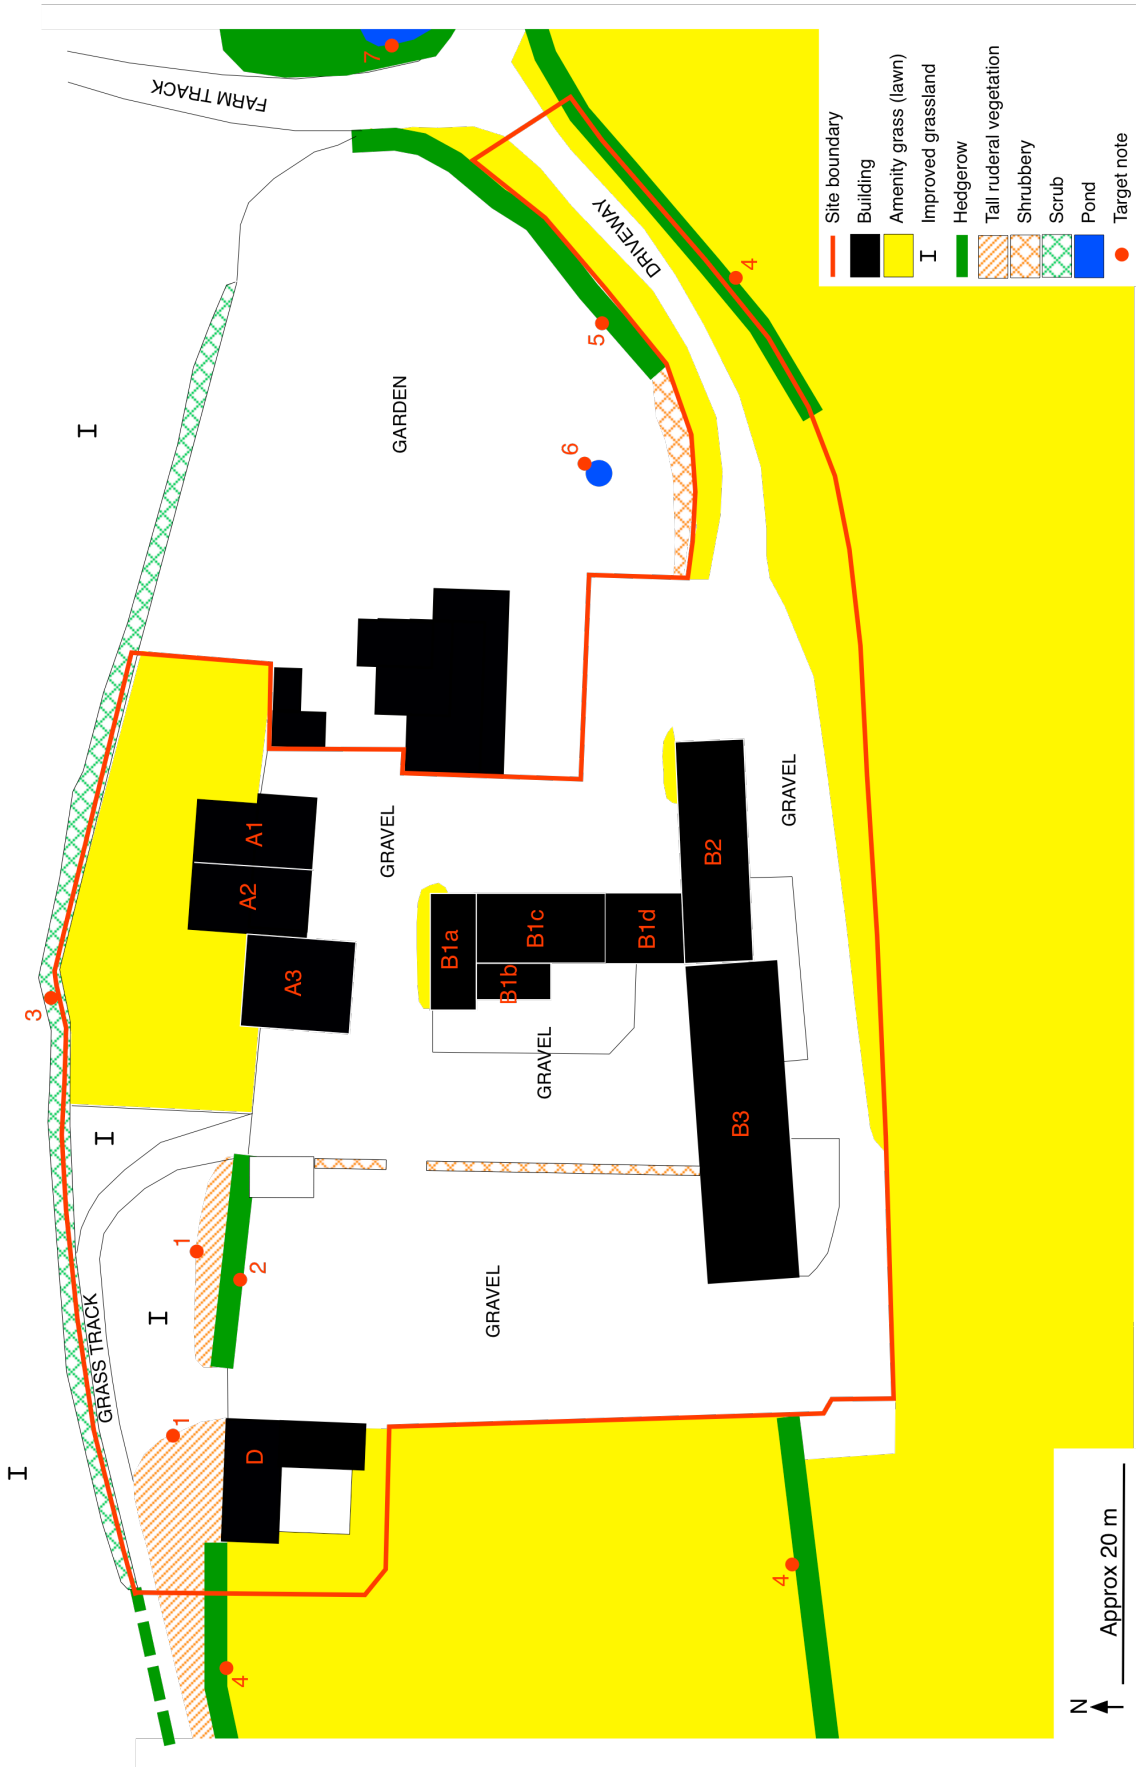
Figure 2. Existing site plan.

- 1 Tall ruderal vegetation dominated by Common nettle (*Urtica dioica*) with significant Bramble (*Rubus fruticosus*).
- 2 Short section of native hedgerow to around 4-5 m in height includes Holly (*Ilex aquifolium*), Hawthorn (*Crataegus monogyna*), Elm (*Ulmus* sp) etc.
- 3 Post and wire fence engulfed in Bramble scrub (*Rubus fruticosus*) to around 1.5-2 m in height.
- 4 Tall native hedgerow to around 5-6 m in height.
- 5 Overgrown conifer hedgerow inside garden boundary wall.
- 6 Small, raised garden pond/water feature. Netted.
- 7 Farm pond within small area of tall scrub/trees. Fully shaded. Fully covered in duckweed (*Lemna* sp) at time of survey. Not accessible for survey.

- 4.1 According to the Magic website, the site does not constitute, fall within or lie adjacent to any statutory or non-statutory wildlife site. We note that the Magic website does not necessarily list all non-statutory sites. Nevertheless, given the character of the site (buildings/gravel/amenity grassland) we judge it highly unlikely to be included within any such sites.
- 4.2 Native hedgerow is a Biodiversity Action Plan priority habitat. There are no other such habitats or other habitats of particular ecological interest or conservation concern present within or adjacent to the site
- 4.3 Given the above we recommend that, to maximise the biodiversity value of the developed site:
 - i. **the existing short section of native hedgerow at Target note 2 be retained.**

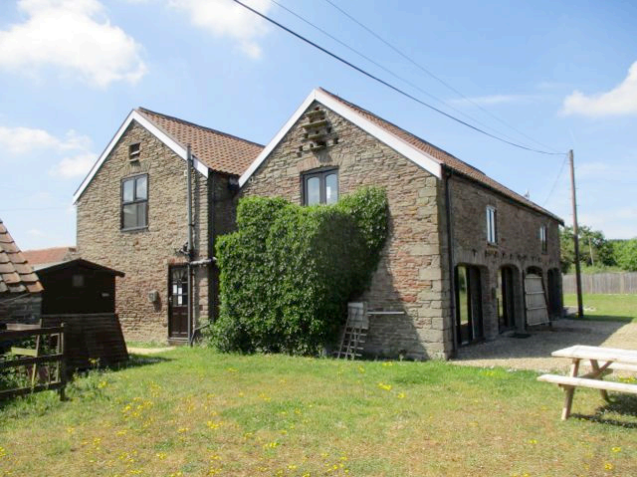
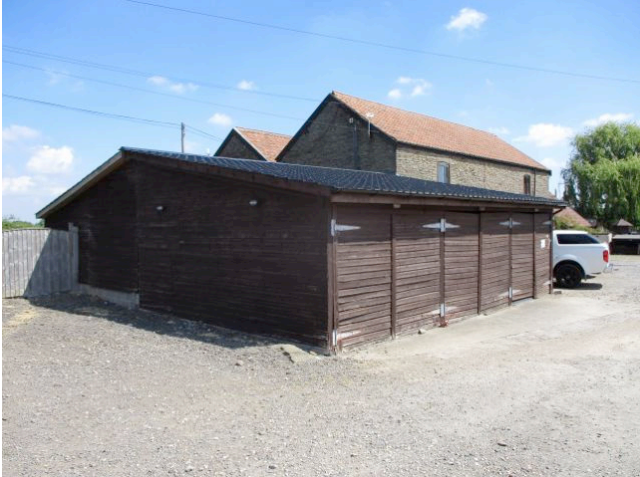
Building	Details	Potential suitability
A1/A2	Interior only partly accessed No flying access No sheltered internal voids (eg roof spaces)? Various gaps in external stone-work Various gaps in roof below lifted tiles, along the eaves etc	High
A3	Fully accessible for survey No flying access No sheltered internal voids (eg roof spaces) Timber cladding tight Roof fitted with interlocking metal tiles	Negligible
B1	Fully accessible for survey No flying access Stone-work sound Sections of timber cladding tight Several roof spaces, all accessible for survey Various gaps in roofs below lifted roof tiles, behind timber fascias/soffits, in edge tile bedding mortar (on gable ends) etc. Ridge tiles appear well-bedded	High

P1 and P2. Building A1-A3 as viewed from the northeast and the northwest respectively.

- 4.7 Given the above and with reference to the table at paragraph 3.6 above and Tables 7.1-7.3 in the Bat Survey Guidelines we recommend that:
 - i. **prior to the commencement of any material works to the roofs or eaves of buildings A1, A2, B1 or B2 the presence/absence of bat roosts within any such roof/eaves be more adequately established by the carrying out of at least 3 (no.) separate watches for bats coming/going from them over dusk/dawn in fair weather sometime between May and September inclusive. The bulk of such watches on any one building should be completed before end August. Consecutive watches on any one building should be at least 2 weeks apart. For further details of acceptable methodology reference should be made to the Bat Survey Guidelines;**

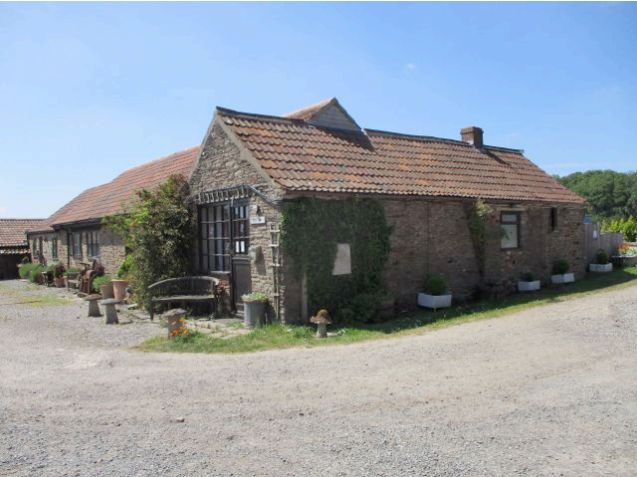
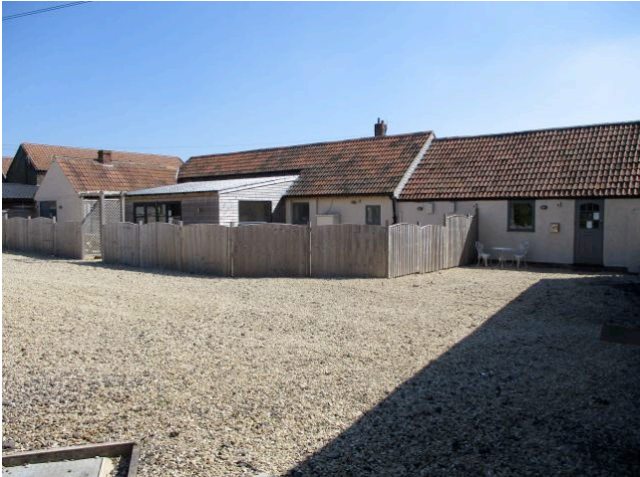
P3 and P4. Building B1 as viewed from the northeast and the southwest respectively.

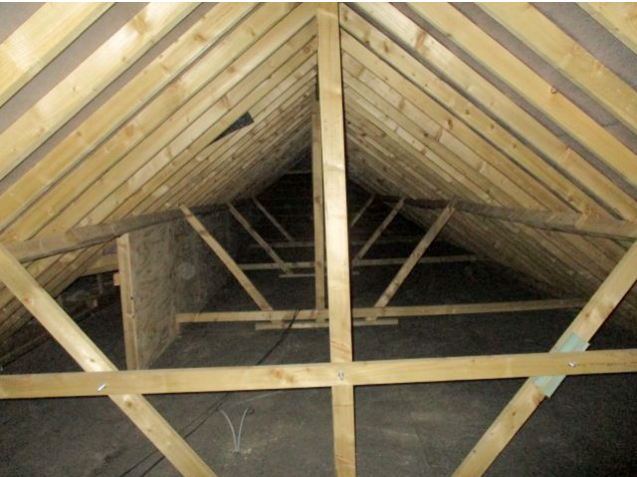
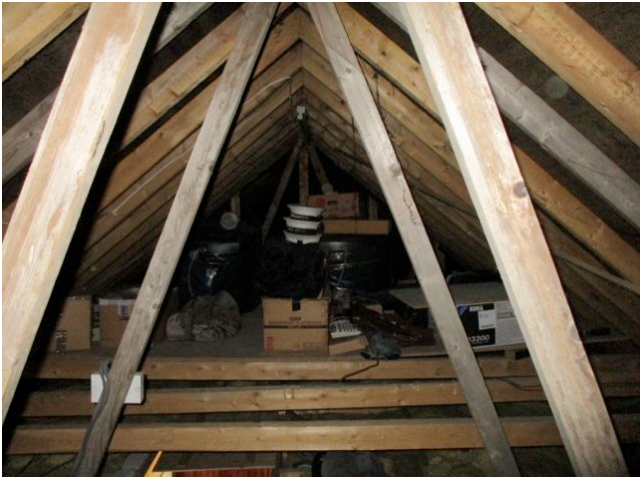
- B1c Stone-built. Previously flat-roofed but now with a 'false' pitched roof fitted with double Roman clay tiles on a modern breathable roofing membrane. Single, large roof space of around 2.2 m in height at the ridge – connects with those above B1b and B1d.

- B1d Stone-built with pitched roof fitted with double Roman clay tiles on a bitumen felt underlay. Single, large roof space of around 2 m in height at the ridge – connects with those above B1b and B1c.

P5 and P6. Examples of roof spaces within Building B1.

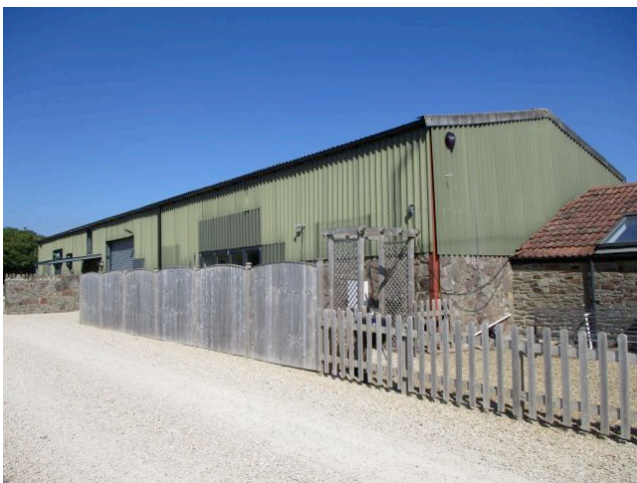
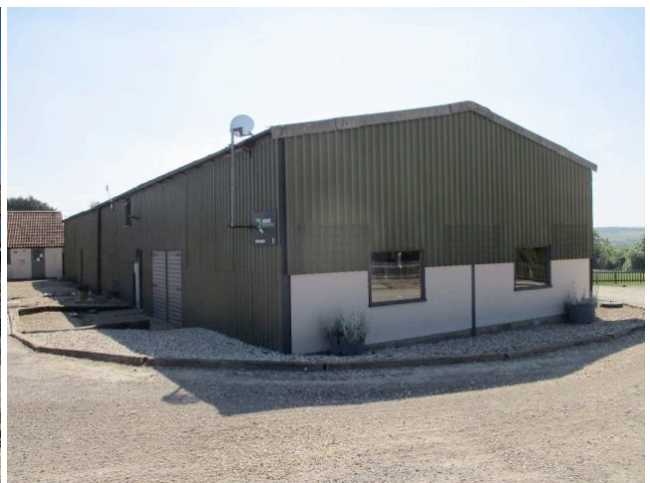
- B3 Two-storey height, metal-clad shed with a pitched roof fitted with sheet metal with no underlay. Mostly open to the roof though with small central upper floor office space. Used for light industrial/storage/office space.

P9 and P10. Building B3 as viewed from the southeast and the northwest respectively.

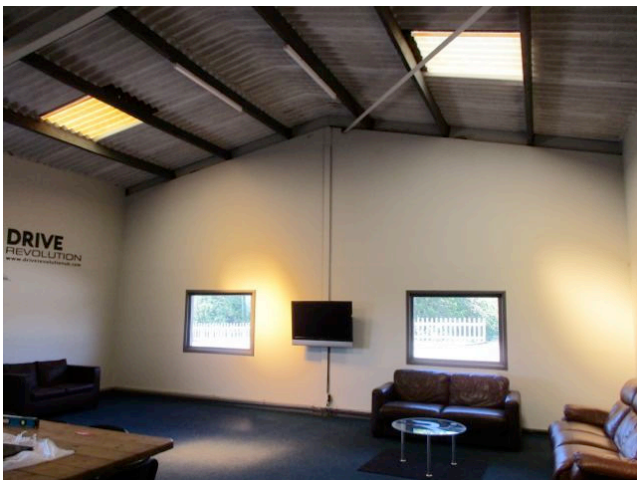
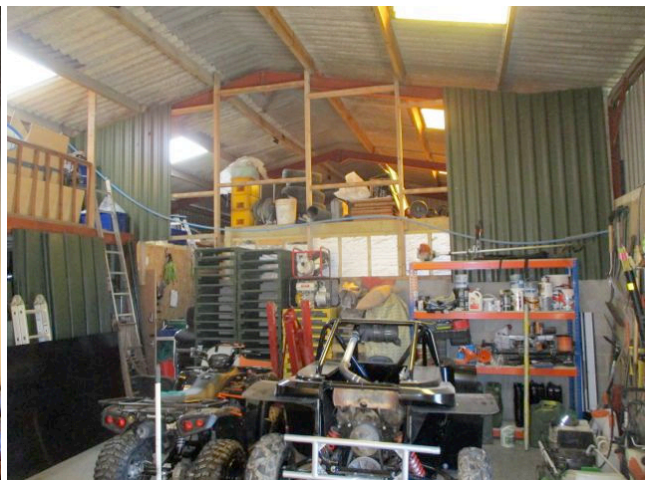
P11 and P12. The interior of Building B3.

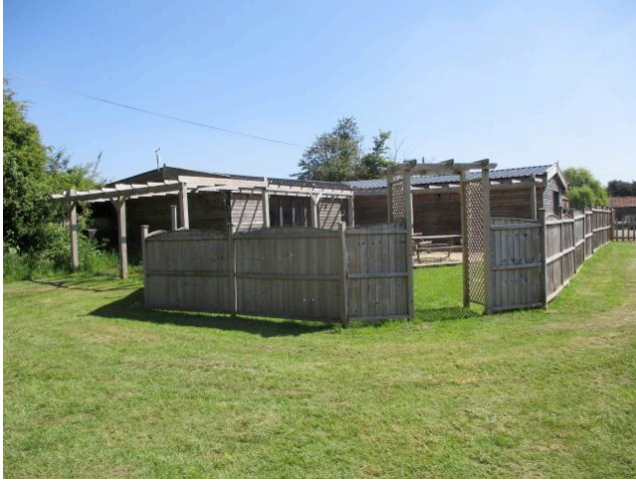
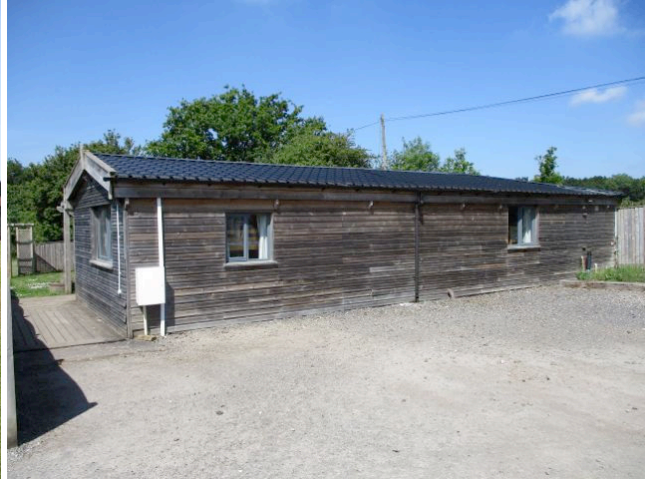
- D Single-storey timber-clad building with a gently pitched roof fitted with inter-locking metal tiles on a modern breathable roofing membrane. Ceilings vaulted. Used for lettings.

P13 and P14. Building D as viewed from the southwest and the southeast respectively.
