CONAULT DESIGN

**Reconstruction of Boundary Wall
Discharge of Condition 4 & 5
Ref: 23/00803LBC**

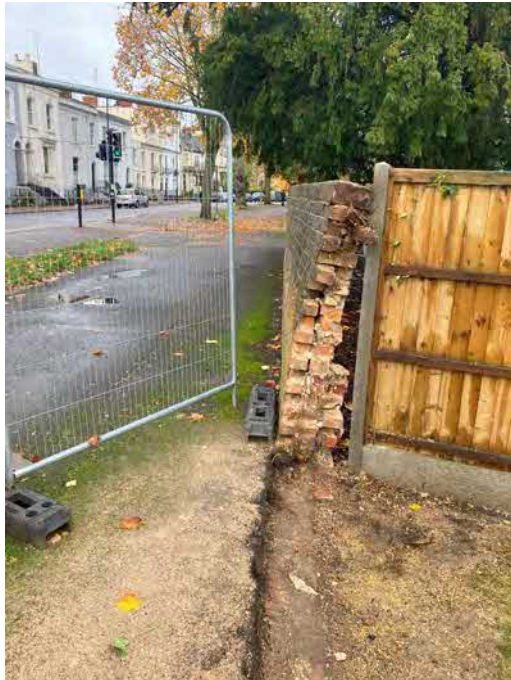
Photo 1 – Neighbours Wall

During demolition it became apparent why the wall may have been unstable and leaning. Whilst the face of the wall is in Flemish bond, rather than the stretches tying the wall in front to back there were a large number of half bricks as can be seen from the section of the neighbours remaining wall. The reason for this may be the inconsistency size of the rather poorly made brick, making it difficult to find bricks of a constant size to marry up front and back, others may have sheared off.

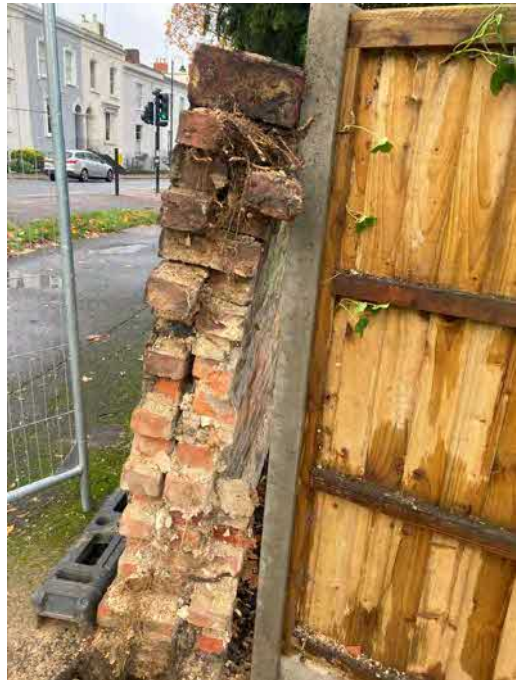
Photo 2 – Only one stretched front to back visible

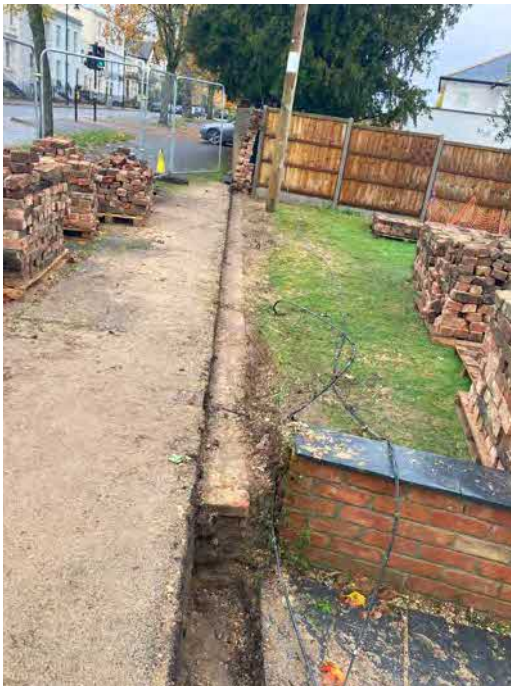
The removal had left the base of the former wall in site and the top surface of this brickwork had been cleaned of debris. The top of the remaining masonry is flat and level across its width which substantiates the previous opinion that the cause of original damage was lateral wind [and growth of vegetation into parts of the masonry] rather than foundation rotation and failure.

As explained above, the cause of original damage was not foundation failure with the conclusion drawn that the existing foundation masonry can remain and support the re-built wall above. The top surface of the brickwork was cleaned at the time of the inspection and ready to receive new brickwork.

Photo 3 – Retained foundation

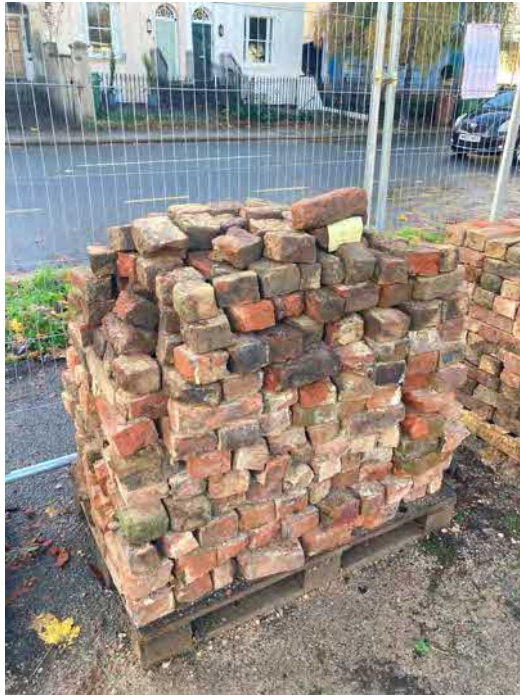
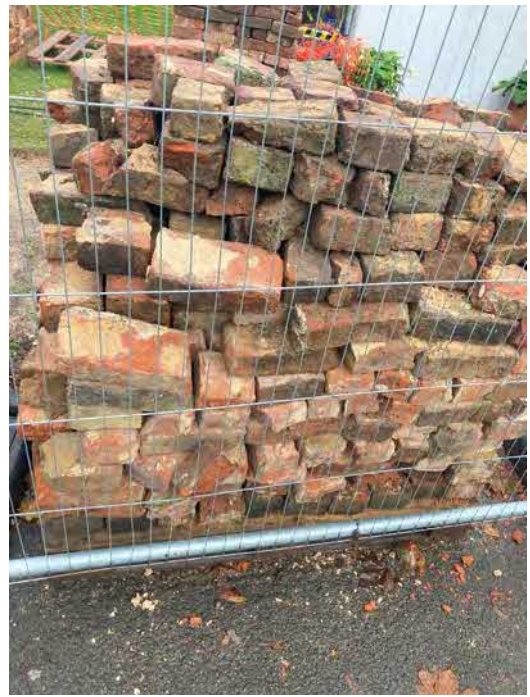
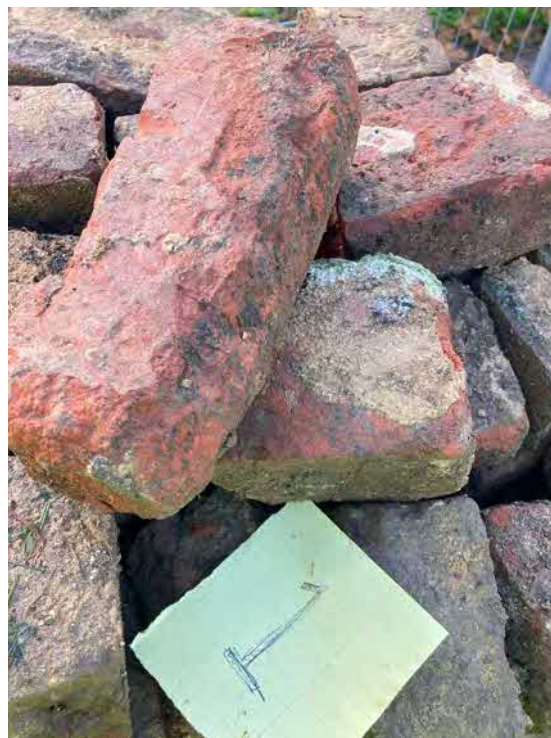
Stack 1 - rejected subject to final hand sort during disposal
in case any better bricks are in the centre of the stack

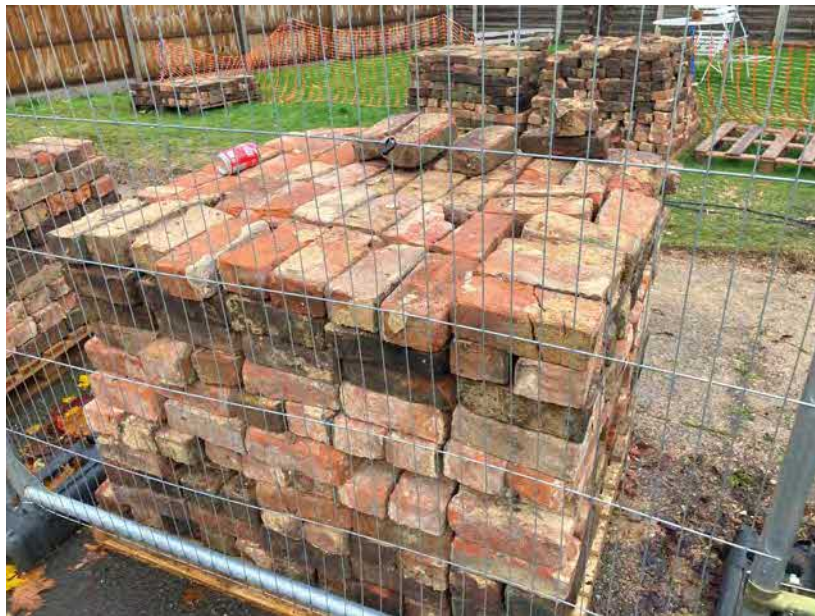
Stack 2 selected for reuse subject to final selection during laying*
*have at least one good face on the stretchers on original inspection
but could expect some limited rejections during the laying process .

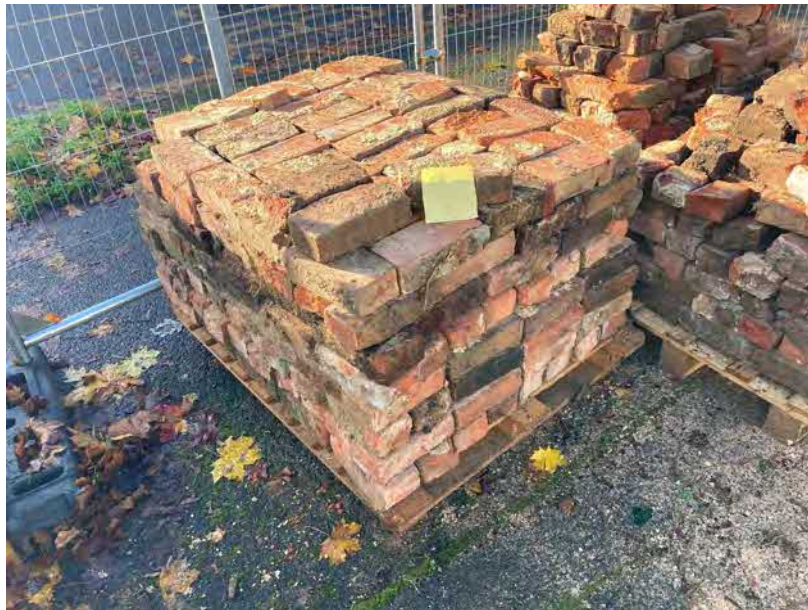
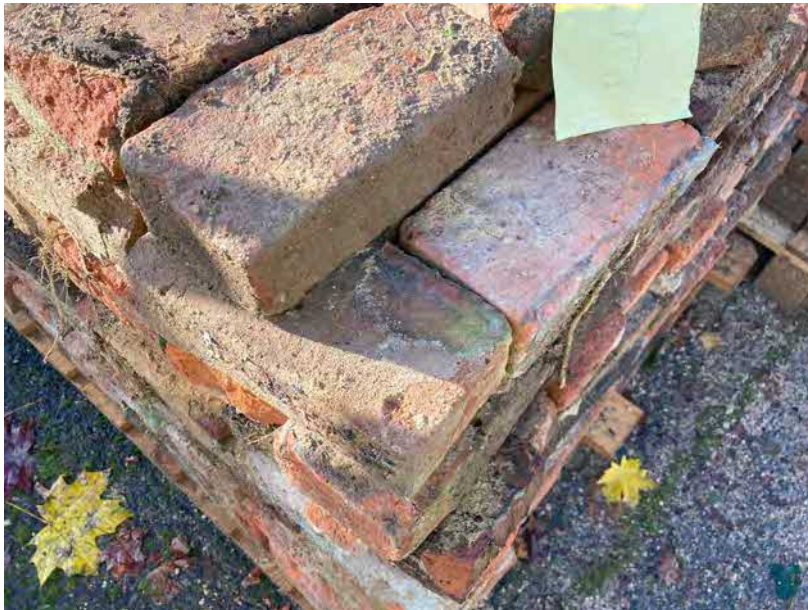
Stack 3 selected for reuse subject to final selection during laying*
*have at least one good face on the stretchers on original inspection but could expect some limited rejections during the laying process

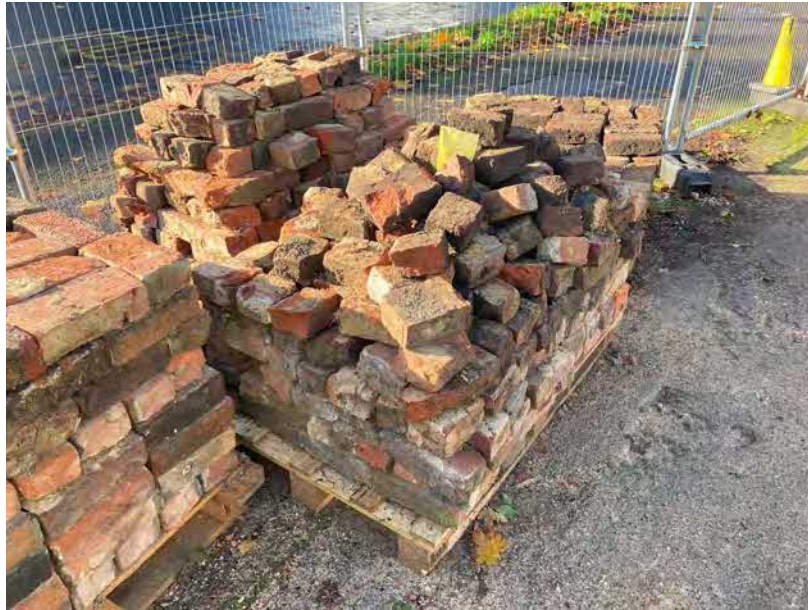
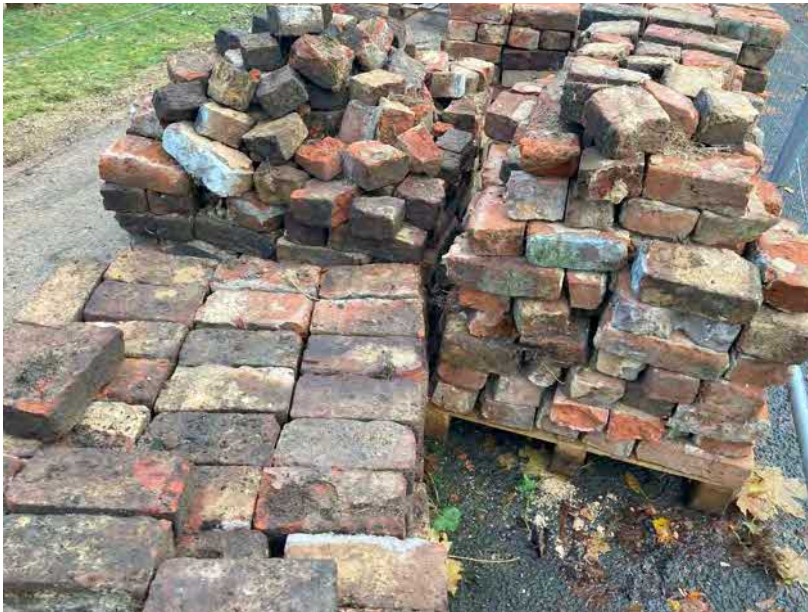
Stack 4 - rejected subject to final hand sort during disposal in case any better bricks are in the centre of the stack

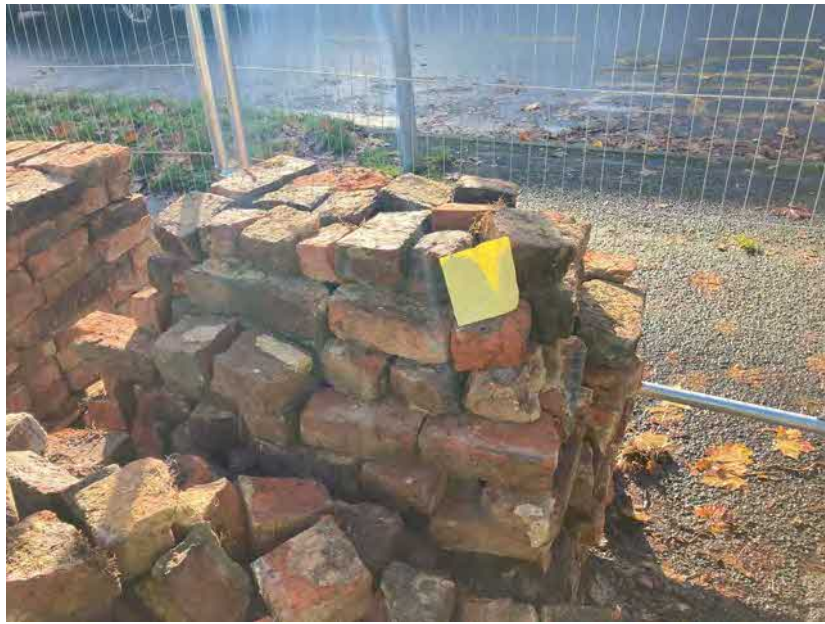
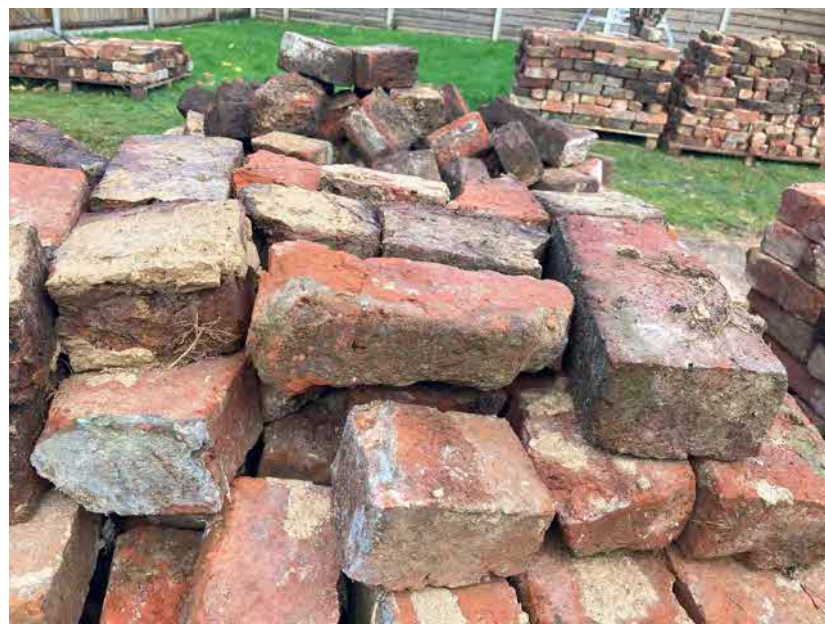
Stack 5 - rejected subject to final hand sort during disposal in case any better bricks are in the centre of the stack

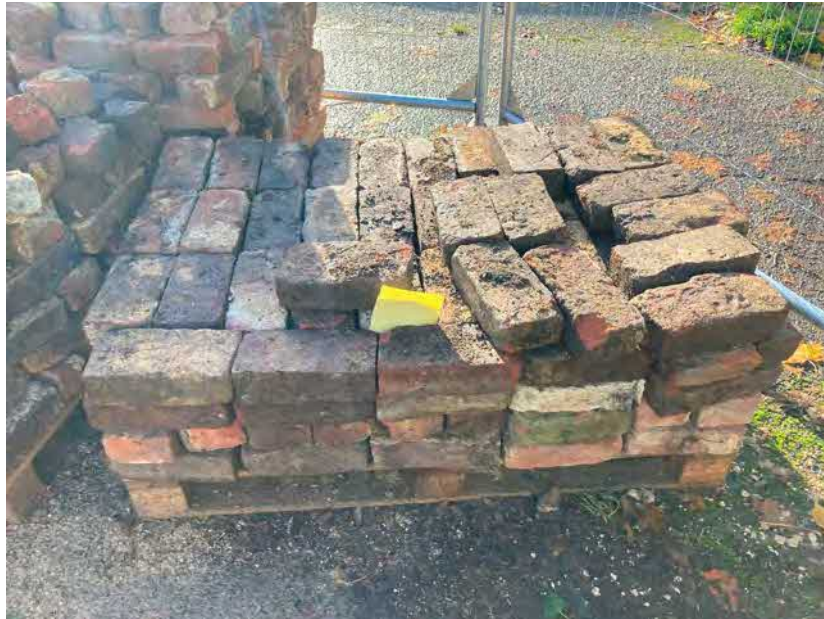
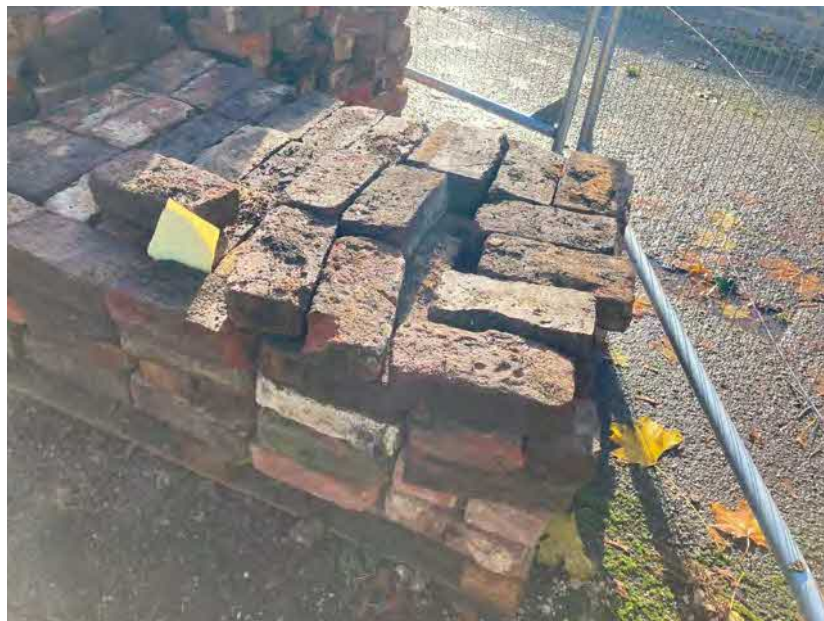
Stack 6 selected for reuse subject to final selection during laying*
*have at least one good face on the stretchers on original inspection
but could expect some limited rejections during the laying process

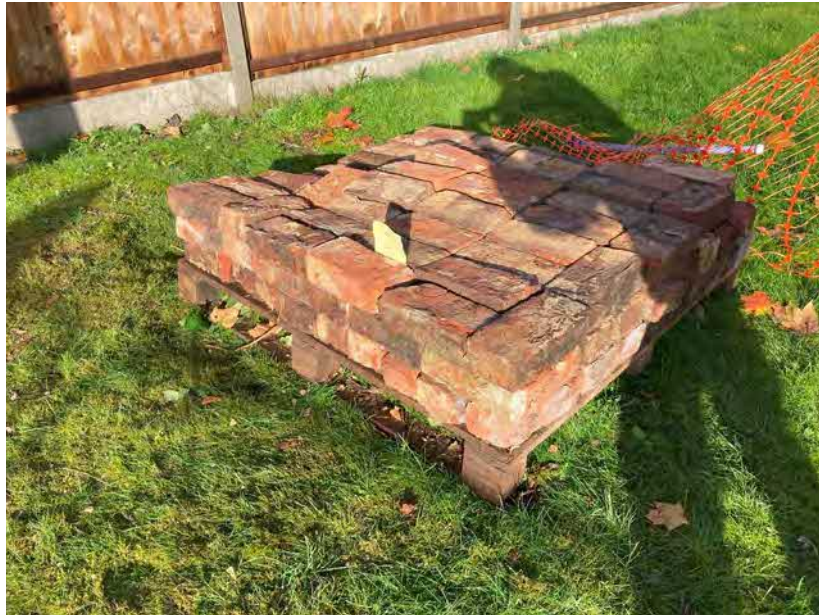
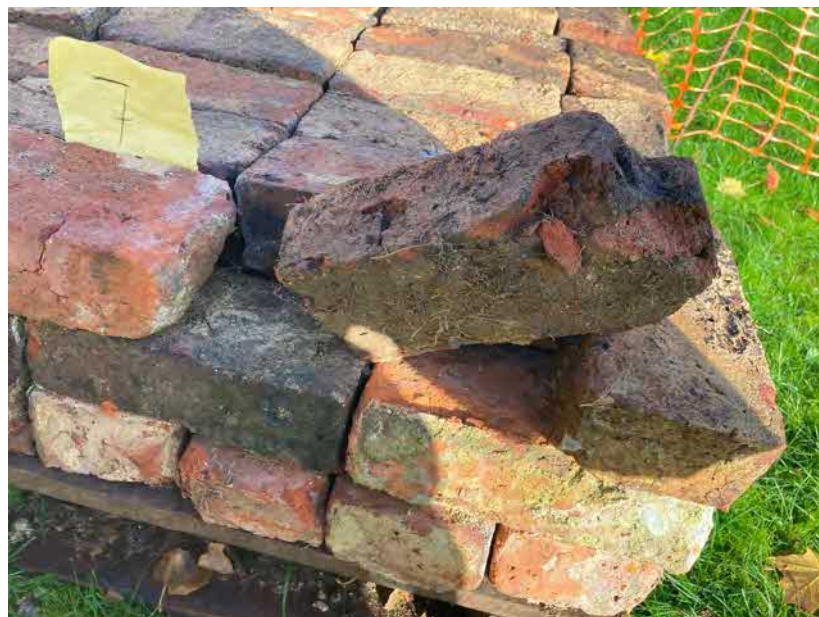
Stack 7 selected for reuse subject to final selection during laying*
*have at least one good face on the stretchers on original inspection
but could expect some limited rejections during the laying process

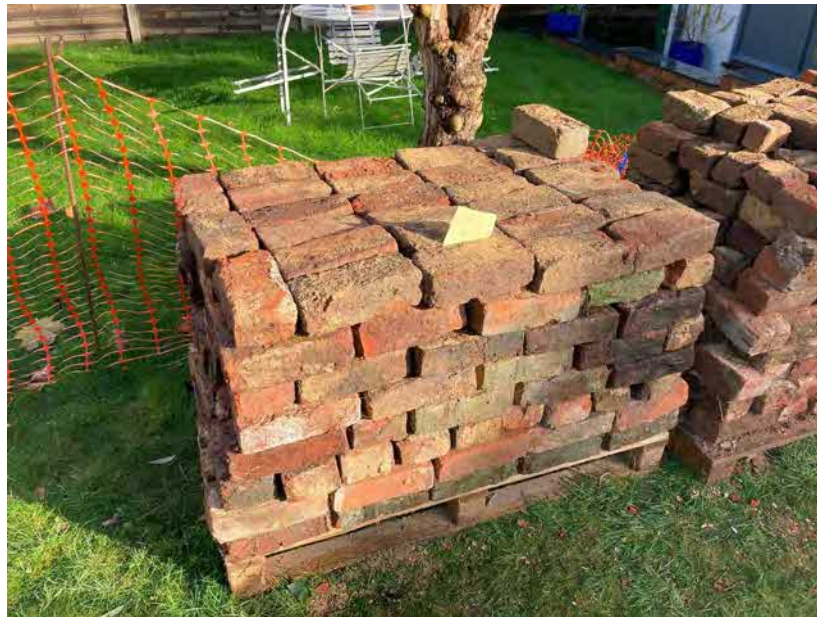
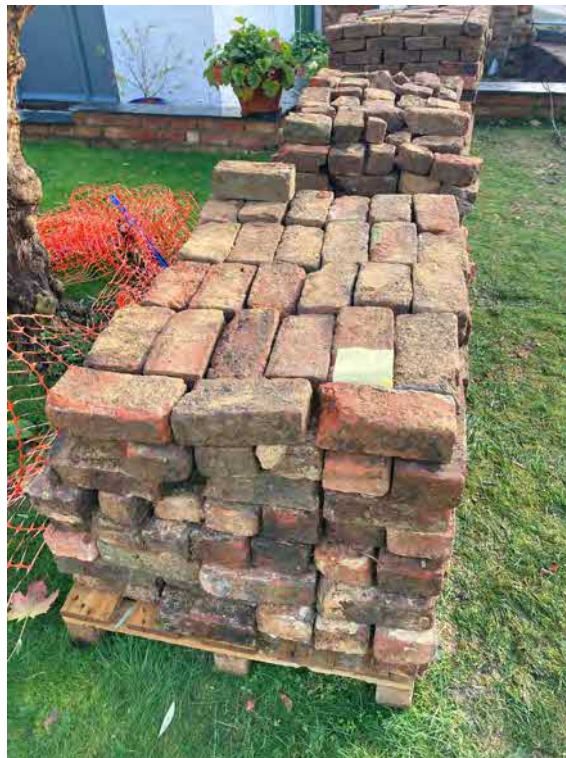
Stack 8 selected for reuse subject to final selection during laying*
*have at least one good face on the stretchers on original inspection
but could expect some limited rejections during the laying process

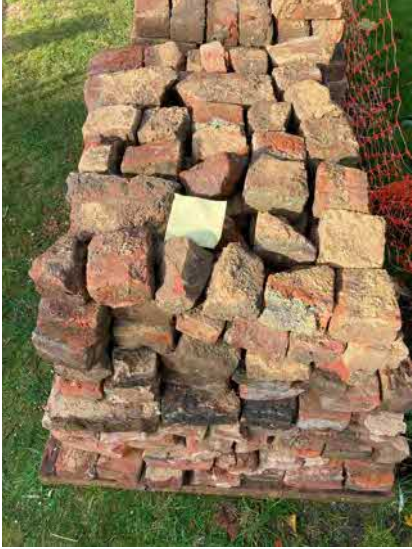
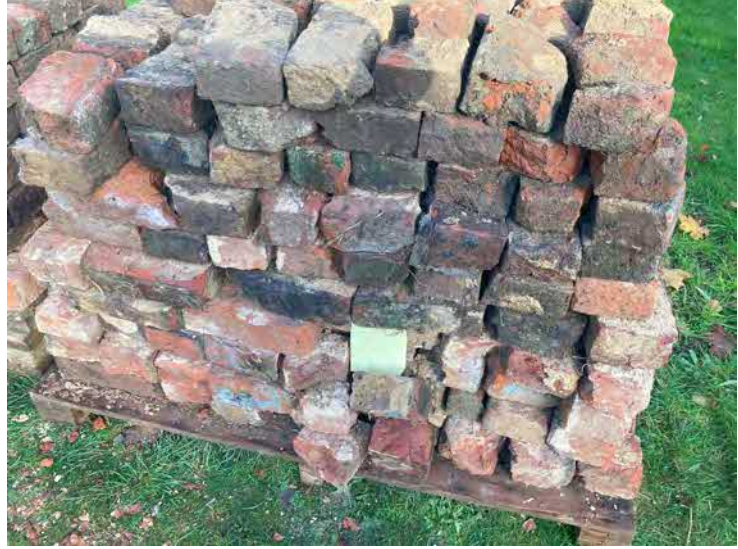
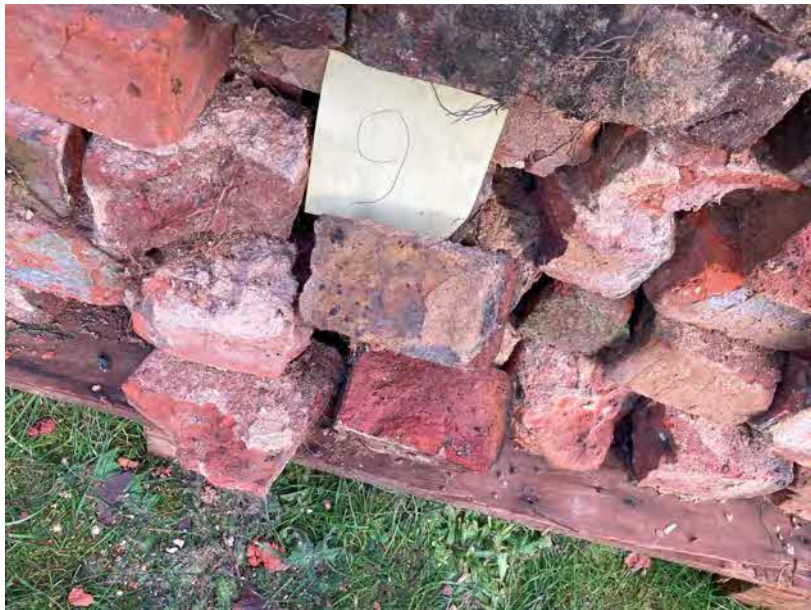
Stack 9 - rejected subject to final hand sort during disposal in case
Any better bricks are in the centre of the stack

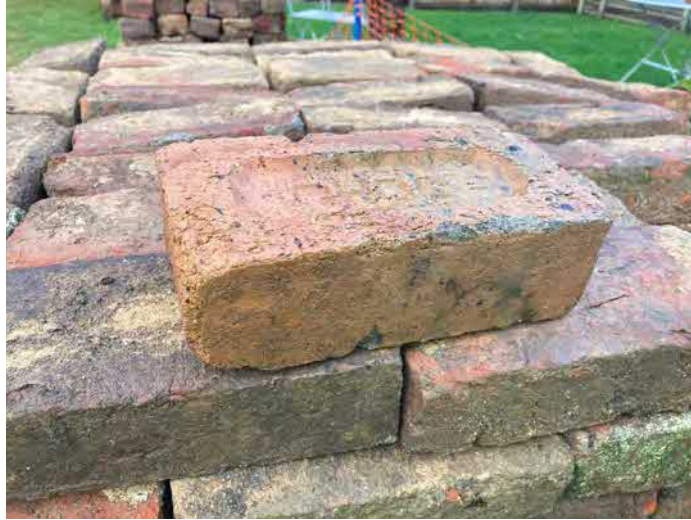
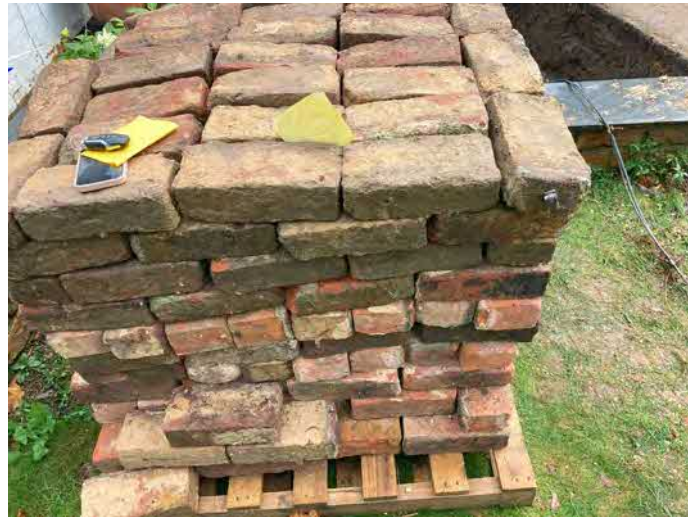
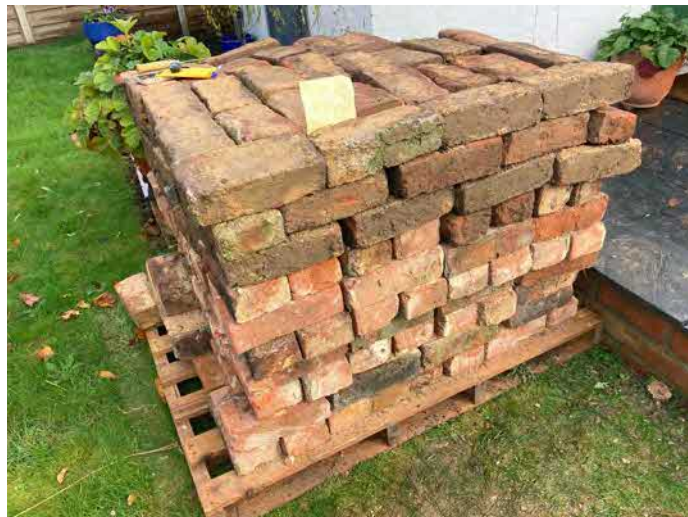
Stack 10 selected for reuse subject to final selection during laying*
*have at least one good face on the stretchers on original inspection
but could expect some limited rejections during the laying process

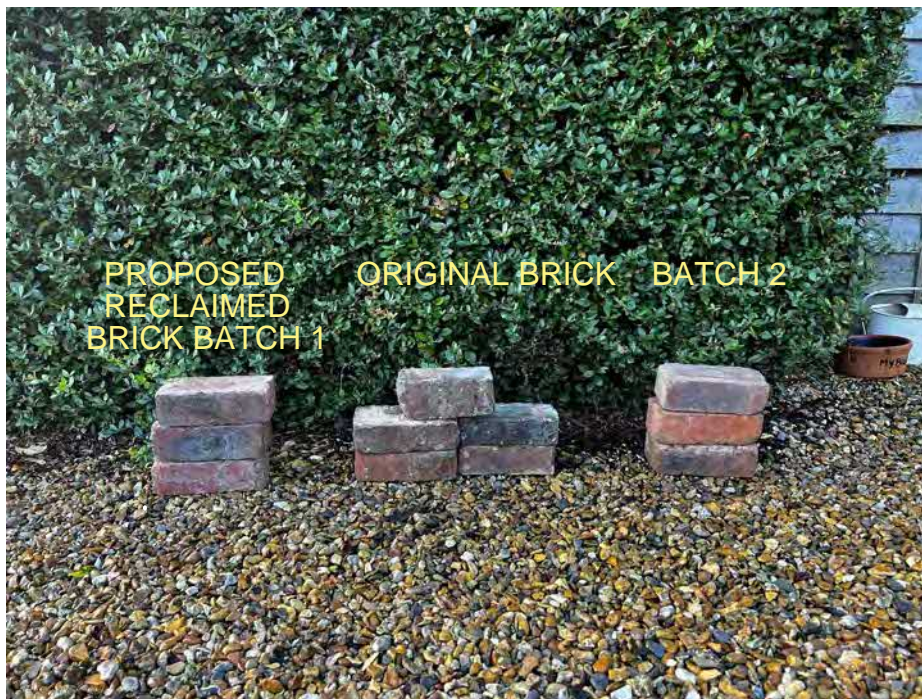
The client has sourced approximately 1000 bricks, shown on the left (in the photo below) which are a very good visual and material match for the original bricks in the centre with additional bricks being made up from a batch matching the bricks on the right which are similar and from the same area as the Darlaston and BHBC brick which are less friable than the very open structured original brick which will be susceptible to frost. The Darlaston and BHBC brick would be used for the capping.

** In Flemish bond every brick would be a full brick with every other brick presenting as a header on the face passing front to back tying the wall together. This would mean that one third of the bricks would be headers (but full bricks). If fiesable the majority of the 600 half bricks should be replaced with bricks from the new batches tying the wall in front to back. If due to the inconsistency of the original bricks this proves impossible or would result in overly large and untidy perp joints it may be necessary to revert to using the half bricks with stainless steel wall ties, fixed in mortar or resin fixed into brick as required.*
