**Arboricultural Implications
Assessment
for a proposed development
at
Land at and adjacent to
Streamside
Harpers Road
Ash
Rev A**

**Client: Bourne Homes Ltd
Langborough House
Beales Lane
Farnham
Surrey
GU10 4PY**

Date
20/11/2023

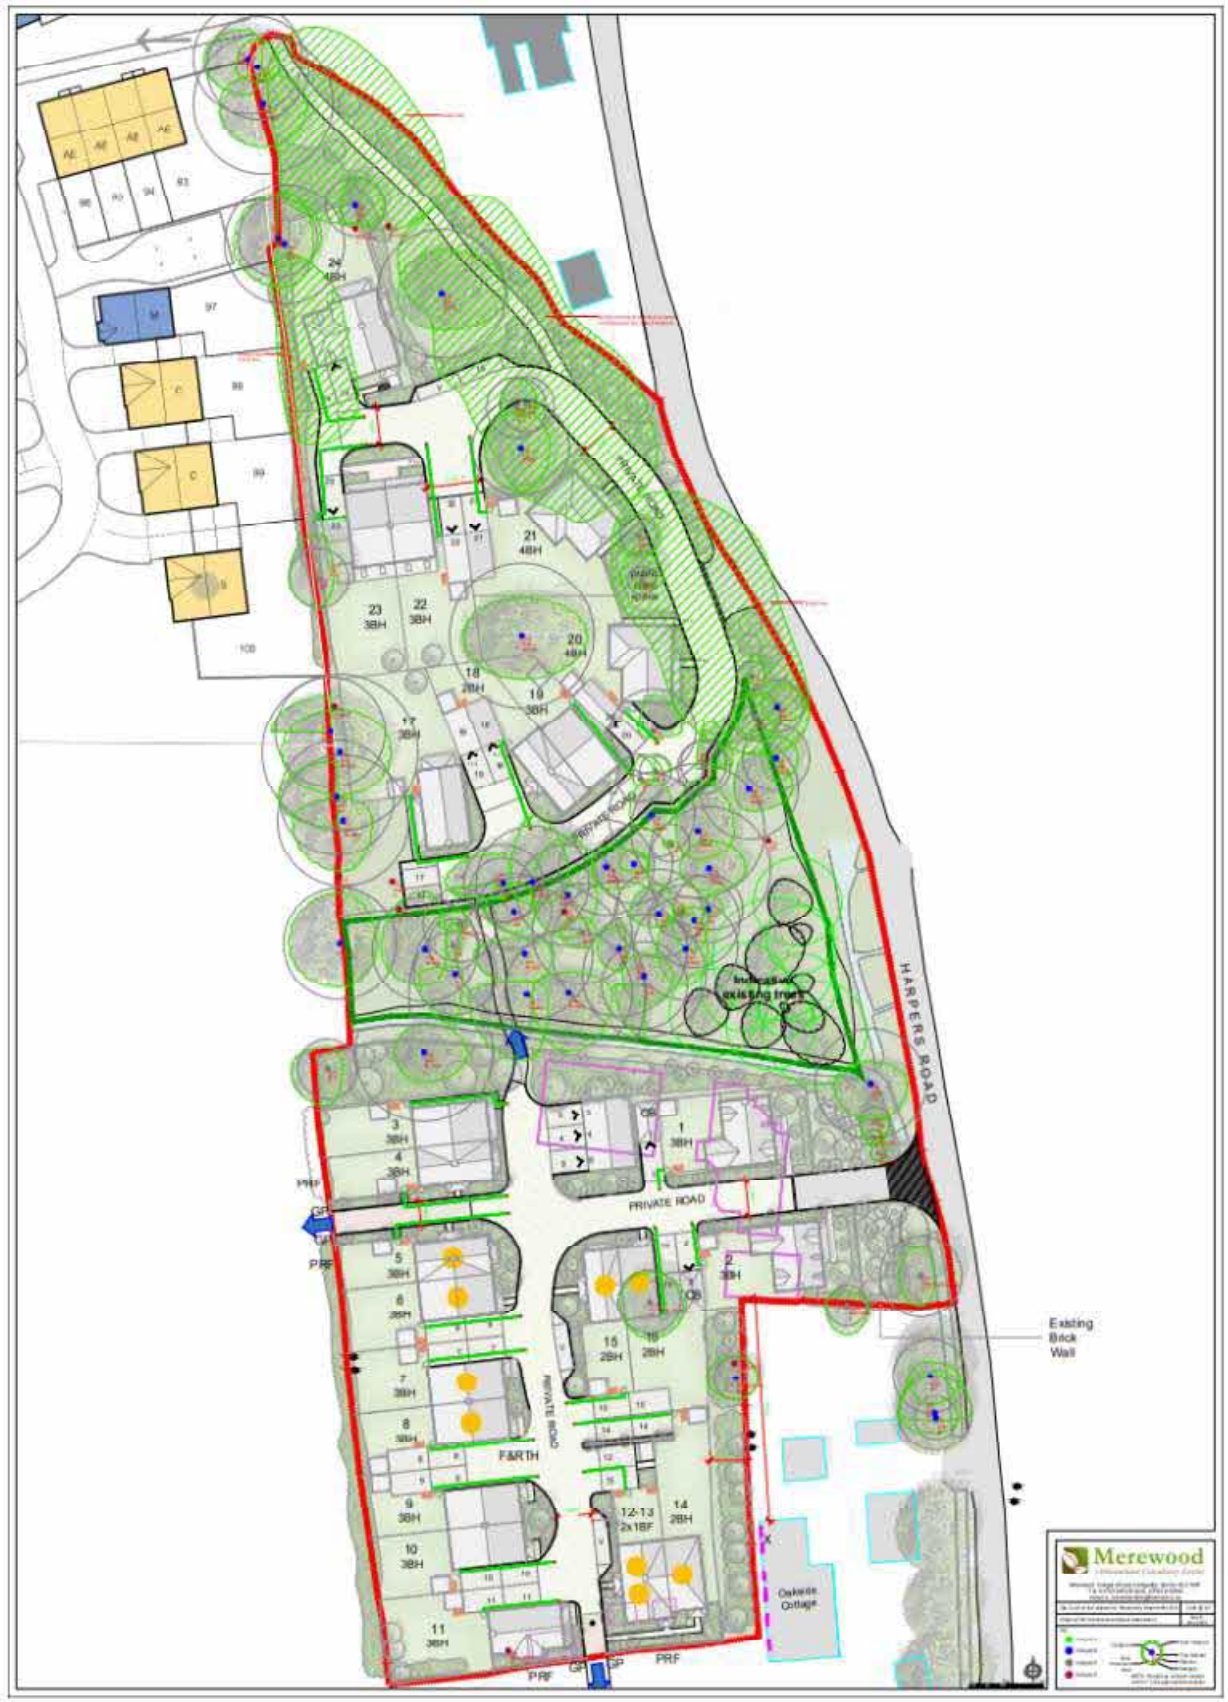
Appendix 4 Impact Assessment Plan

- 3.6.1 The proposed houses are located outside the RPA's of trees to be retained, other than a very small encroachment of the footprint of the houses and the associated cycle stores onto the RPA's of the oaks (T49) and (T55) and the ash (T65). These slight encroachments are so small that they are of no consequence. Furthermore the removal of hard standing areas and the masonry wall will improve the rooting conditions for T66.
- 3.6.2 The excavations of the foundations (whether a strip foundation or a pile foundation is used) will not otherwise impact on the RPA's.
- 3.6.3 The services and drains have not yet been detailed. Normally service trenches connecting with new houses would be routed beneath the driveways of the houses and it can be seen from the tree protection plan that this will be easily
