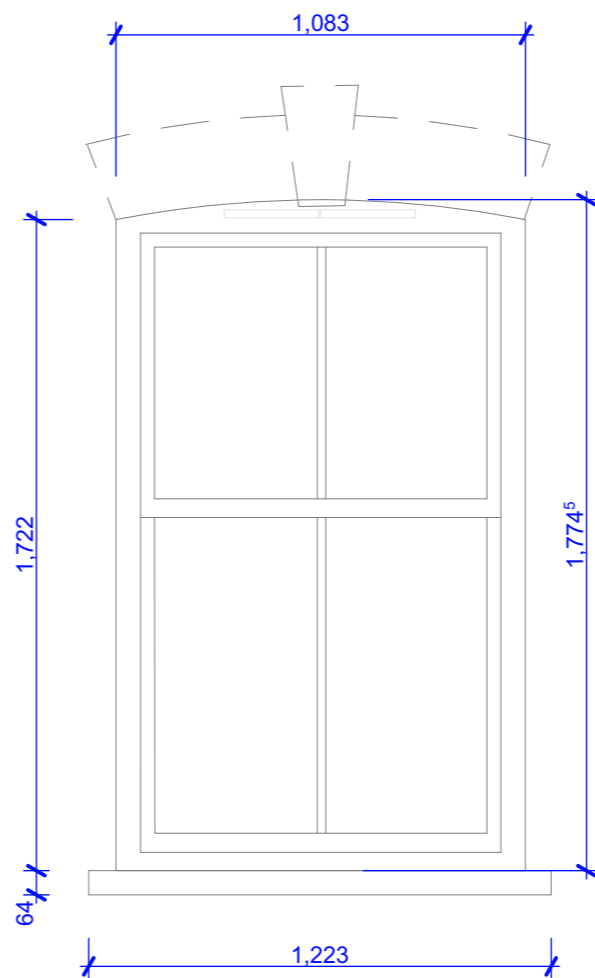
Existing Section 1:20

Existing timber frame window dotted and damage beyond repair.

New uPVC sash window with frame size to match original with trickle vent incorporated to aid ventilation.
