Craigenhigh House Plots Desk Study April 2023

PROJECT TITLE: Craigenhigh House Plots

REPORT TITLE: Desk Study

PROJECT REFERENCE: 153608

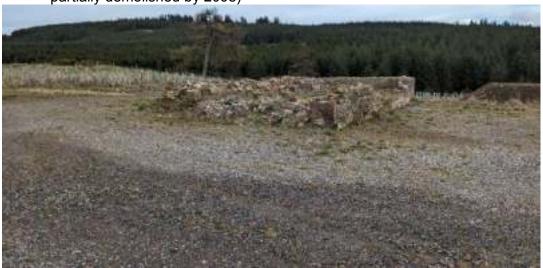
4. Western structure wall detail with discarded materials

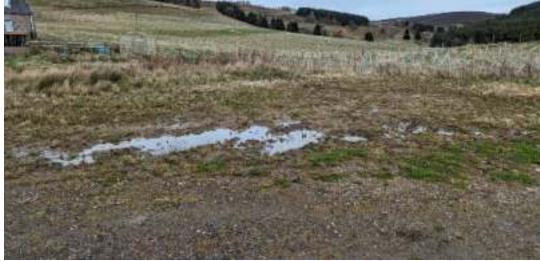
Seepage is noted on northern edge flowing into the site, with further seepage noted flowing offsite from underneath the surface gravels onto the unnamed access road.

6. Northern Boundary, water seepage
