# The Hawthorns

High Street, Thorpe-le-Soken, CO16 OEA

## Proposed Alterations

## Heritage Impact Assessment and Heritage Statement

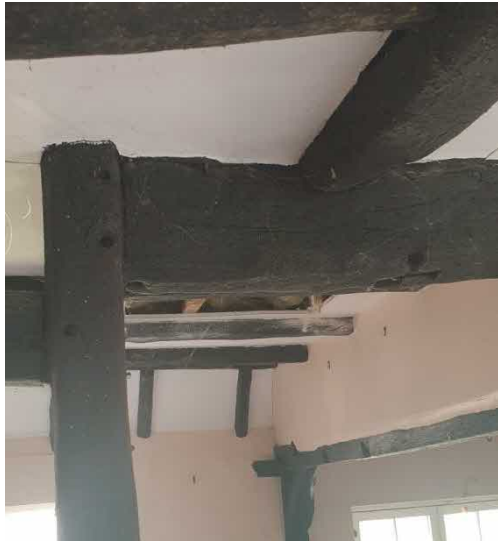
Figure 6, left: Heavy pegged timbers in the kitchen, with heavily scored carpenters marks. Clearly reused from a much older building.

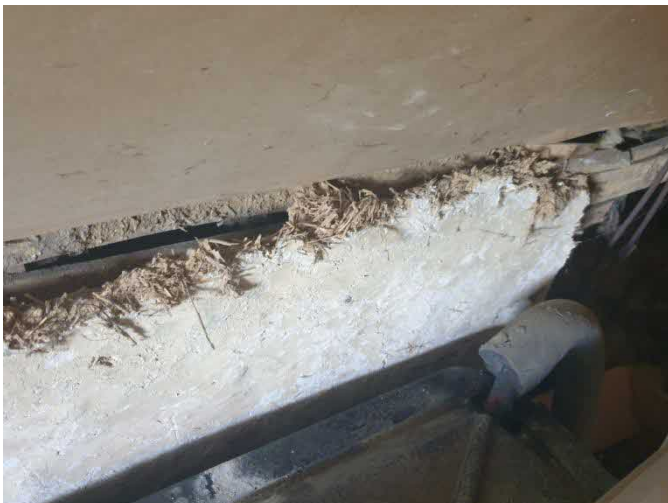
Figure 8, left: In the roof space are panels of riven hardwood laths, coated with daub and finished with a thin lime plaster skim can be seen. This would remain in situ, safely preserved behind new wall finishes.

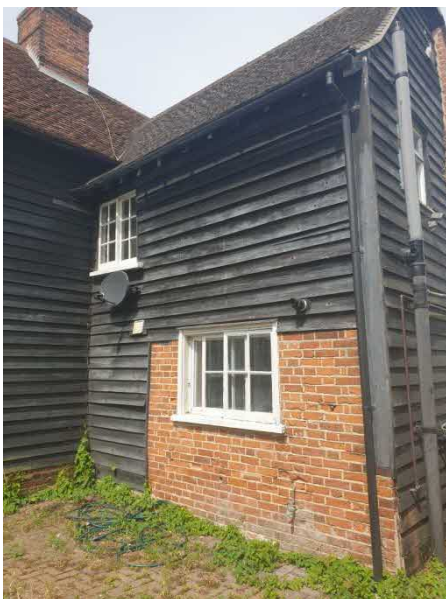
Figure 10, left: The area of weatherboarding to the left of the kitchen window covers the location of a former doorway that appears to have been closed sometime during the 20<sup>th</sup> century.

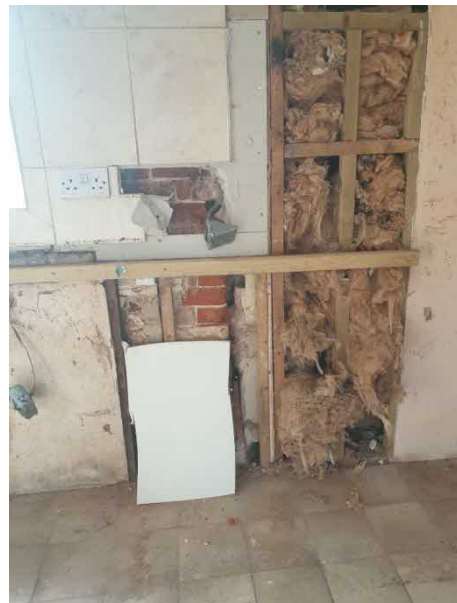
Figure 11, right: Internal view of the infill in the location of the former external door in the kitchen.

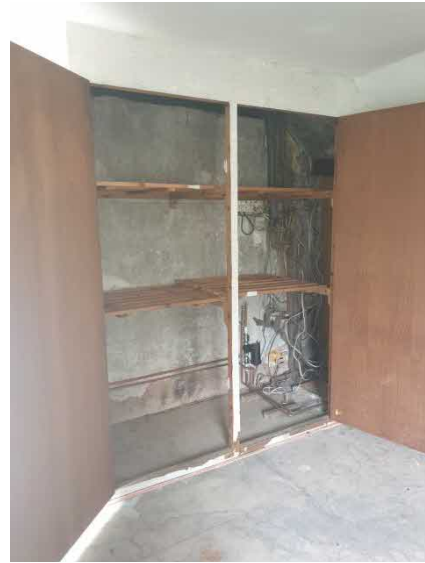
Figure 12, left: Ledged and boarded bathroom door.  
Figure 13, right: The large airing cupboard in the bathroom.

The existing bathroom is unnecessarily large, with an enormous modern airing cupboard taking up much of one wall. This airing cupboard would be removed and the room divided into two to form the family bathroom and a modest third bedroom. The airing cupboard has no historic significance and is poorly built, apparently as a DIY job in the latter part of the 20<sup>th</sup> century. It makes no contribution to the house. The location of the bathroom is in a later rear projection and the division of this space into two would not impede legibility of the historic plan form of the building. The existing bathroom door is a ledged and boarded door of some age. It could be retained in situ or relocated to form the door either to the new family bathroom or the bedroom. However it is very

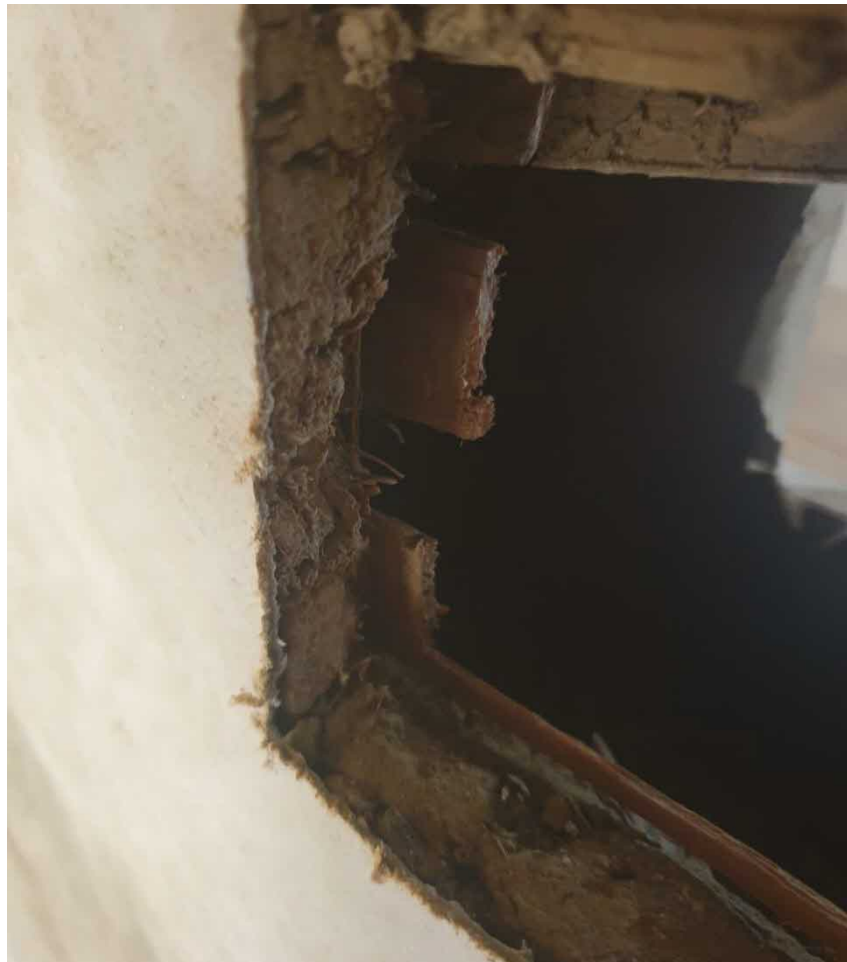
The dividing wall between the two cupboards is of some age. One side of the wall is finished with the lath and daub found elsewhere in the building, the other with modern plasterboard, suggesting that this fabric has been disturbed in the past. The lath and daub wall finish survives extensively at second floor level and in other locations around the building. Its loss in this location therefore would constitute minor harm as it would remain in situ elsewhere in the building. It is of some interest, as lath and lime plaster is more commonly found.

Figure 14: The opened up wall between bedrooms 1 and 2. Sawn softwood laths can be seen here, suggesting a later date than other wall finishes elsewhere in the building. Note the plasterboard finish on the far side of this partition, at the top right of the picture.

In order to avoid losing this small area of historic fabric it could be cut out as a panel, labelled with a note stating its original location and preserved behind the new wall finish elsewhere in the house, for example at second floor level where new wall finishes will be required anyway. This ensures that the historic fabric would remain within the building and could be returned to its original position if required in the future, as its original location would be documented on the panel in perpetuity.

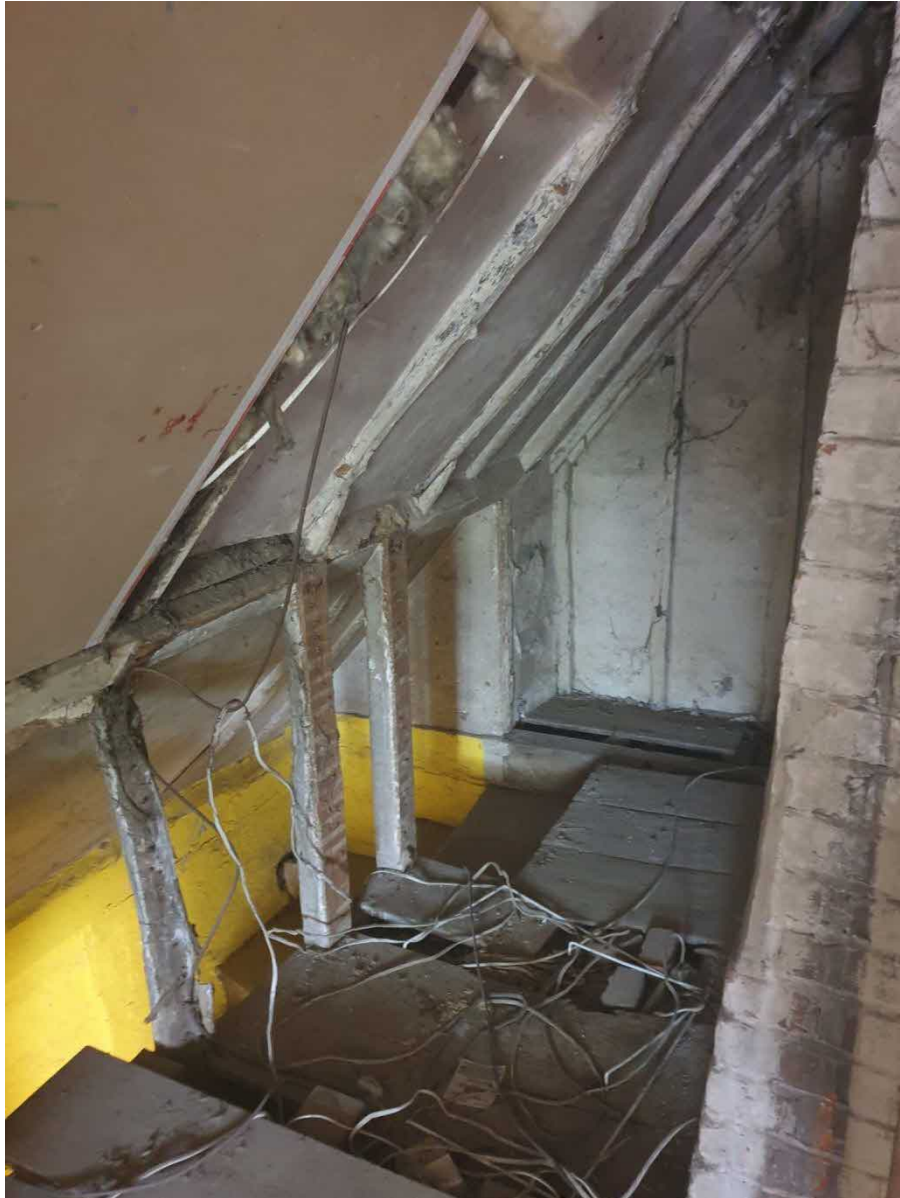
An historic staircase leads up to the second floor level although no adjustment has been made in the roof to accommodate head-height while climbing the stairs. This necessitates going upstairs in an almost crouching position and the safest way to descend is feet first, sitting on the steps and working slowly downwards. Clearly the current arrangement is unsafe and inappropriate for modern living.

Figure 15: The stairwell is painted yellow. This photo clearly shows the inadequate head height above the stairs, making them unsafe to use. The vertical timbers show evidence of lath and plaster wall finishes, removed at some point in the past.

It is proposed that the roof should be adapted at the point directly above the staircase to allow the stairs to be used normally and safely without crawling. This would take the form of a lead-topped bulkhead that would read as the top of a small stair tower. The position of the staircase is fortunate as the alteration would need to be on the rear slope on the far side of the two storey rear extension.

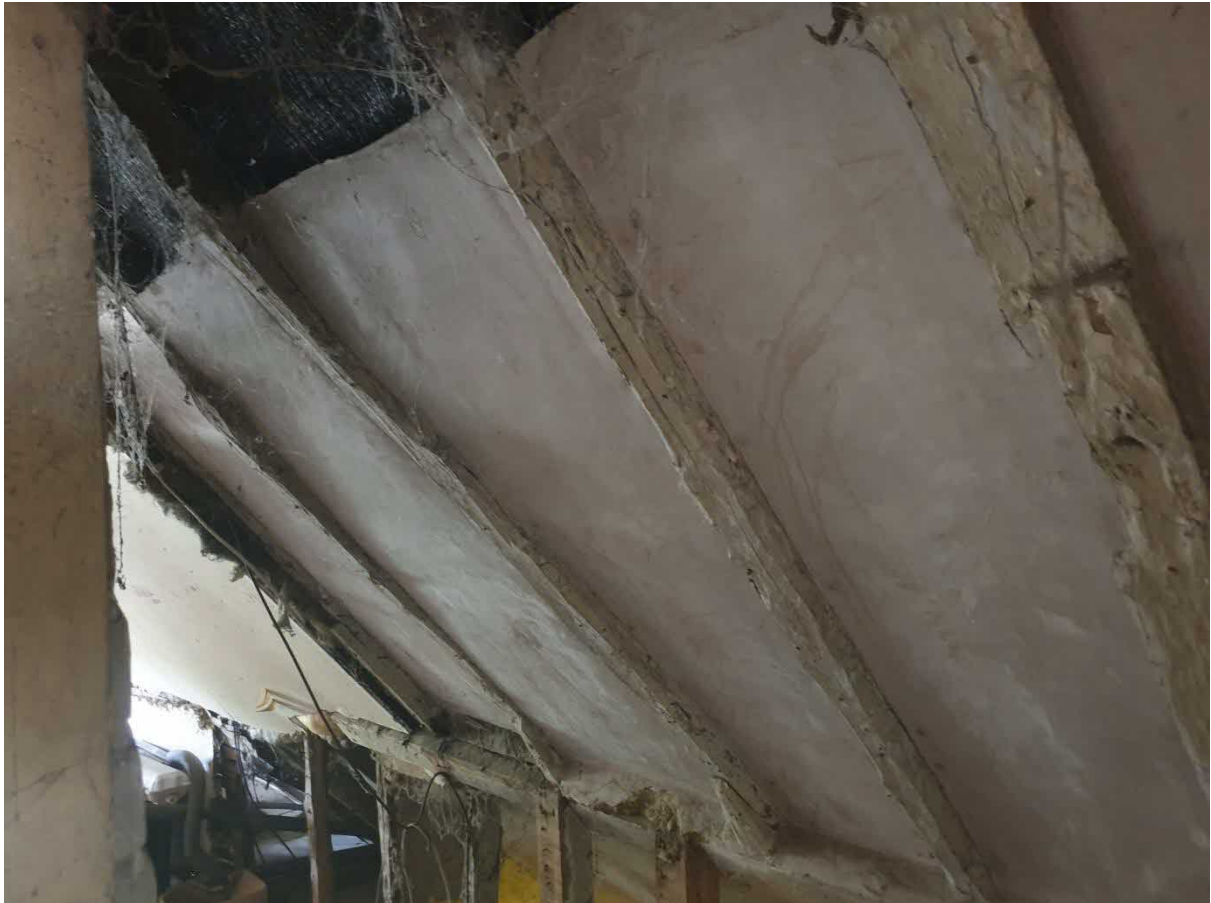
This part of the main roof has a mix of different aged timbers and the two rafters that would be affected are rather thin and flimsy, suggesting that they are probably later infill; the timbers nearer the gable ends are comparatively large and sturdy. If necessary the two rafters could be relocated elsewhere in the building or concealed behind wall finishes, but given their later date and rather poor quality their loss is not considered to be harmful to the significance of the building. They would be recorded before removal.

Figure 16 Two of these undersized rafters would need to be removed to create head height; allowing the stairs to be used safely. The tiny knee braces suggest that they have been retro-fitted. They would be recorded before removal

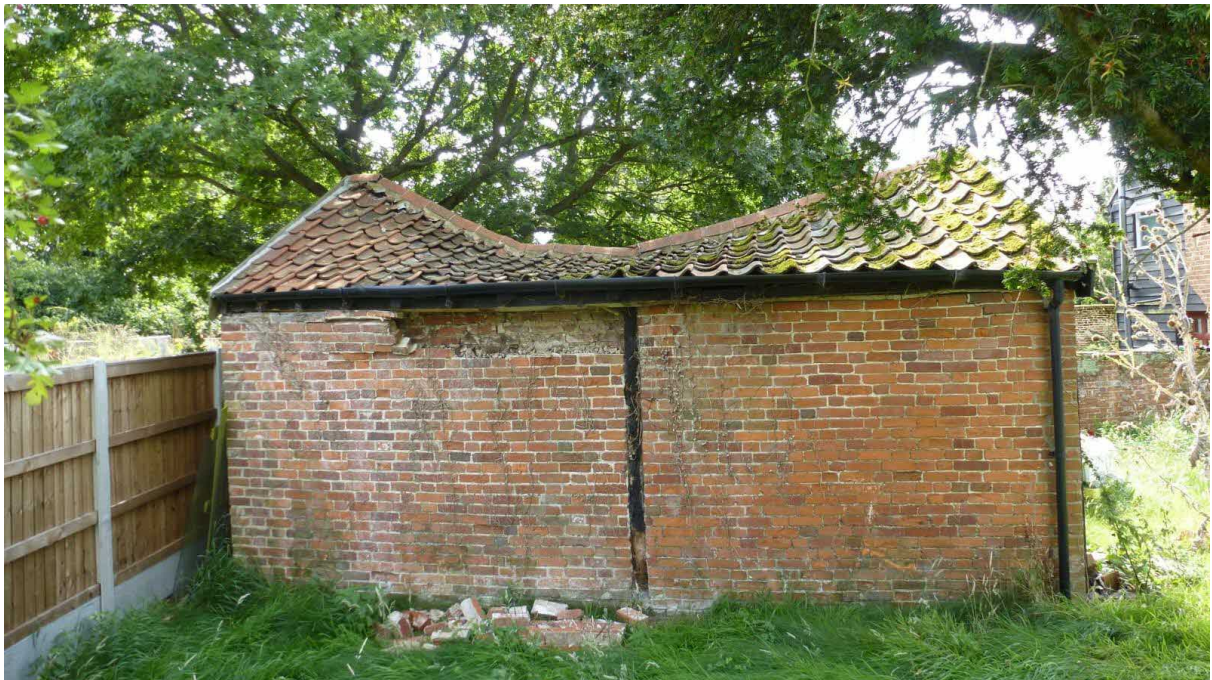
Figure 17: photograph of the old shed in 2014 with its roof partly collapsed

The owner would like to rebuild a small brickwork structure in the back garden that was used by his uncle as a pottery studio until the roof collapsed. The concrete pad on which it stood still remains in the garden so the footprint of the building could be accurately replicated. The structure can perhaps be seen on the Ordnance Survey maps above, as several outbuildings are shown. Some have glass roofs and therefore were presumably greenhouses or glass houses, but others with solid roofs can also be identified in the garden. The dilapidated condition of the outbuilding can be seen in the following photographs taken in 2014.

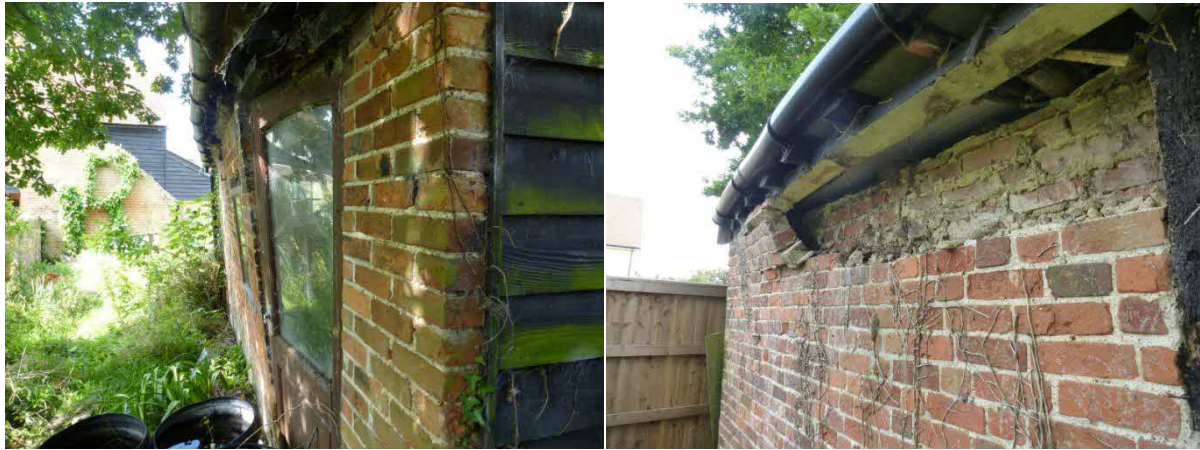
Figure 18, left: The leaning wall of the shed following the collapse of the roof  
 Figure 19, right: the outer skin of brickwork partially collapsed after the roof fell in, exposing the inner skin of brickwork.
