**Re: Wick Quarry – Simplified Geological Summary**

Appendix A      Relevant extracts of: *"Phase 1 Geotechnical Assessment - Preliminary Sources Review and Walkover Survey Report"* by Geo Consulting Engineering Ltd, January 2021, ref: GCE01065/R1.

**Wick Quarry**

**Report: GCE01065/R1**

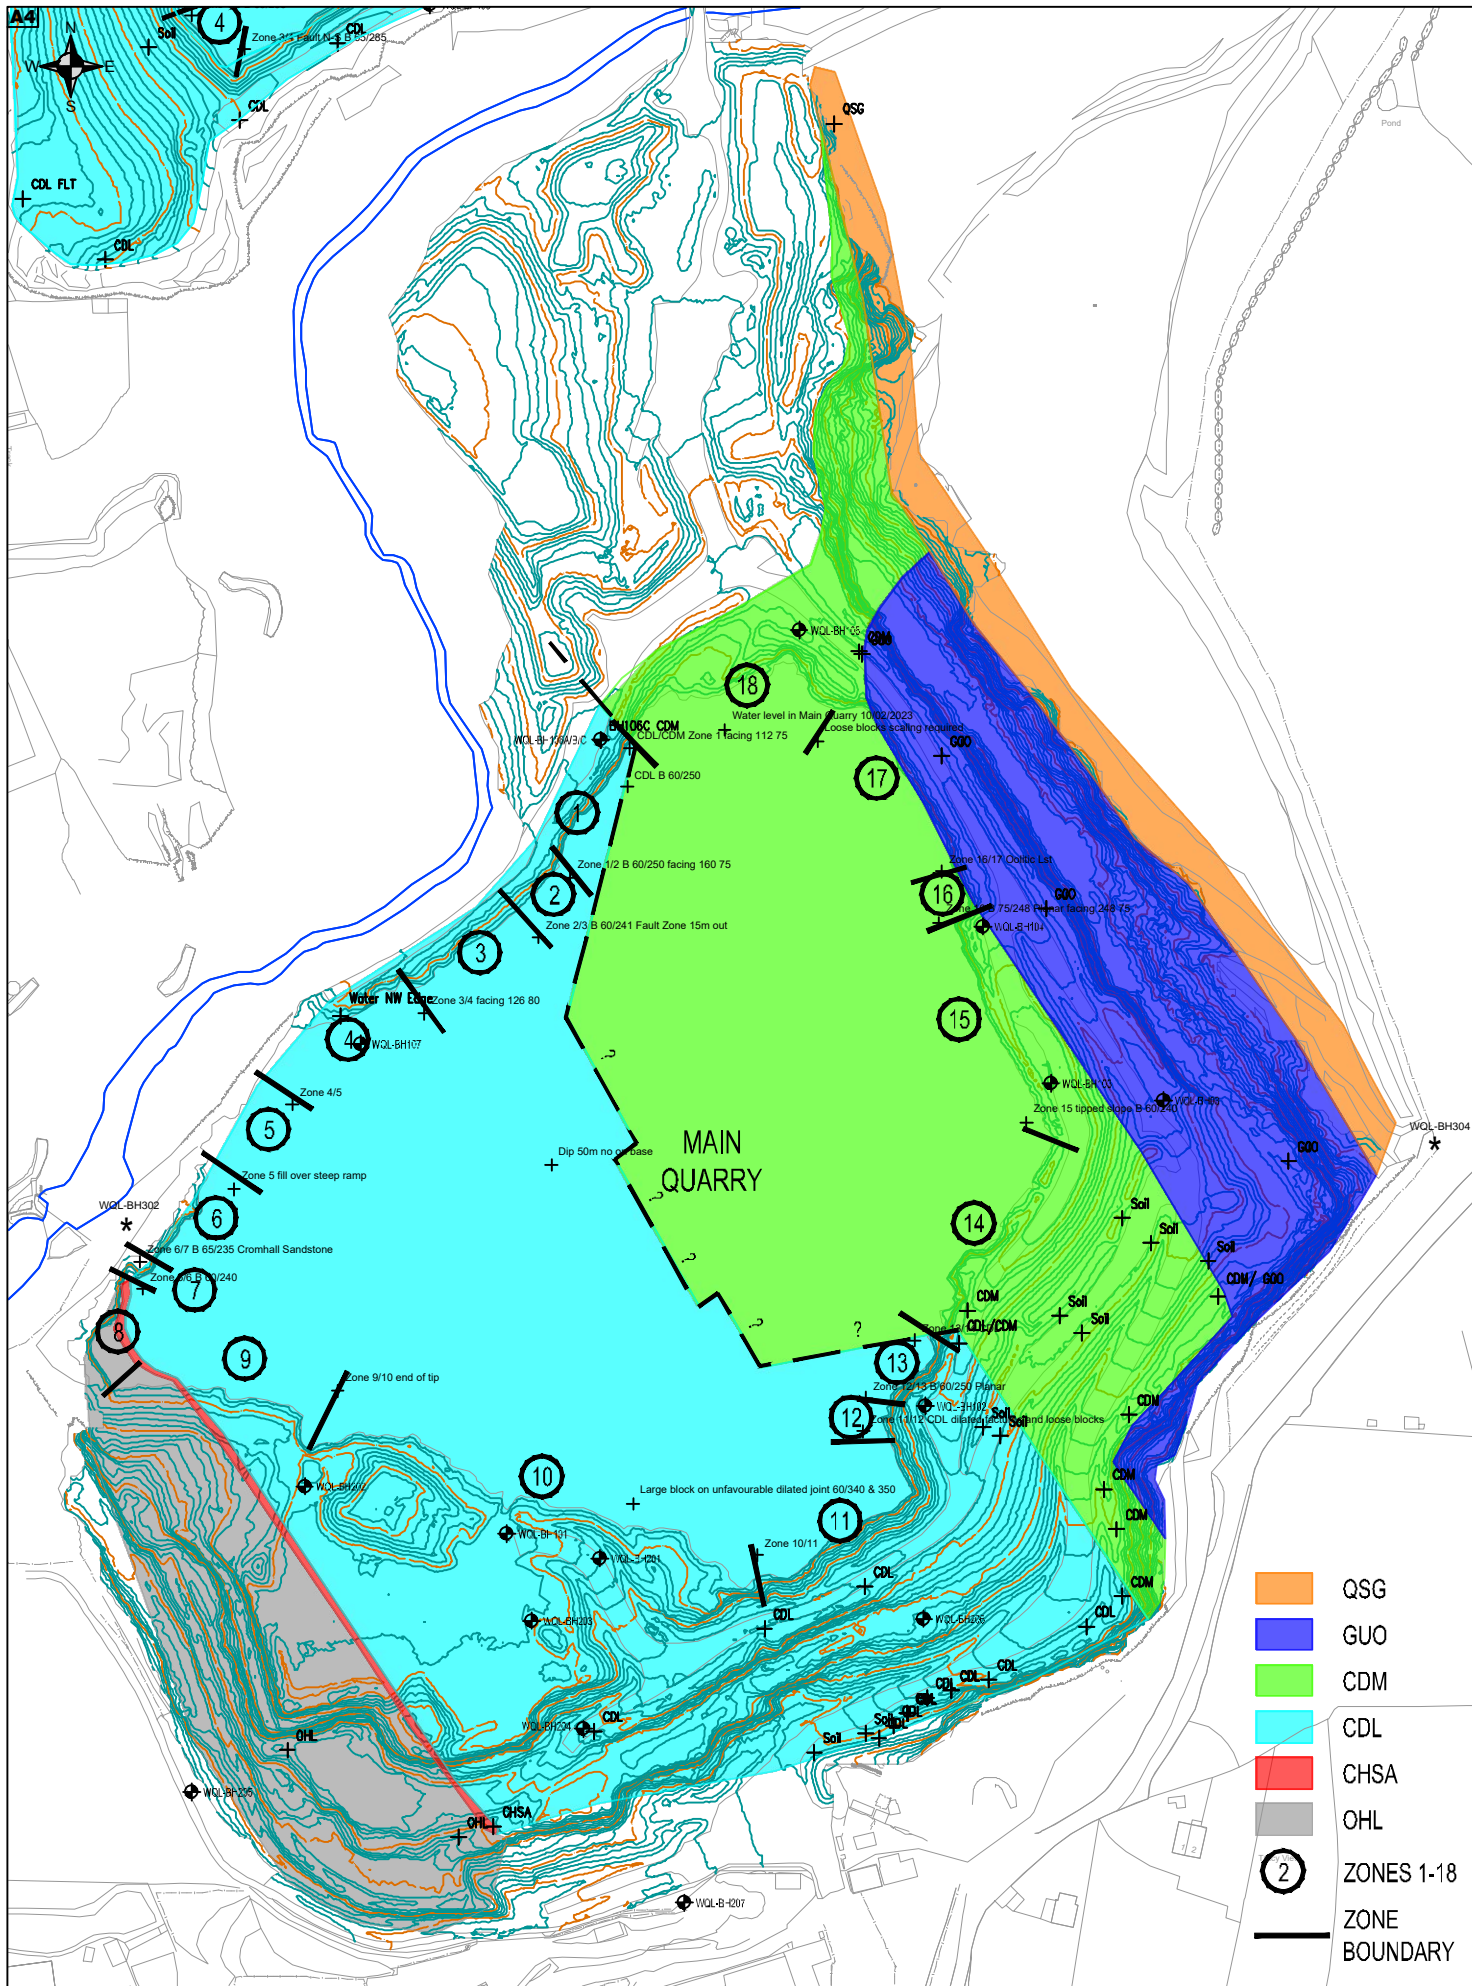
The attached Figures 1 & 2 provide geological maps of Main Quarry and Truebodies respectively.

The Main Quarry void comprises five distinct rock units as summarised in the table below, see the attached Figure 1 for a geological map of Main Quarry:

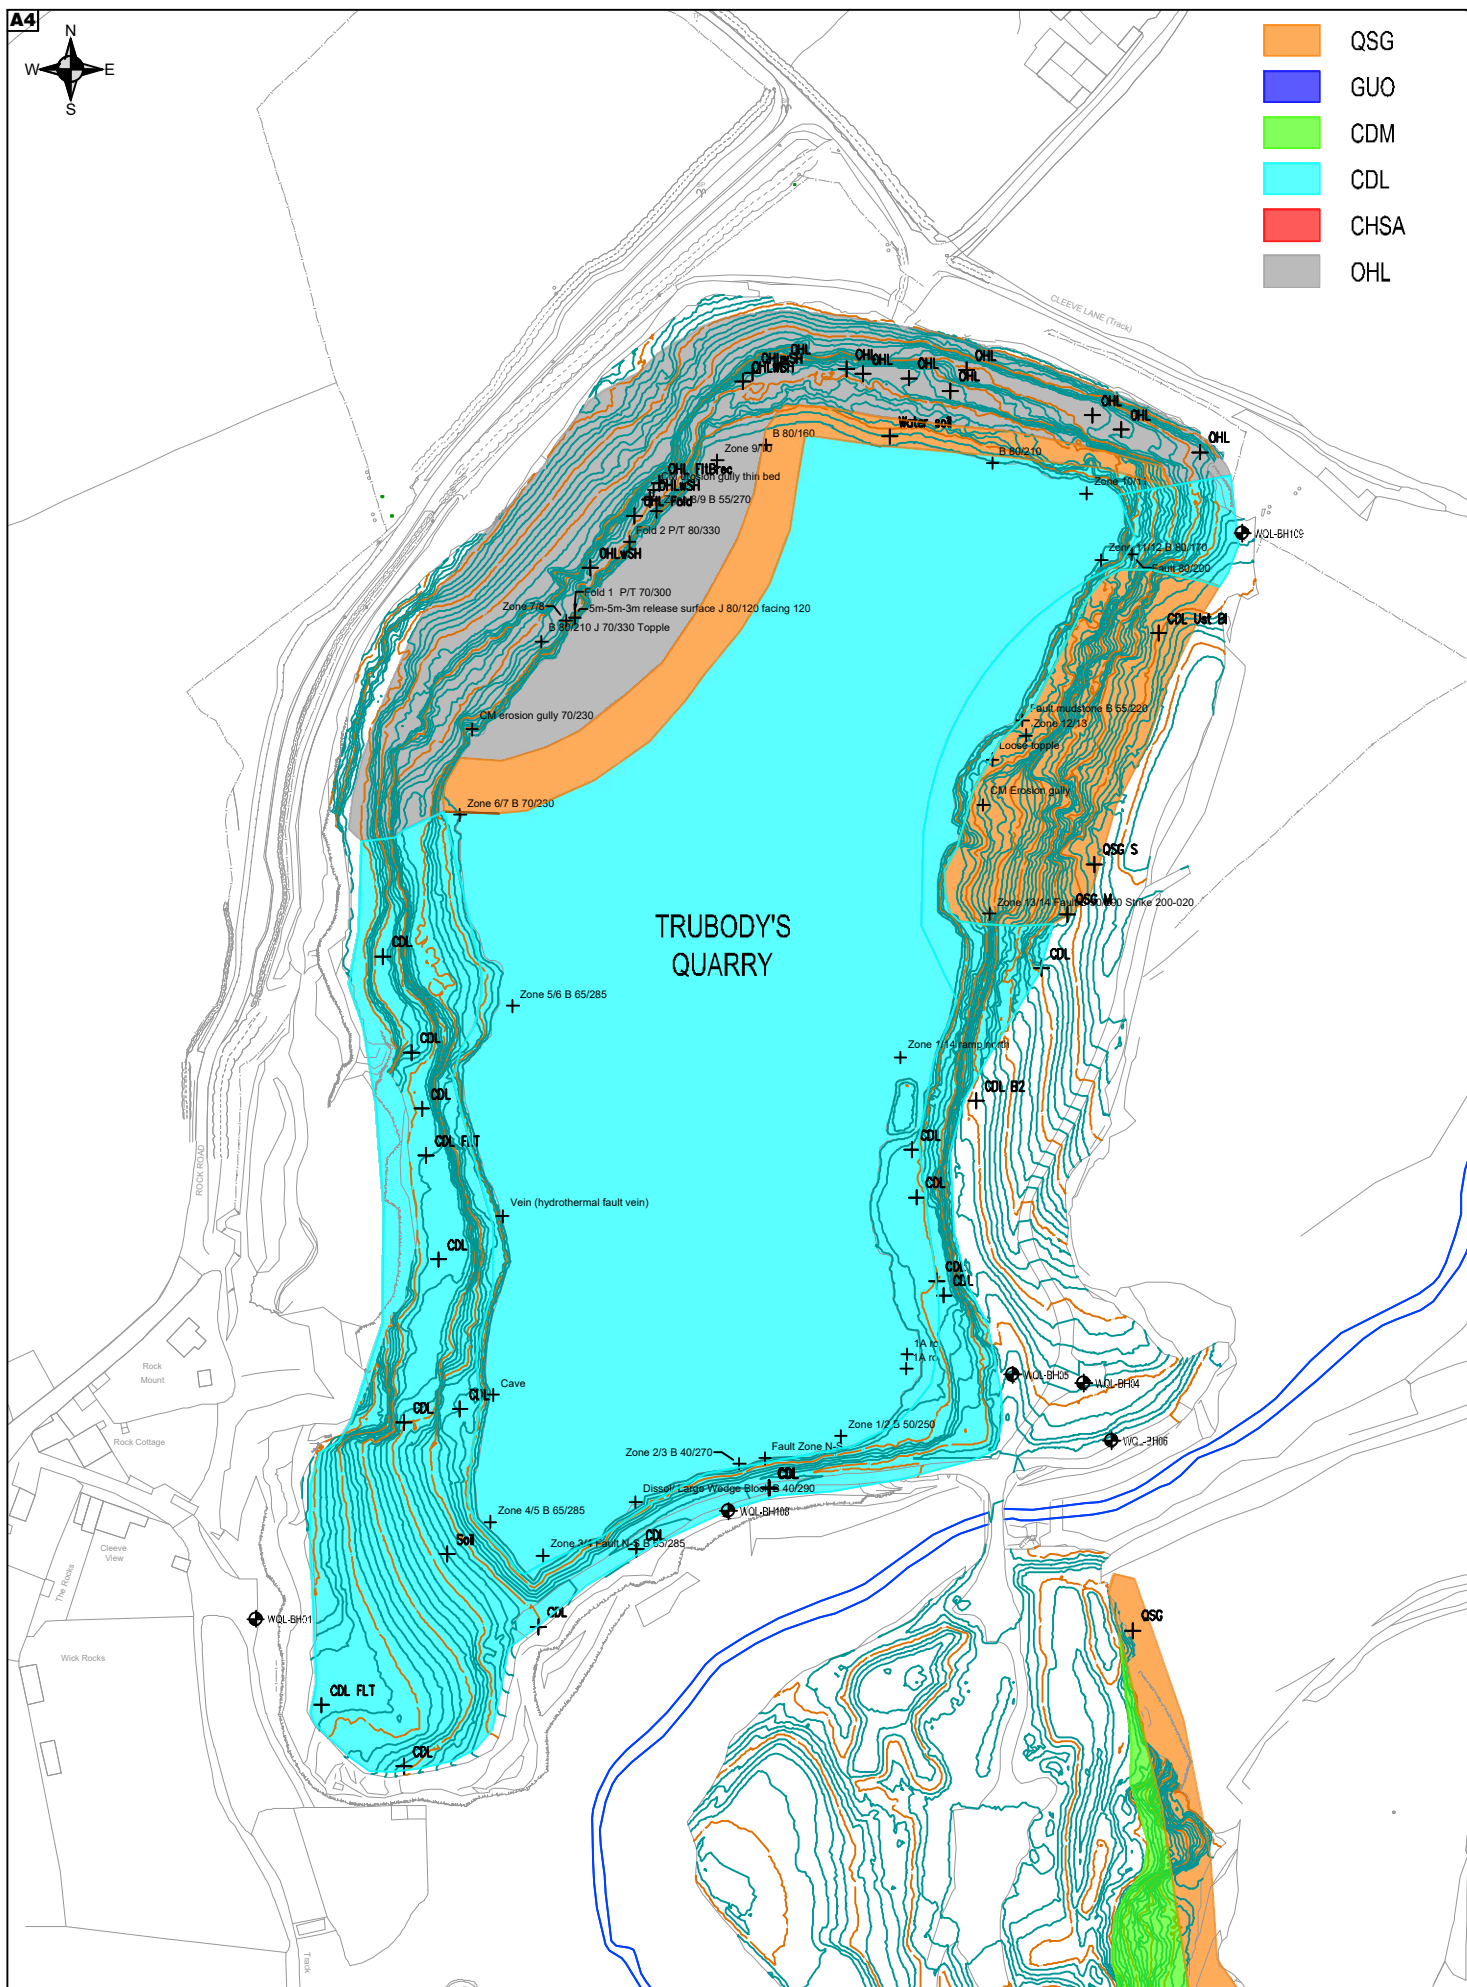
Client: <b>Wick Quarry Limited</b>	
Scale: 1:2500 @ A4	Drawn: HM
Date: June 2023	Checked: PC
Drawing not <b>GCE01065-WS-Fig2</b>	Rev: -

The Truebodies void outcrops fewer rock units but is structurally more complex than Main Quarry. The following table summarises the rock units encountered, see the attached Figure 2 for a geological map of Truebodies:

<p><b>Job Title:</b></p> <p><b>Wick Quarry Wick</b></p>
<p><b>Design Title:</b></p> <p><b>Waterside Survey Zones - Preliminary Engineering Geological Mapping</b></p>

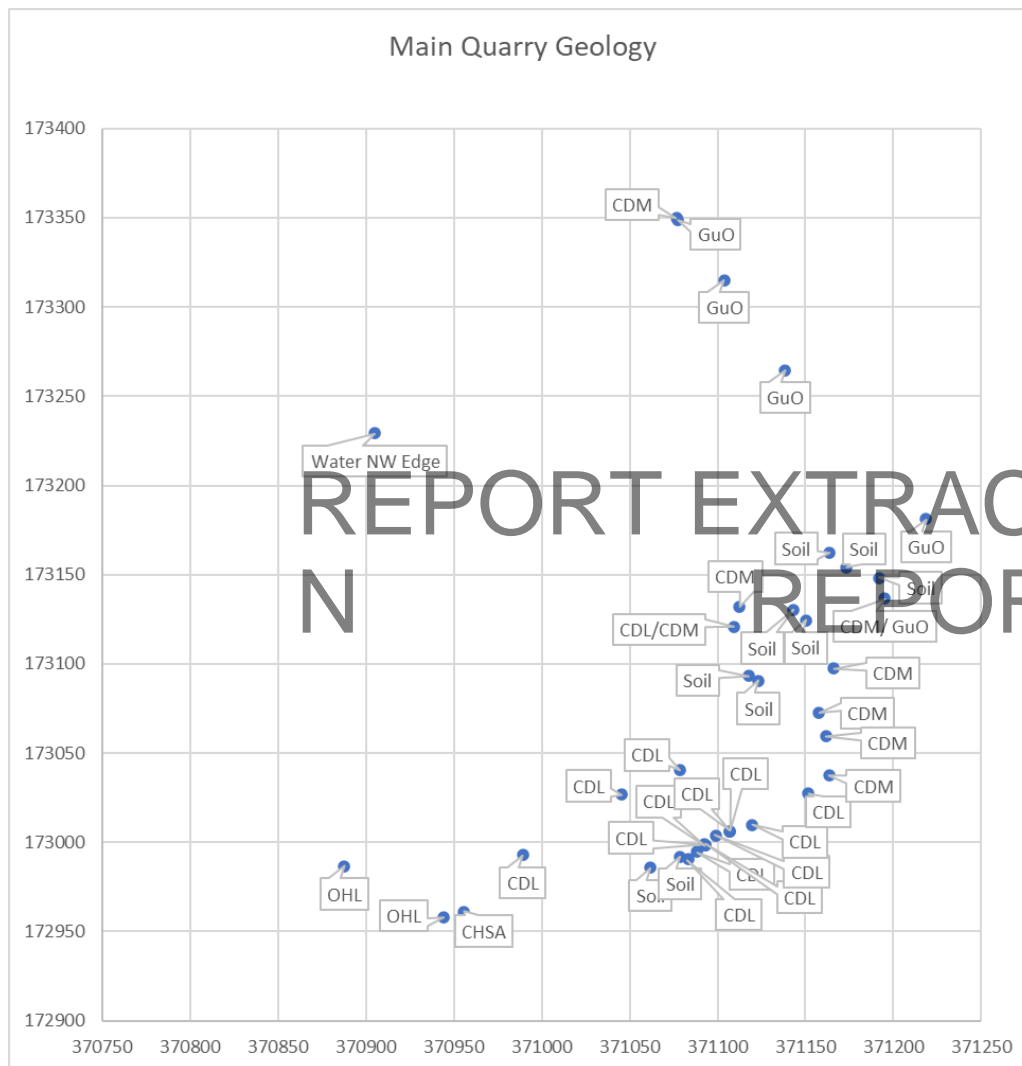
The following plot of points based on eastings and northings shows the identified geological formation at each location:

The above plot combined with the walkover survey observations provides the following:

- South Slope characterised by Clifton Down Limestone. A 4m bed of Cromhall Sandstone was encountered on the west boundary of the CDL and Oxhill Head Limestone to the west of the CHSA. Soil filled berms and haul roads present.

A groundwater monitoring borehole is recommended on the south side of the quarry within the Clifton Down Limestone.
