# ***ARBORICULTURAL IMPACT ASSESSMENT***

## **PROPOSED COMMERCIAL DEVELOPMENT – TOR HILL WORKS, CONSTITUTION HILL, WELLS, SOMERSET, BA5 3NT**

August 2023

## **Arboricultural Impact Assessment**

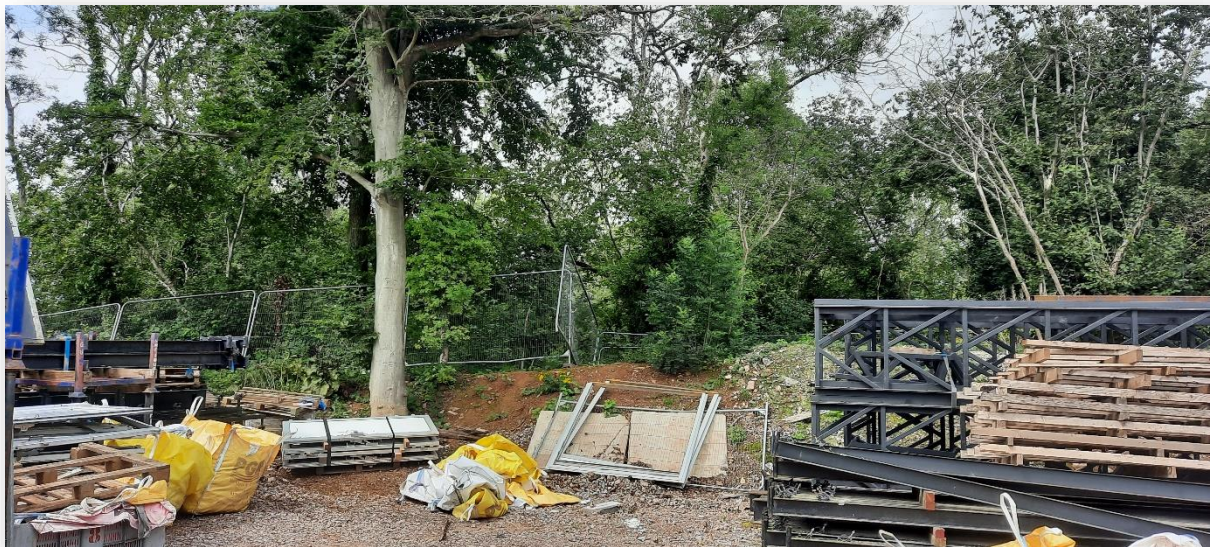
*View looking south to the temporary storage close to the Beech, T4.*

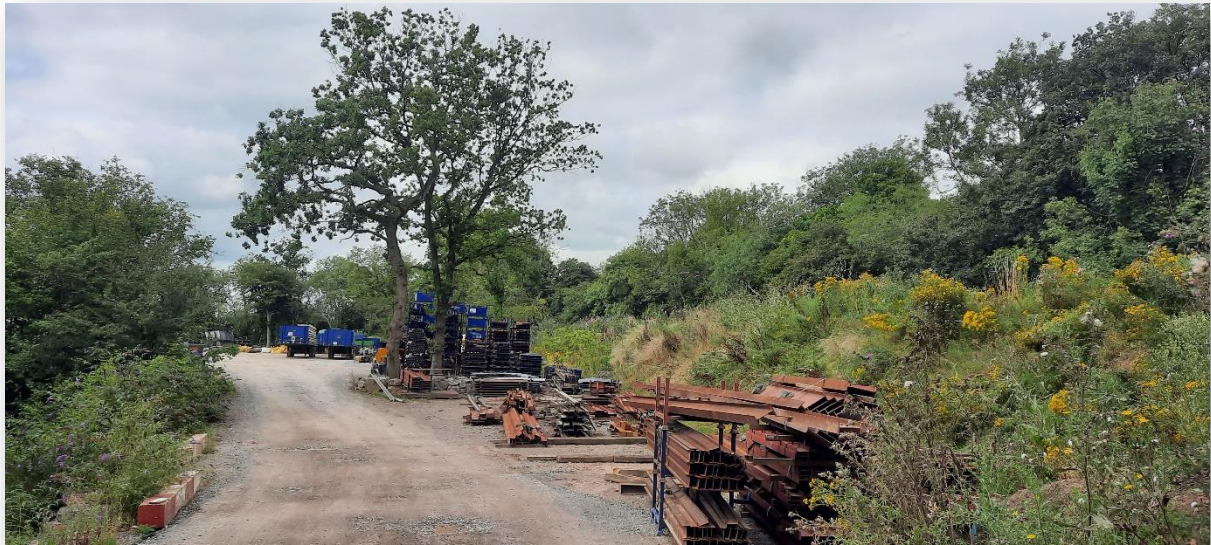
*View looking south-west along the access track towards the storage area with the two Oak trees, T7 and T8, in the near middle ground.*

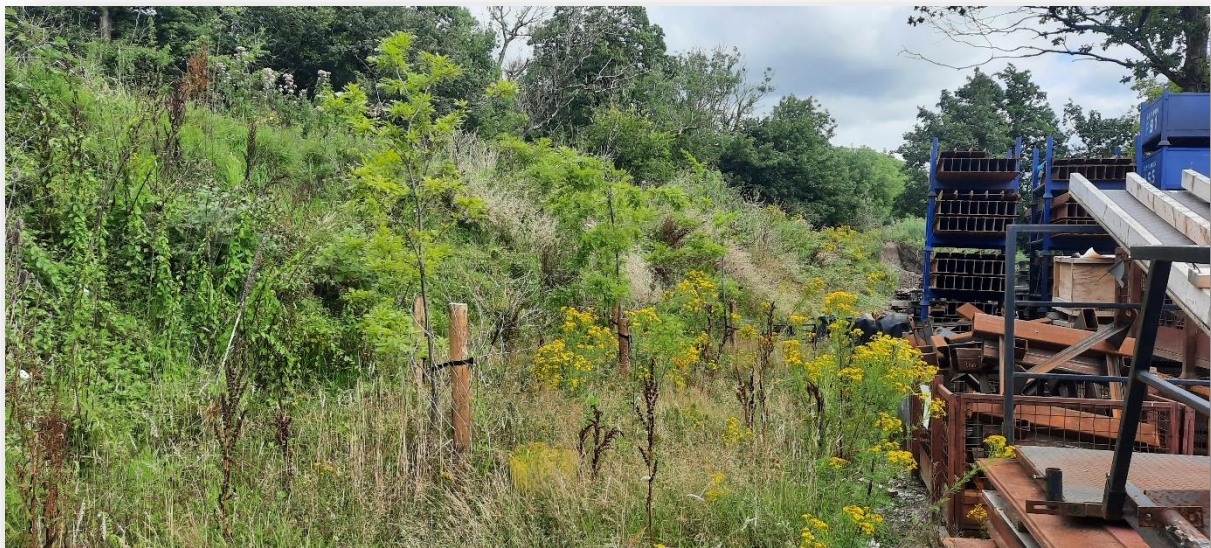
*The western boundary embankment showing some new tree planting.*

There is scope for replanting along the western boundary with Hazel planted at 3m centres. On the sides of the banks and with trees, such as Field Maple, along the top of the bank.

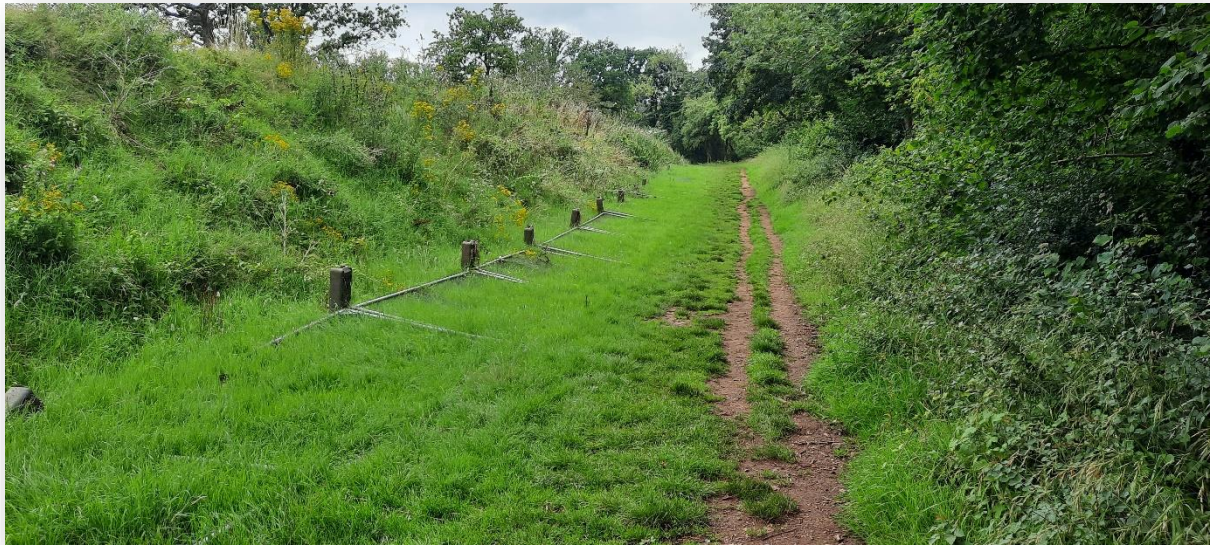
*View looking west along the public footpath with the embankment on the left of the photograph.*
