Ref: 23207 – KIRLAND MANOR, BODMIN

## HERITAGE & PLANNING STATEMENT

ON: KIRLAND MANOR, BODMIN, PL30 5AA

DATE: SEPTEMBER 2023

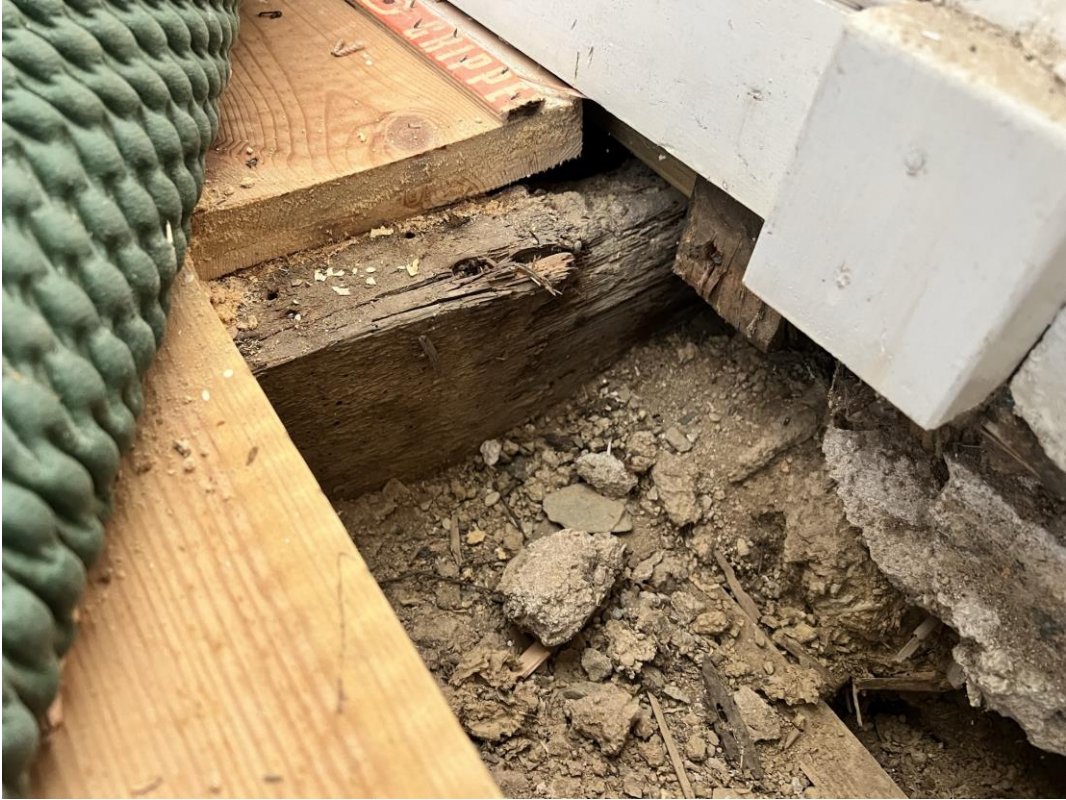
The floor joists to the landing at first floor are currently undersized and in poor condition; please refer to appended photographs.

Figure 2 - Photograph showing rotten floor joists to first floor landing.

The existing floor joists to the landing area will remain unaltered, and new 60x170mm deep timber joists will be installed alongside at a maximum spacing of 300mm. The existing finishes that were removed will be reinstated. It is assumed that the ceiling finish below is lath and plaster – this will be repaired as required.

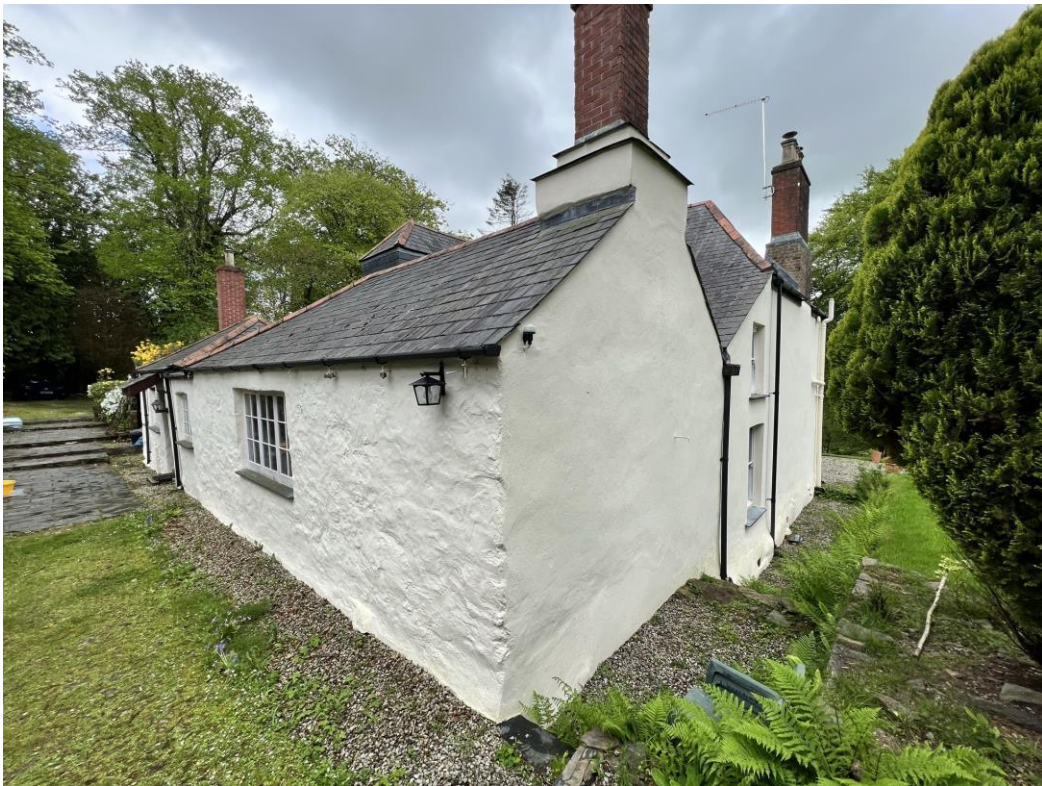
Particularly to the North elevation, the internal face of the external wall has signs of damp ingress which could lead to further deterioration of the building. This elevation is currently finished with a cement-based render.

Figure 3 - Photograph showing North elevation.

The North elevation cement render will be removed, and the wall will be allowed to dry out. When a satisfactory moisture level is achieved, the wall will be repointed with a lime-based mortar and finished with a lime-based render.

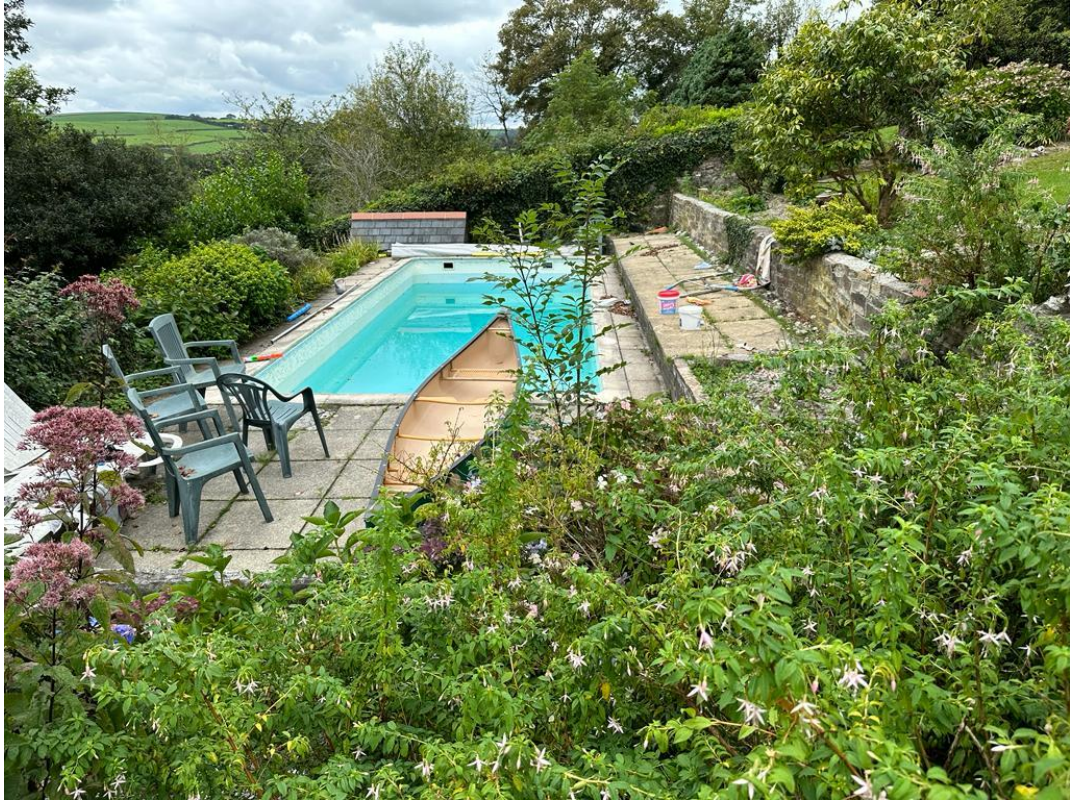
The existing external pool has been poorly maintained.

Figure 4 – Photograph showing existing pool.

The existing pool is to be replaced to match existing size and position, with a new terrace area to the North. A new block retaining wall will be required in order to form a larger terrace area. The retaining wall will be finished with painted render.

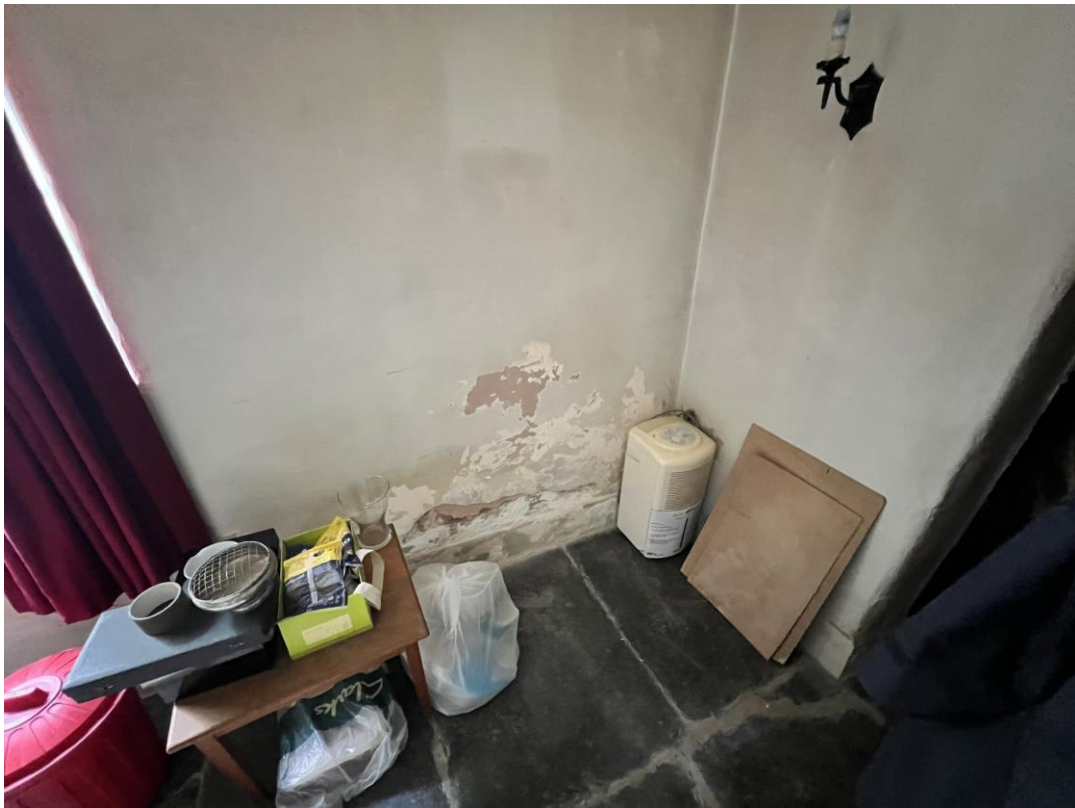
Figure 5 – Photograph showing damp staining and plaster blistering.

Internally the Kitchen, Snug and Hallway walls of the North elevation will be stripped of cement finishes and replaced with a lime-based plaster to improve breathability.
