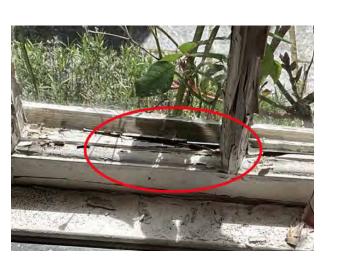
Figure 2: Photographs showing condition of Annexe windows internally.
