## COPPERHOUSE TIDAL GATE OPERATIONAL IMPROVEMENTS

Preliminary Roost Assessment (PRA)

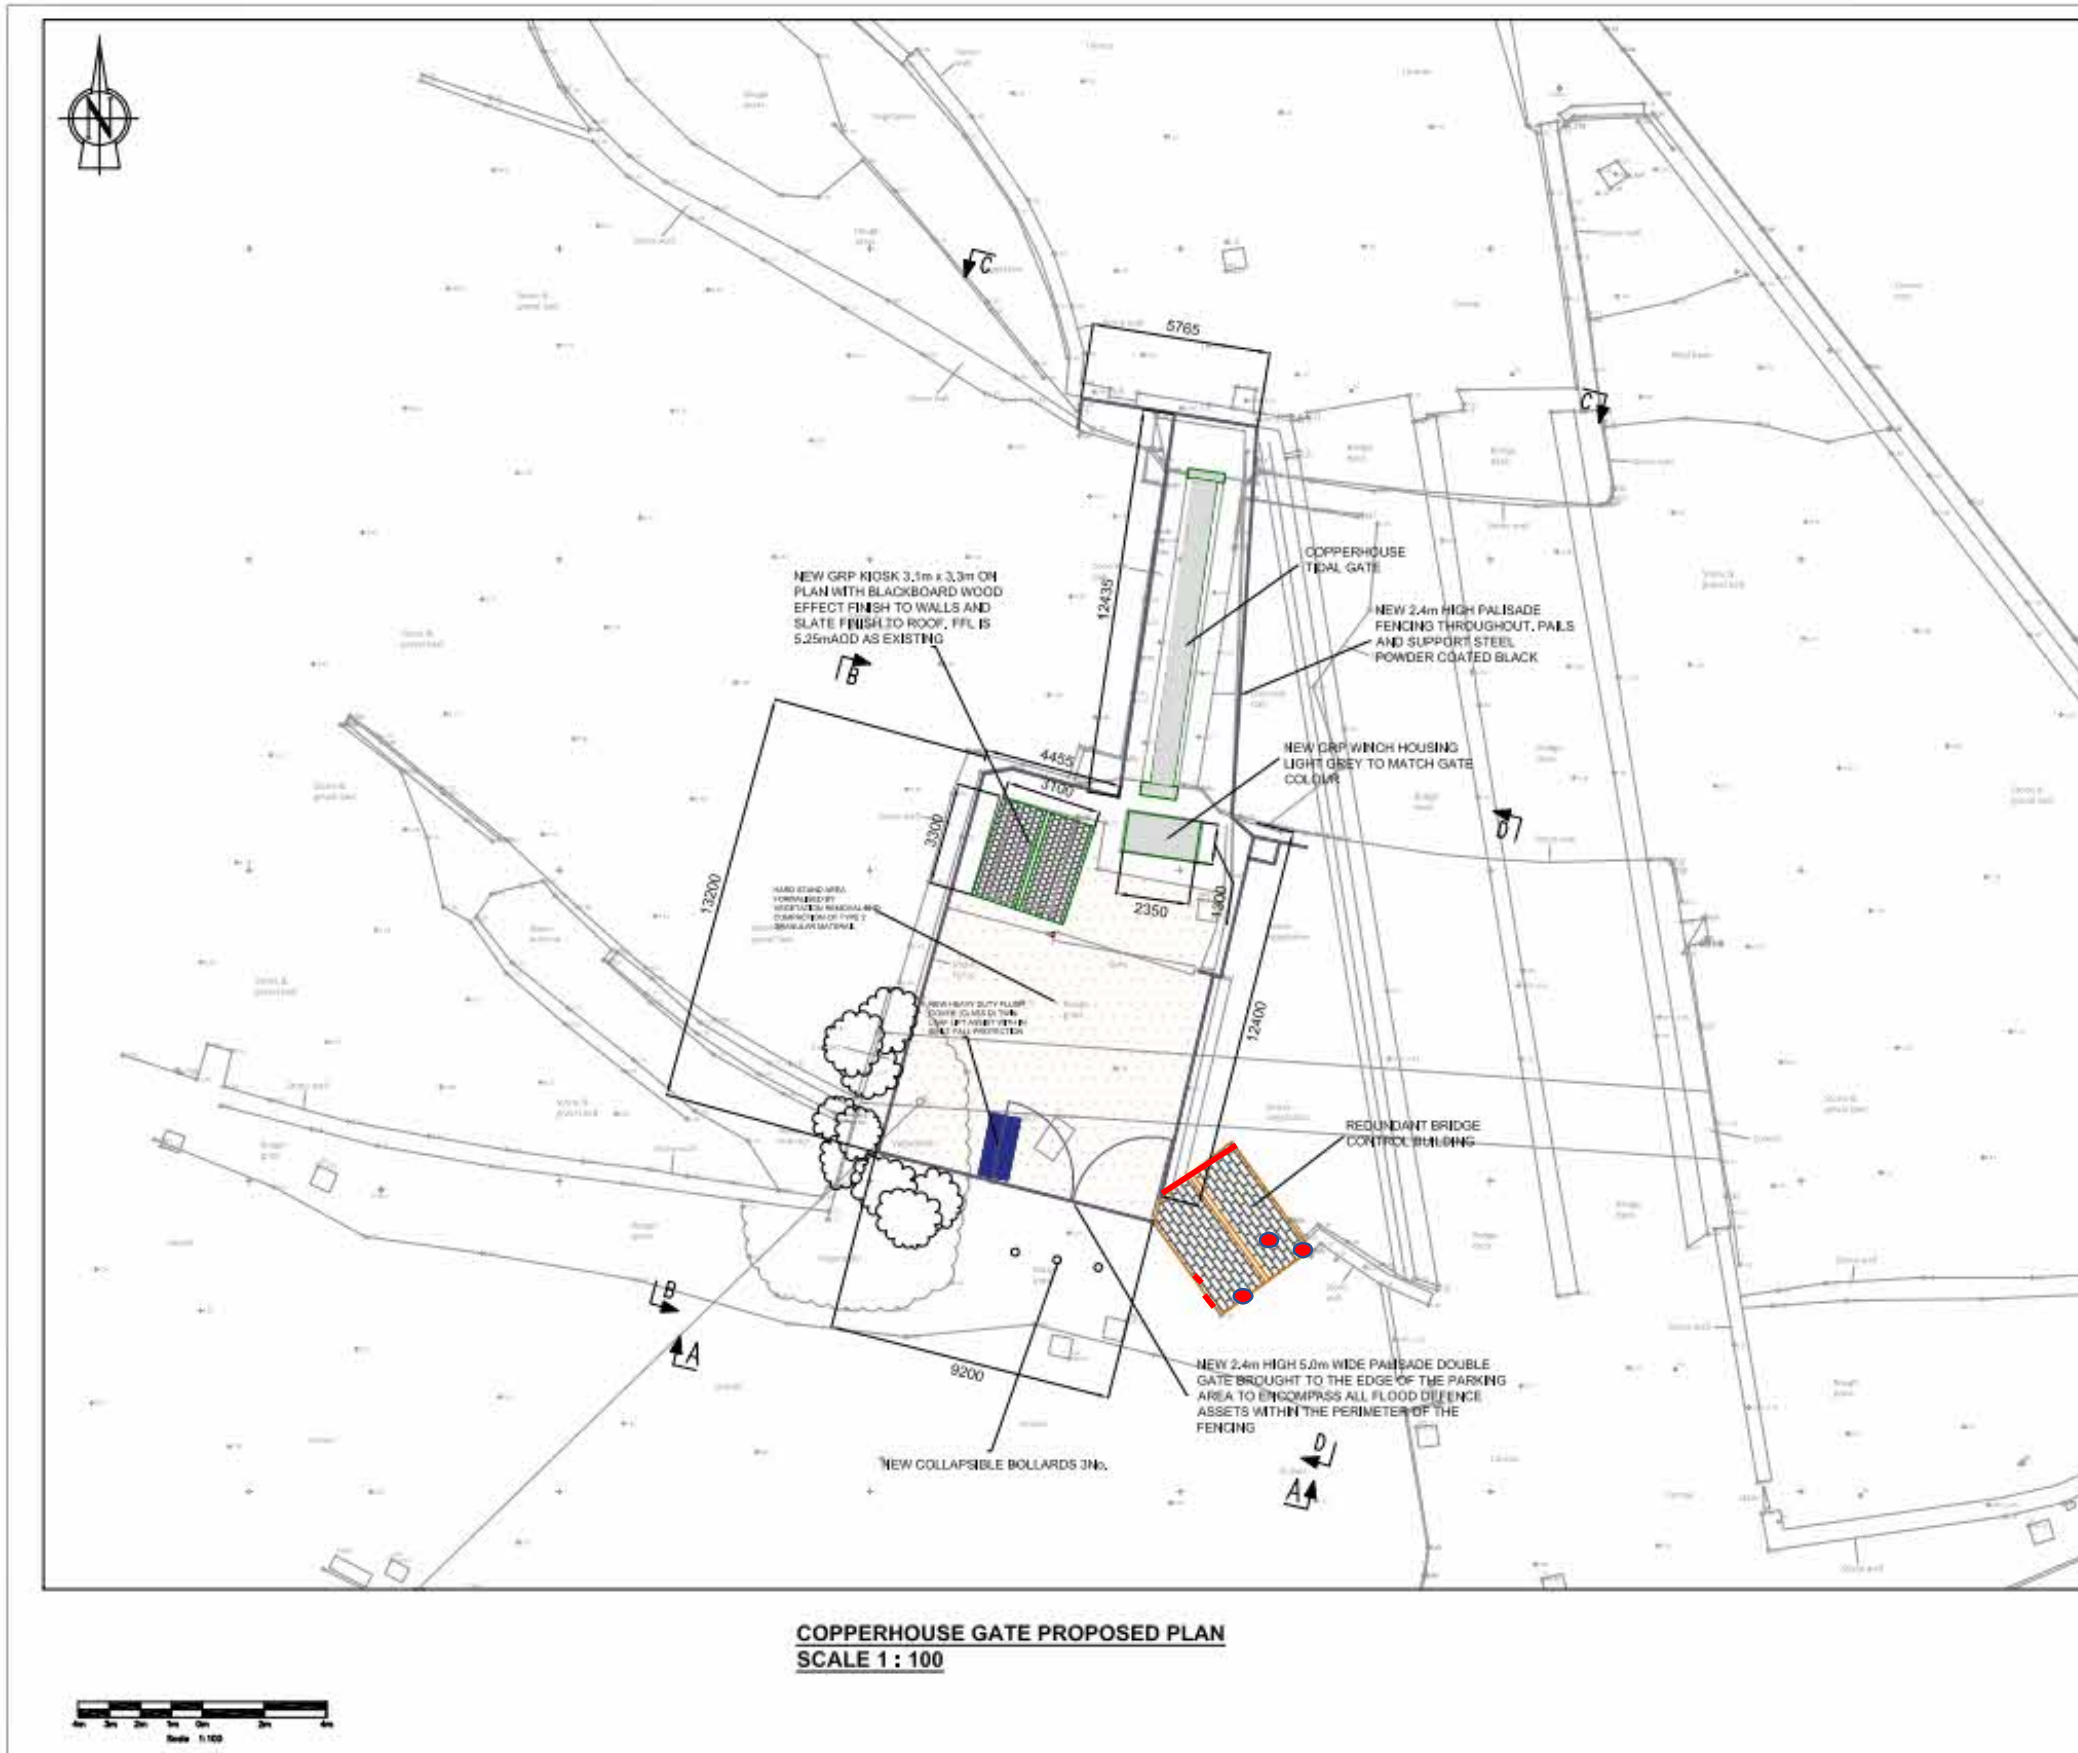
APPENDIX A: Proposed Works and Potential Roosting Feature Locations

faces. On the north-western face, where ivy coverage is present there is low potential for the new fencing to obscure access to a PRF as it is directly adjacent to the building (see Appendix A), though the ivy coverage would be making access very cluttered at present.

● = Potential roosting features

- Ivy should be retained on the redundant bridge control structure where possible. If any removal of ivy is required to facilitate the security fencing installation, the ivy should first be hand searched by a licenced bat ecologist, with minor ivy removal undertaken as required.

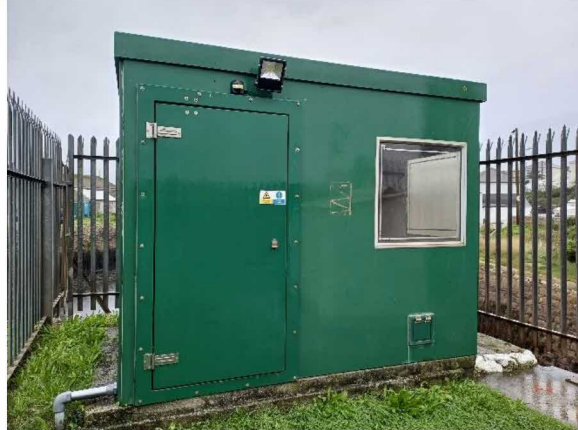
The kiosk that is due to be removed is a prefabricated, reinforced plastic unit, completely sealed with a small overhang at roof level around the entirety of the building. There is a vent at both the north and south ends with a plastic grid behind. The kiosk is not considered to offer potential roosting habitat for bats and has therefore been categorised as having negligible suitability.

**Kiosk to be replaced.**

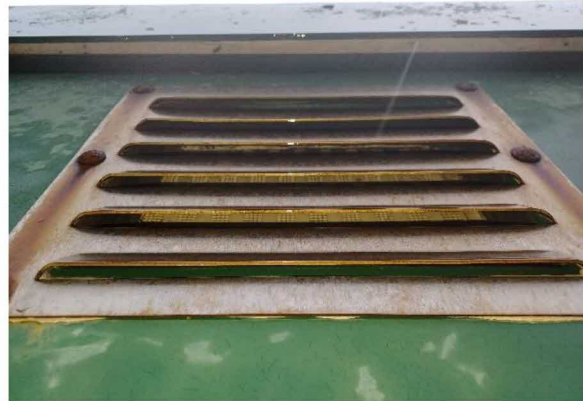
**Vent and typical overhang on roof of kiosk.**

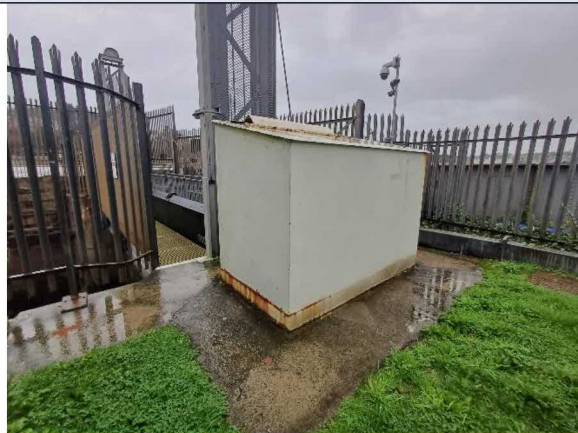
The winch housing that is due to be replaced is a completely sealed metal container less than 2m in height and has no suitability for roosting bats. This structure has therefore not been considered further in this report.

**Winch housing to be replaced.**

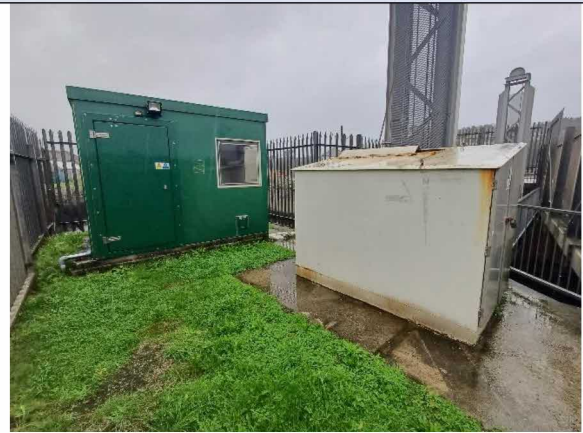
**Winch housing to be replaced.**

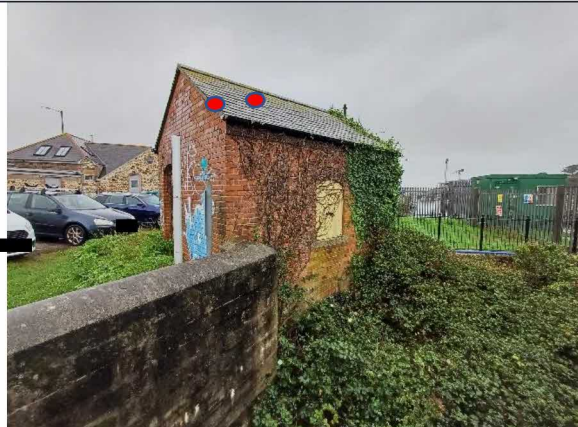
The redundant bridge control structure is a brick building with a slate pitched roof and wooden shutters / door. This building will not be directly affected by the works, but the security fencing extension will extend adjacent to this building. The building is located adjacent to a car park and road with street lighting to the south. The brick work and roof are generally in good condition. There are two slightly lifted tiles on the north-eastern roof face which could offer roosting habitat for bats. On the south-eastern face of the building there was evidence of vandalism to the door, with litter present inside. The damaged door could provide an entrance point for bats into the structure. There is a reasonable amount of ivy growth on the north-western face and there is a possibility this is obscuring a PRF on this building side, though the ivy would be making access very cluttered at present. The ivy itself was quite immature and unlikely to be utilised as a PRF in its own right. The timber fascia board on the south-western face has a slight gap behind it in two places, offering some potential roosting opportunity for bats. Because of restricted access to the inside of the building and based on the potential roosting features seen on the outside of the building, this structure is considered to have moderate suitability for roosting bats as a whole.

**Redundant control building – south-east face and slightly lifted tiles on north-east face.**

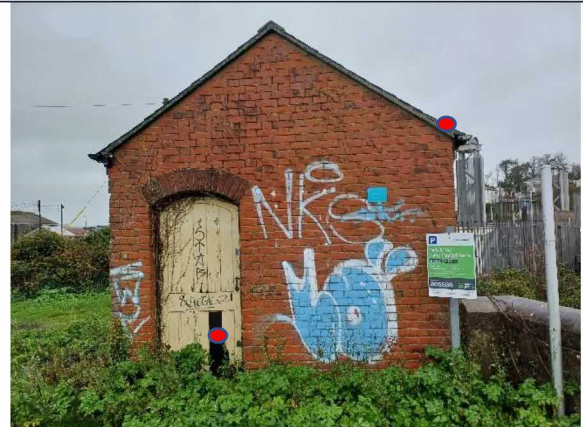
**Redundant control building – potential roost access points under lifted tile and through broken doorway on south-eastern face.**

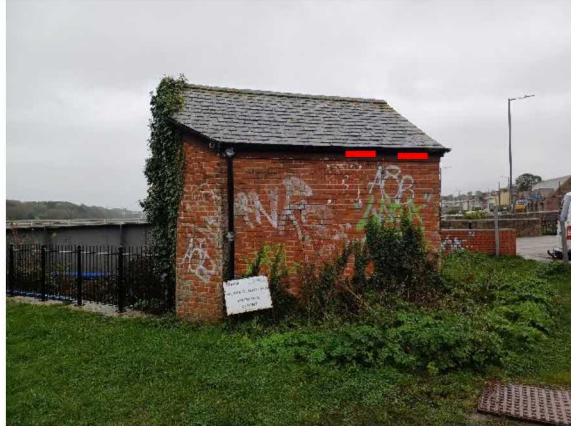
Redundant control building – gaps behind fascia on south-western face.

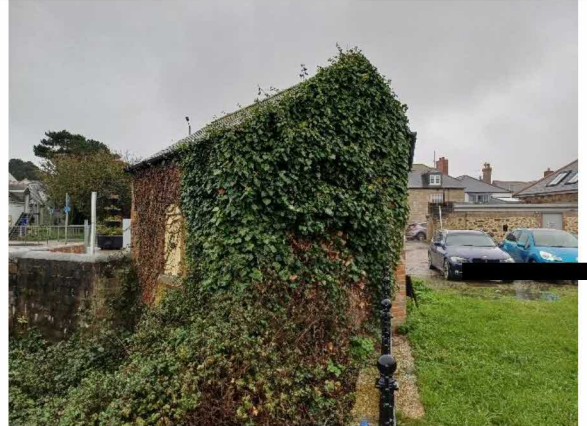
Redundant control building – ivy coverage on north-west face.

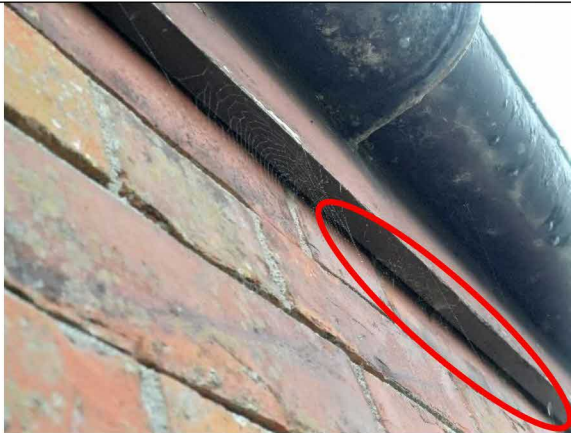
Redundant control building – gap behind fascia in places on south-western face.

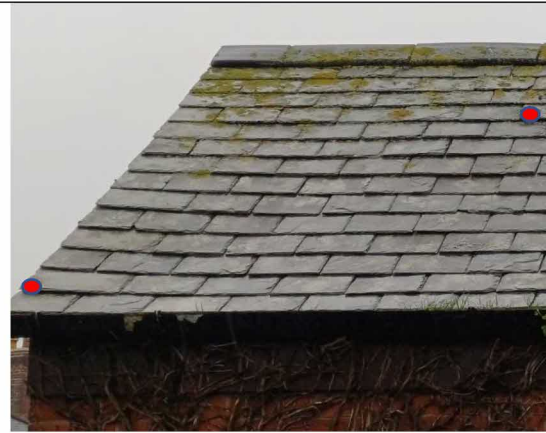
Redundant control building – slightly lifted tiles on north-east face.

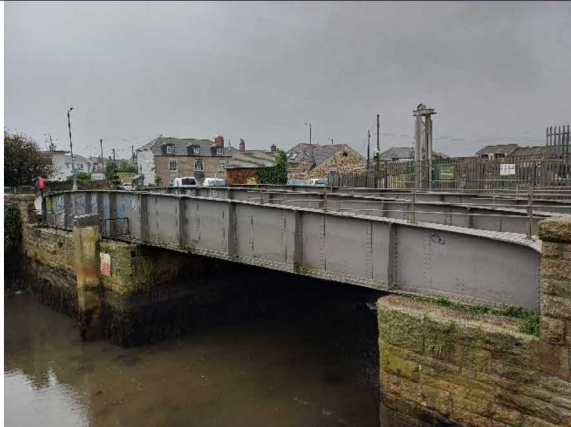
The adjacent pedestrian bridge is a metal sided structure on stone abutments. It will not be directly affected by the proposal. Due to access constraints, it was not possible to fully inspect around and underneath the pedestrian bridge and as such, this structure has been assigned high suitability for roosting bats as a precaution in the absence of survey data.

Pedestrian bridge – eastern face.

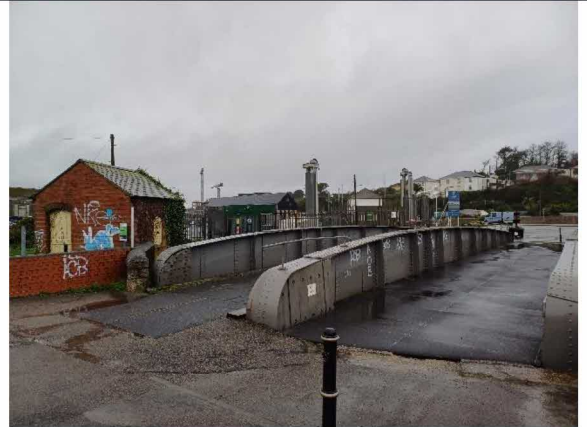
Pedestrian bridge viewed from south.
