Our Ref: SHF.245.002.GE.L.002.A
Date: 12th June 2019

MEDMERRY PARK HOLIDAY VILLAGE –GROUND WATER LEVEL ASSESSMENT

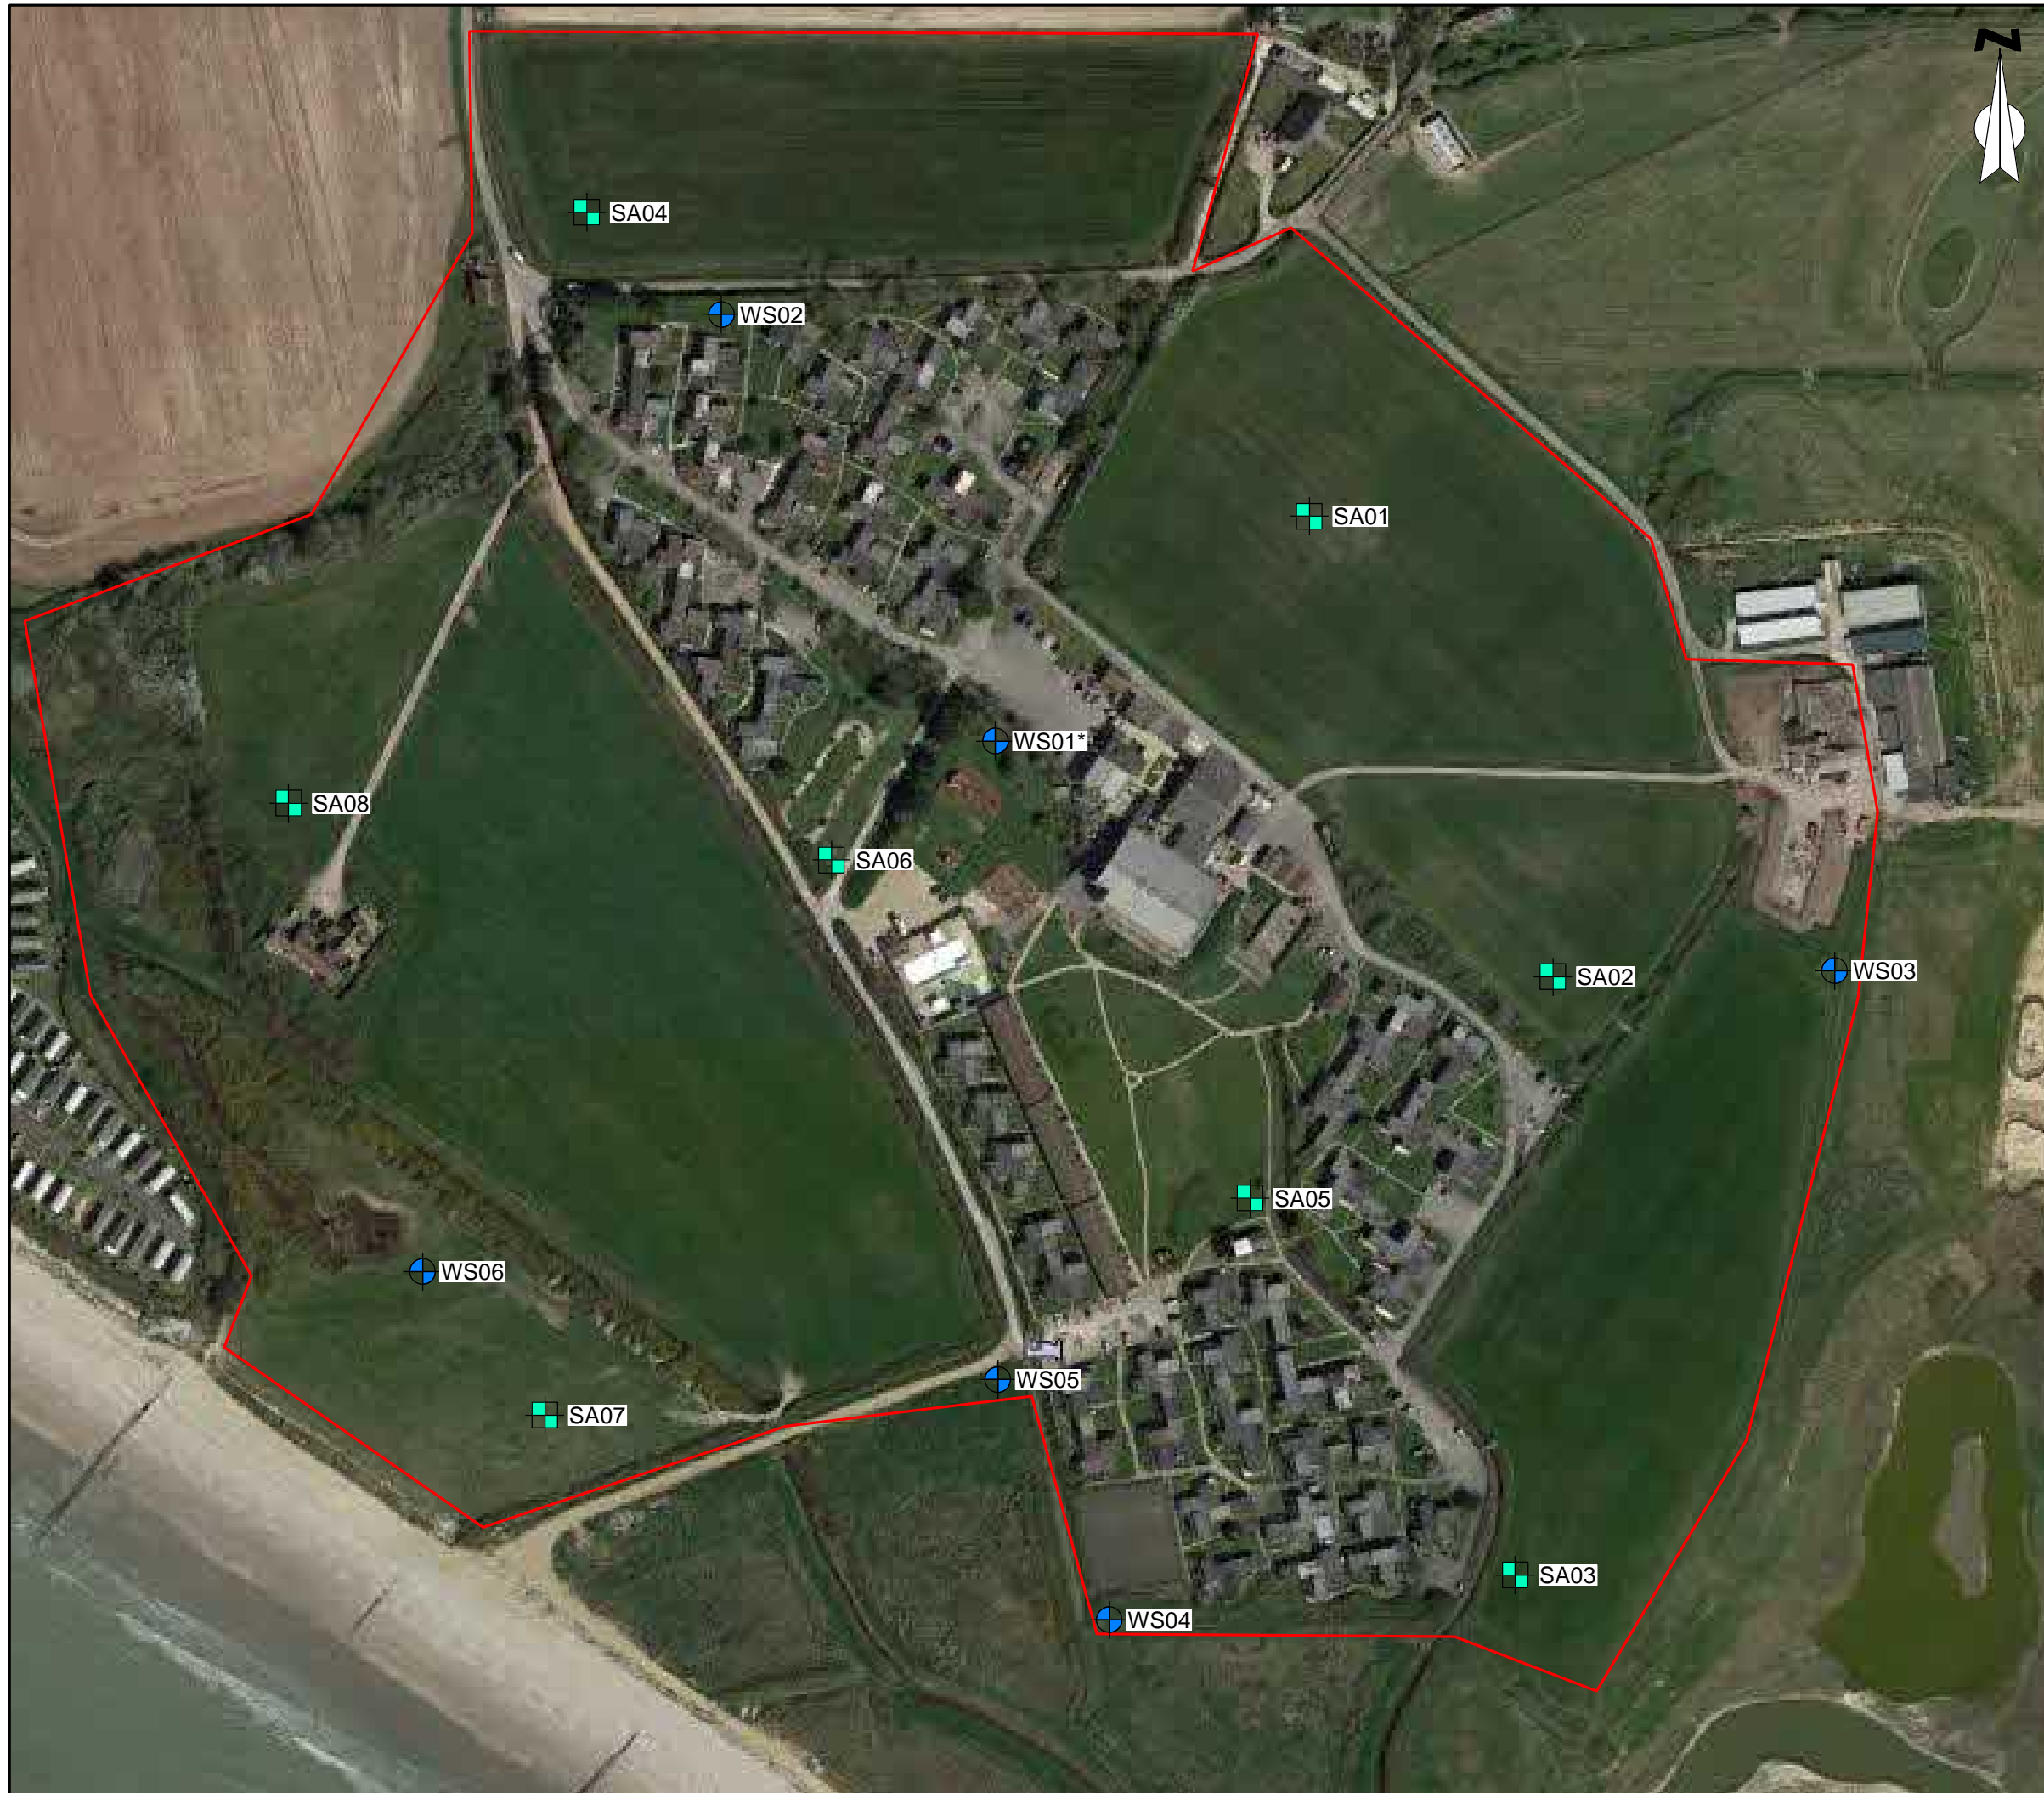
Exploratory Hole Location Plan

The exploratory hole locations are shown on the exploratory hole location plan referenced, SHF.245.002.GE.DR.001, which is appended to this report.

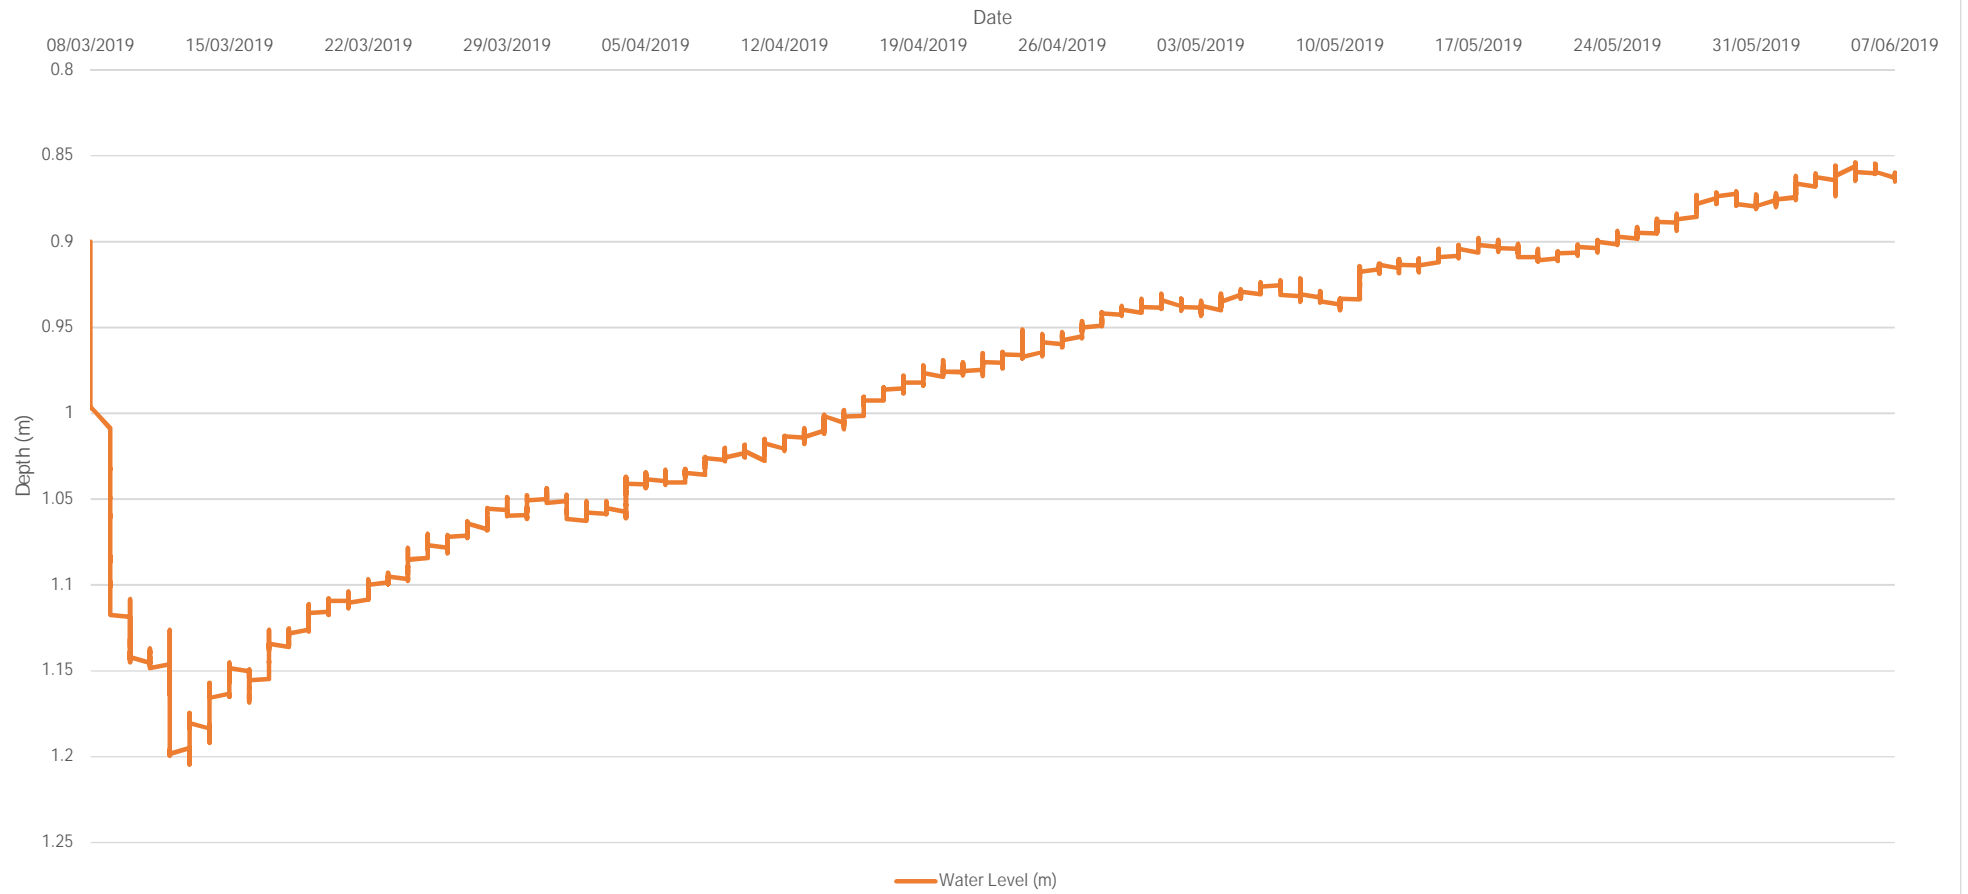
Ground Water Level Over Three Months

The monitoring showed an approximate 0.35m change in level over the three months ranging from 0.85m begl to 1.20m begl. (Refer to groundwater level graph, which is appended.)

The results of the groundwater monitoring confirm the findings of the soakaway testing, reported in our letter report, SHF.245.002.GE.L.001.A. Groundwater levels are too shallow for viable soakaway drainage and alternative methods of drainage should be utilised.
