Pre-development Tree Survey and Report

Dickley Wood Ashford Road Harrietsham Kent ME17 1BJ

12th October 2022

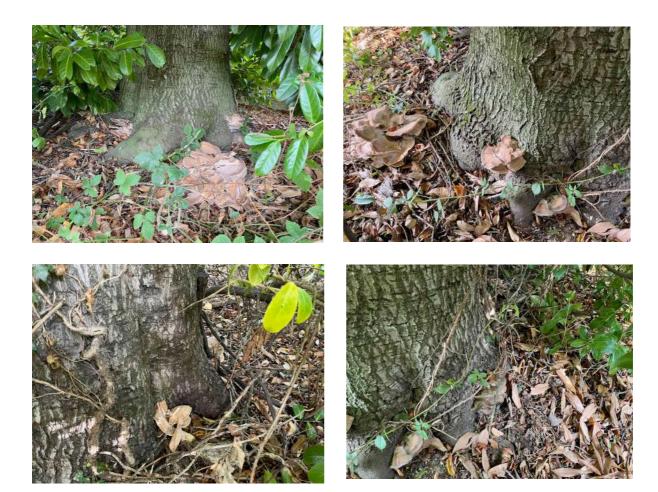
3.4 T1, Copper Beech is located immediately adjacent the main access driveway and existing detached bungalow that is to be demolished to enable the proposed development. A multitude of fungal fruiting bodies of the decay fungi *Meripilus giganteus* are evident around the circumference of the base of the tree and within the ground around it and as such extensive decay is suspected throughout the underside of the trees root plate.

Meripilus giganteus is a significant fungal pathogen associated with Beech trees, with infected trees having a relatively high incidence of uprooting even in calm weather conditions. Canopy condition is not a reliable indicator of the extent of root plate weakening. Also, the condition of the roots near the surface can be misleading as the decay tends to be confined to the underside of the deeper roots.

It is my opinion that the tree is formally unsafe and poses an unacceptable risk to the adjacent bungalow and users of the wider site and should be felled to ground level regardless of the development proposal at the earliest opportunity and in any case within one month of the date of this report due to the unacceptable risk it poses.

I include several photographs of the fungi at the base of the tree below:
