Tree Report: Arboricultural Impact Assessment (AIA)

Rawcliffe Lodge
Shipton Road
York
YO30 5RX

Vincent and Browns c/o Mark Smith
November 2022

<i>Title</i>	Tree Report: Arboricultural Impact Assessment (AIA)		
<i>Client</i>	Vincent and Brown		
<i>GC Project Reference</i>	J221106 – Rawcliffe Lodge		
<i>Author</i>	<i>Robert Wortley FdSc Arboriculture and Urban Forestry, BSc (hons) Applied Horticultural Sciences, MArborA Arboricultural Consultant</i>		
<i>Author Contact Details</i>	Ground Control Limited, Kingfisher House, Radford Way, Billericay, Essex, CM12 0E M: [REDACTED] T: 01277 650697 E: [REDACTED] www.ground-control.co.uk		
<i>Reviewed</i>	<i>Kevin Slezacek DipArb. MArborA. MCIHort Head of Arboricultural Consultancy</i>		
<i>Issue Status</i>	Issue	Date	Status
	1	22/11/2022	Planning
<i>Revision</i>			Revision
			Final
<i>Disclaimer</i>	<p><i>The recommendations contained in this Report represent Ground Control's professional opinions, in exercising the duty of care required of an experienced Arboricultural Consultant. The information contained has been prepared and given in accordance with the author's professional institution's Code of Professional Conduct and the opinions

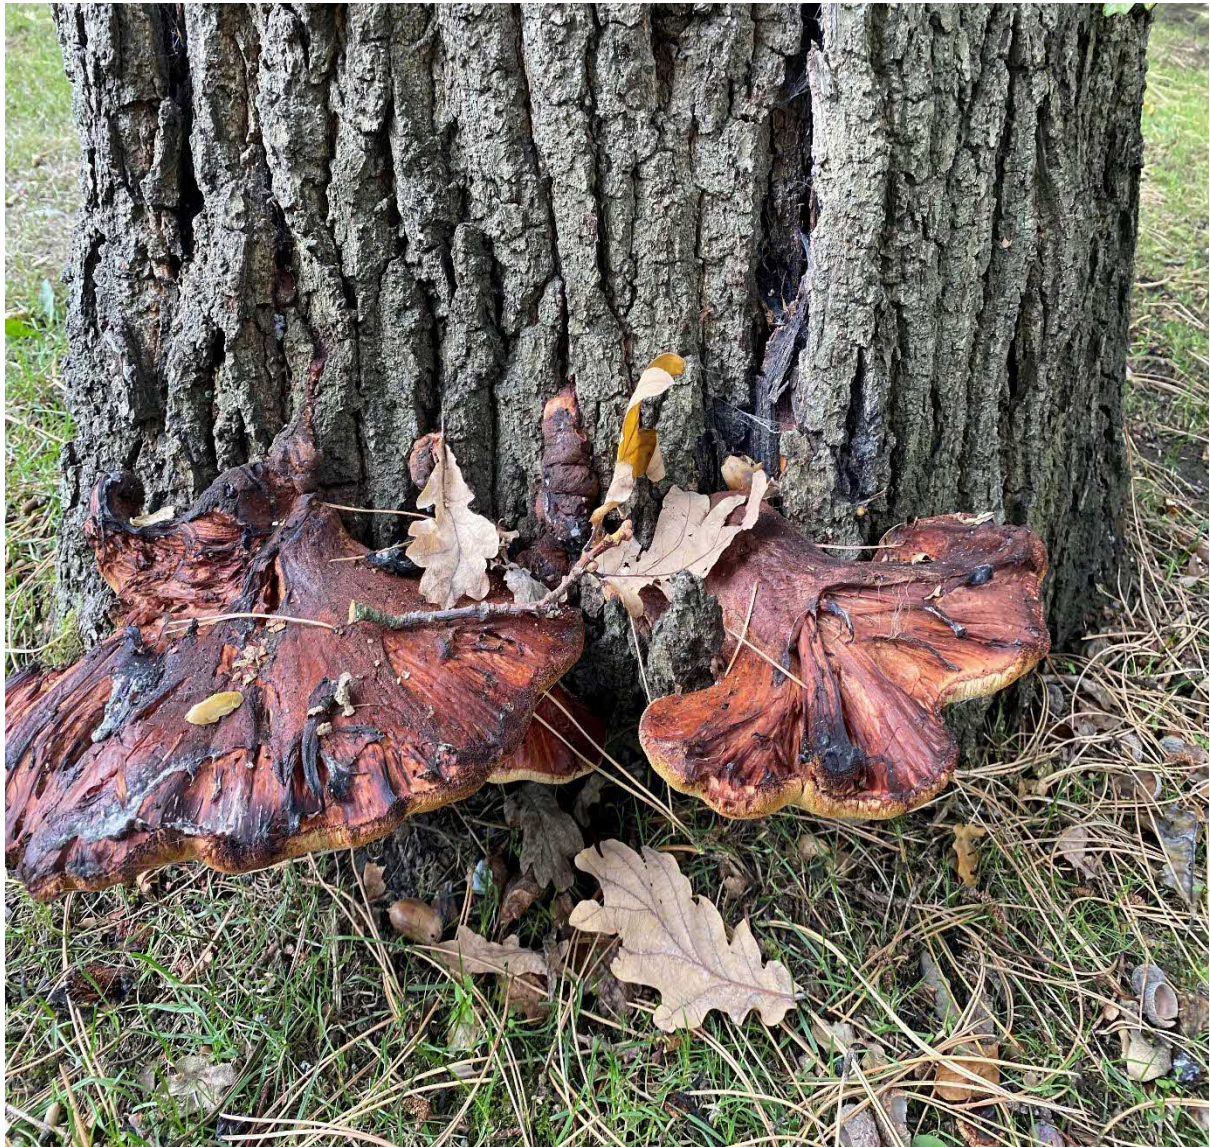
6	Pedunculate oak	Quercus robur	Mature	17	570	4	7	8	1	6	8	E	Fair	Poor	Tree has beef steak fungus at the base. Hammer test revealed bark and sap wood necrosis. Tree does not sound hollow. Tree has epicormic growth on main stem with leaves appear to have powdery mildew. Leaves are changing colour due to seasonal changes. Tree is within falling distances of building. Structural integrity unknown.	It is recommended that the tree is to felled on Arboricultural grounds.	Very Short (<10 years)	U	1	6.84	07/10/2022	RobW
7	Pedunculate oak	Quercus robur	Mature	17	490	6	4	2.5	4	7	7	E	Good	Poor	Tree has decay at the base with bark necrosis approx. 2 meters in length in a vertical strip. Secondary wood has formed although structural integrity unknown. Leaves are changing colour due to seasonal changes. Tree is within falling distances of building. Tree also has pruning wounds from previous Arboricultural work. Hammer test was conducted, slight hollowing sound although further inspections would be required to determine accurate results.	Tree is recommended to be removed on Arboricultural grounds.	Very Short (<10 years)	U	1	5.88	07/10/2022	RobW

Photo 1: Beef Stake fungus – *Fistulina hepatica* Located at the base of T6 facing northeast

- 4.5.1 On the basis of the above assessment, we recommend the following construction sequencing and measures are adopted.
 - 4.5.1.1 *Pre-construction phase*
 - 4.5.1.2 *Undertake Tree removals to T1, T2, T6 and T7.*
 - 4.5.1.3 *Erection of temporary tree protection fencing in accordance with BS 5837:2012 and establishment of as Construction Exclusion Zone (CEZ) as indicated on TCPP to protect RPA's of the retained trees. This is to take place before main construction phase*
 - 4.5.1.4 *Main construction phase*
 - 4.5.1.5 *Landscaping*
 - 4.5.1.6 *Project snagging*
 - 4.5.1.7 *Dismantle and removal of tree protection fencing.*
 - 4.5.1.8 *Ongoing site monitoring of retained trees*

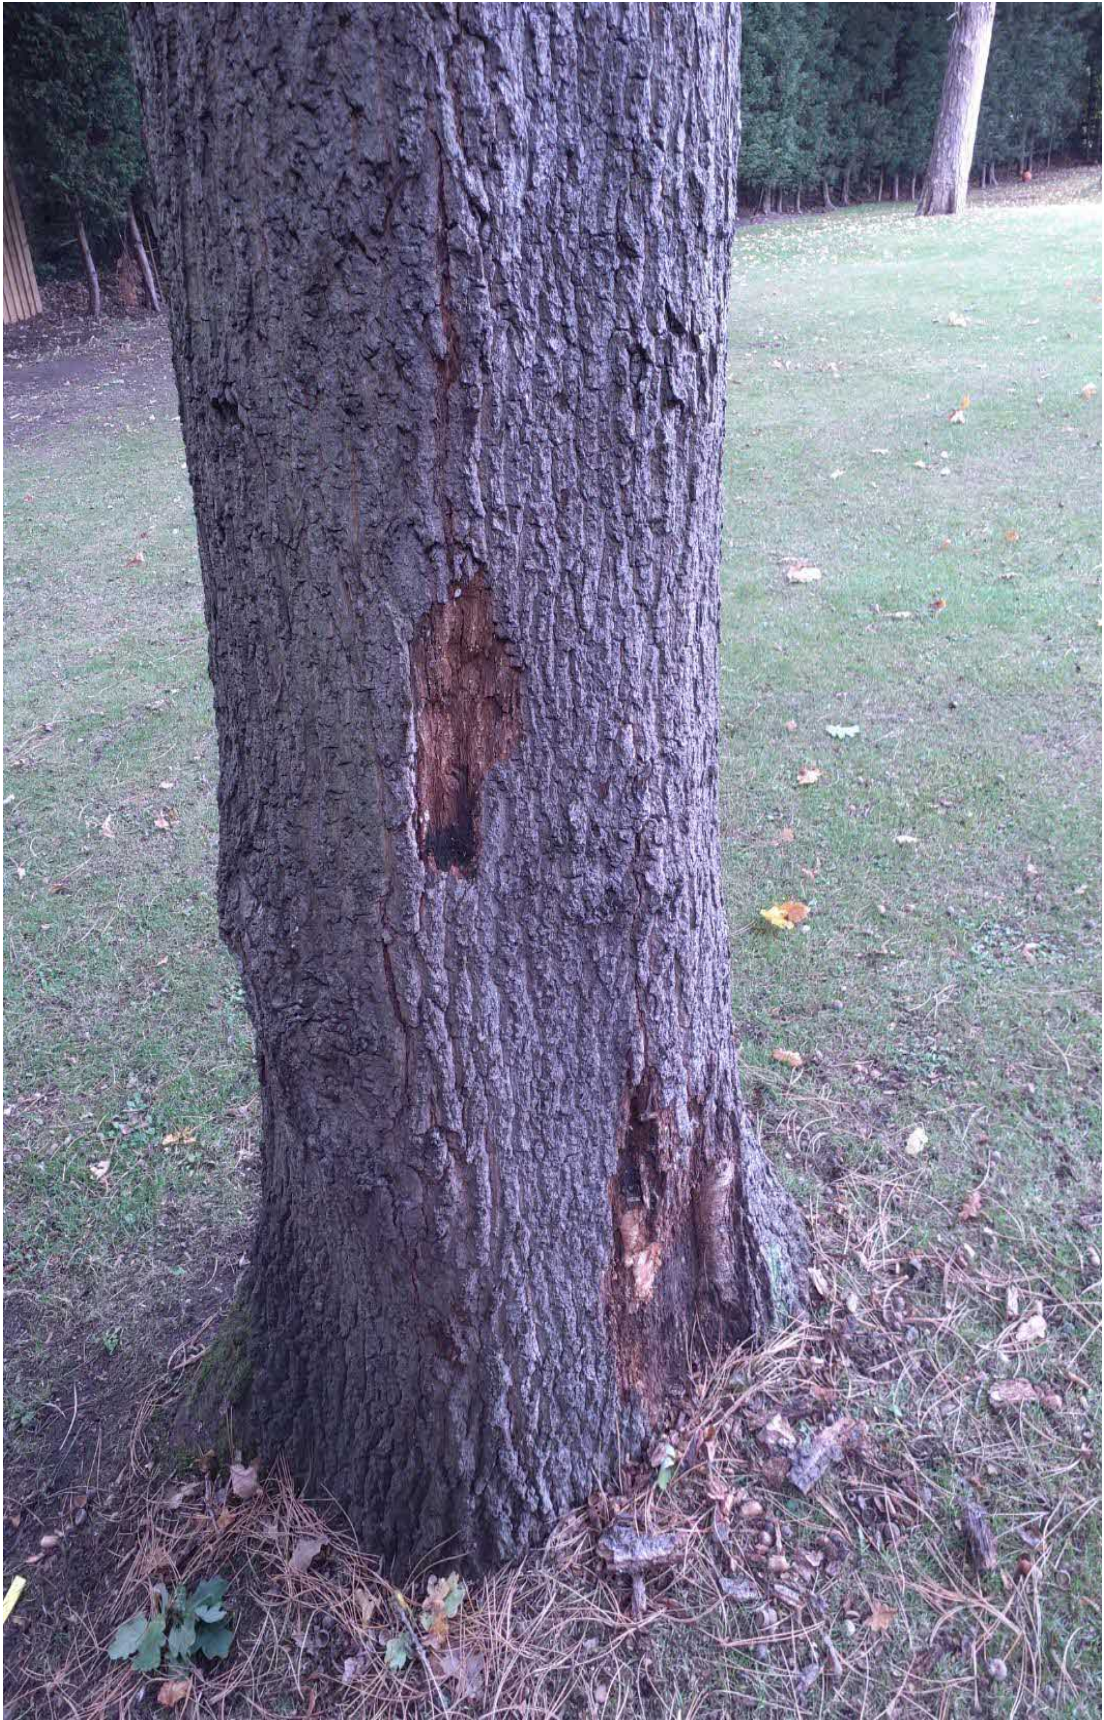
- 4.1.1 Two surveyed trees T6 and T7 have been categorised as Cat 'U' as part of this survey.

Photo 2: Basal decay showing compromised structural integrity of T7 facing south.

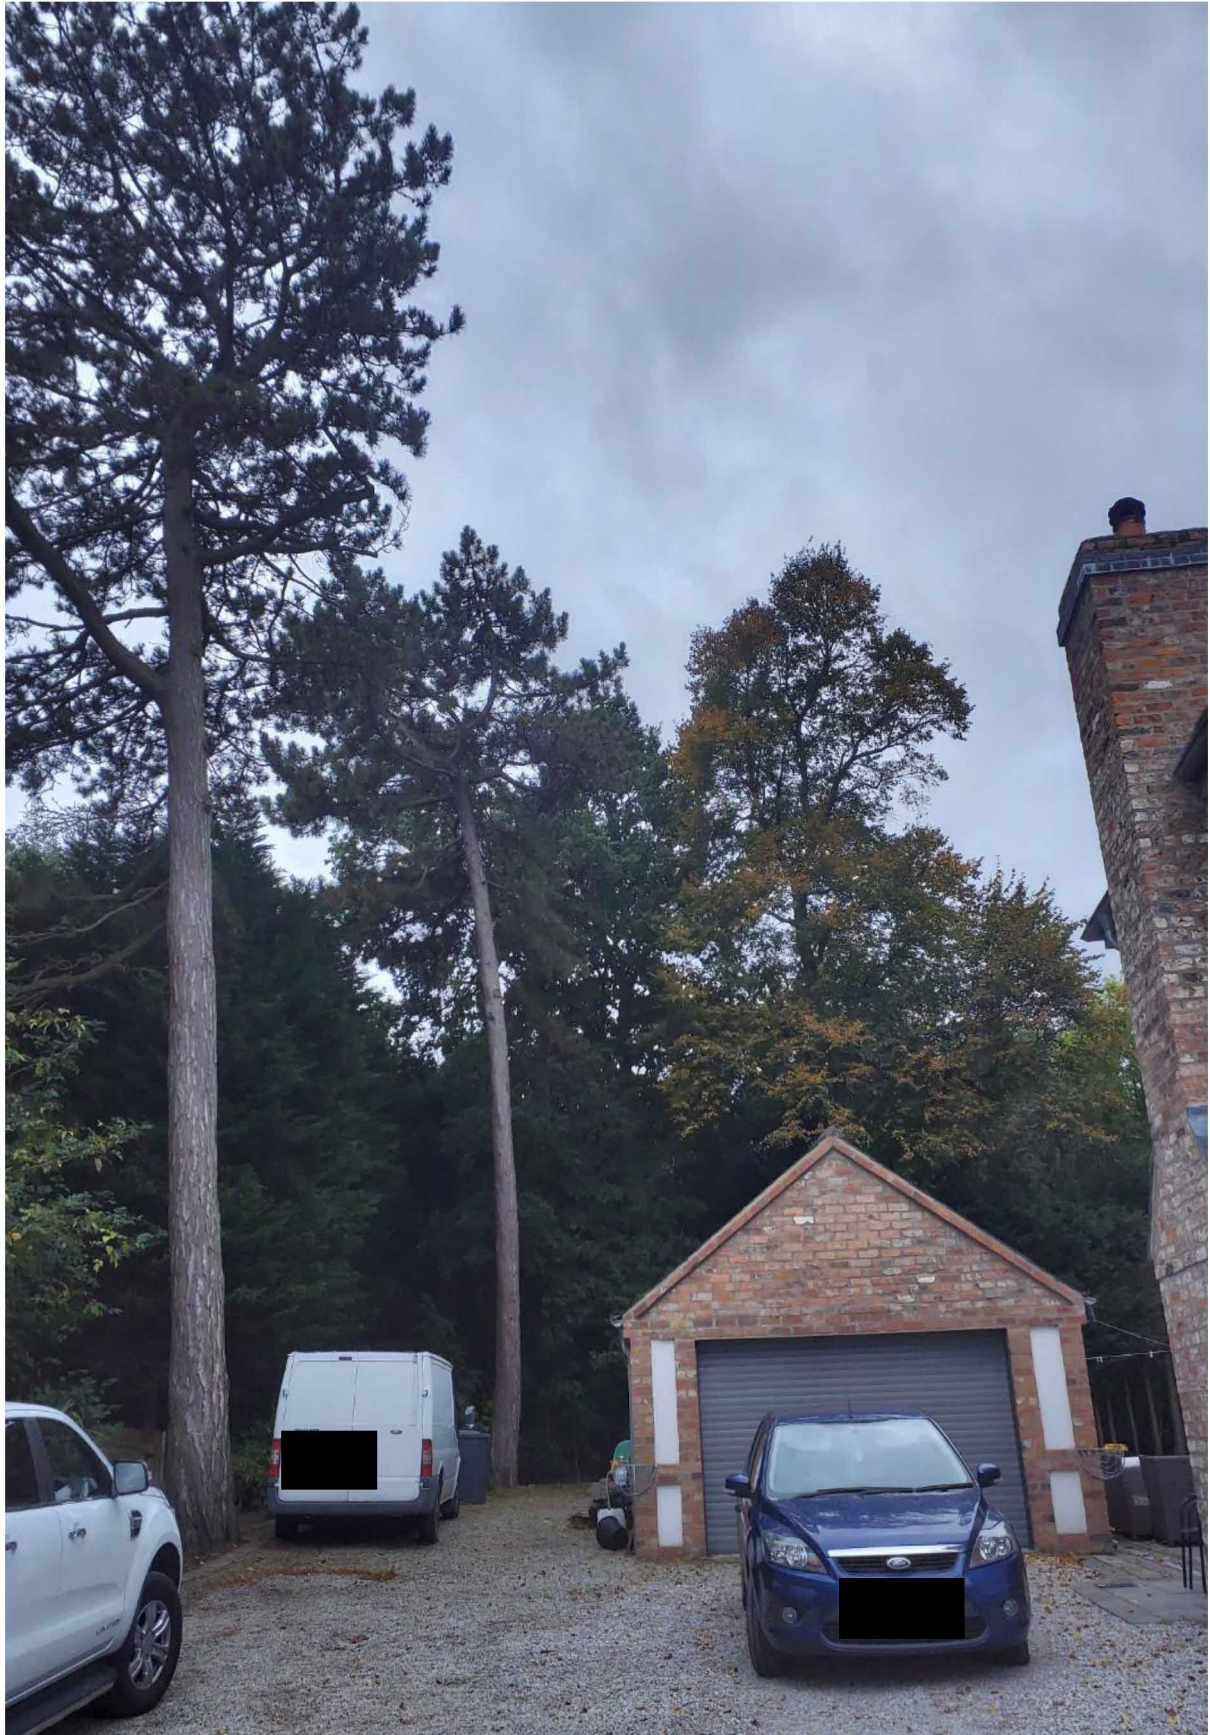
Subject Trees: T1 and T2

Photo 3: T1 and T2 requiring removal on development grounds.

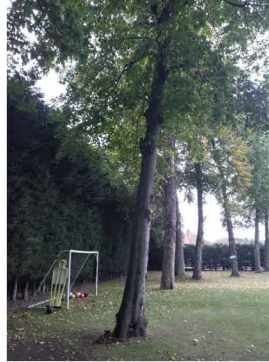
Small-leaved lime Tree ID #13

13	Small-leaved lime	Tilia cordata	Mature	18	430	4.2	4.3	4.3	2.5	5	7	SE	Good	Good	Tree has closed and open pruning wounds on main stem and areas of poor pruning. Tree has minor lean although outside falling of property. Tree leaves are changing colour due to seasonal changes.	No works on Arboricultural grounds.	Medium (20 to 40 years)	B	1	5.16	07/10/2022	RobW
14	Scots pine	Pinus sylvestris	Over-mature	18	520	3.9	2.2	3.8	4.5	16	16	W	Good	Good	Tree has had ivy growing up the main stem although this has been severed and left to die off. No significant faults observed.	No works on Arboricultural grounds.	Short (10 to 20 years)	B	1	6.24	07/10/2022	RobW
15	Small-leaved lime	Tilia cordata	Mature	18	410	2.8	4.1	2	1.4	4	6	SE	Good	Good	Base of tree is on raised landscape although does not appear to a root plate shift. Leaves are changing colour due to seasonal changes.	No works on Arboricultural grounds required.	Medium (20 to 40 years)	B	1	4.92	07/10/2022	RobW

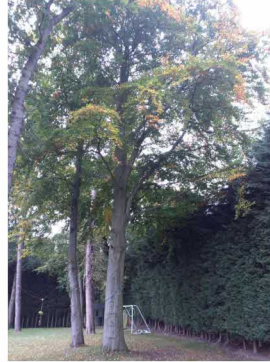
Common beech Tree ID #16

16	Common beech	Fagus sylvatica	Over-mature	19	800	8.6	4.2	4.1	7	4	6	W	Good	Good	Tree is situated on raised landscape. Although appears to not be a root plate shift. No significant faults observed. Tree appears to be healthy and in good condition.	No works required on Arboricultural grounds.	Medium (20 to 40 years)	B	1	9.6	07/10/2022	RobW
17	Pedunculate oak	Quercus robur	Mature	19	440	3.8	3.1	2.5	6.2	6.5	7	SE	Good	Good	Tree has annuated crown structure with majority of canopy growth facing south. This is due to proximity of neighbouring trees and competition for space and light. There is dead wood within the canopy.	Remove dead wood.	Medium (20 to 40 years)	C	1	5.28	07/10/2022	RobW
18	Small-leaved lime	Tilia cordata	Mature	18	420	2.5	2.1	2.8	2	5	7	S	Good	Good	Tree is situated on raised landscape although it appears to not be a root plate shift. No significant faults observed.	No works on Arboricultural grounds required.	Medium (20 to 40 years)	B	1	5.04	07/10/2022	RobW

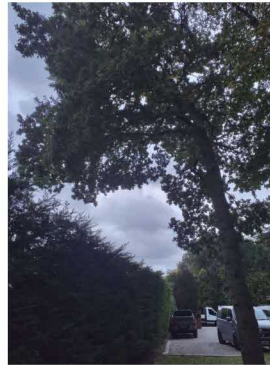
Pedunculate oak Tree ID #19

19	Pedunculate oak	Quercus robur	Mature	16	450	7	5.5	8	2.2	5	7	E	Good	Good	Tree has annuated crown structure due to proximity of neighbouring tree competing for space and light. Tree is now growing towards public footpath and road.	Monitor the health and condition of the tree. Legal duty.	Medium (20 to 40 years)	C	1	5.4	07/10/2022	RobW
20	Lawson cypress	Chamaecyparis lawsoniana	Semi-mature	7	150	1.1	1.4	1	1.2	0.5	0.5	W	Good	Good	No significant faults observed	No works on Arboricultural grounds.	Long (>40 years)	C	1	1.8	07/10/2022	RobW
