## PHOTO EXTRACT from the Design Access Heritage Statement

### 3.1 AMENDING THE NUMBER AND CONFIGURATION OF THE ROOF LIGHTS

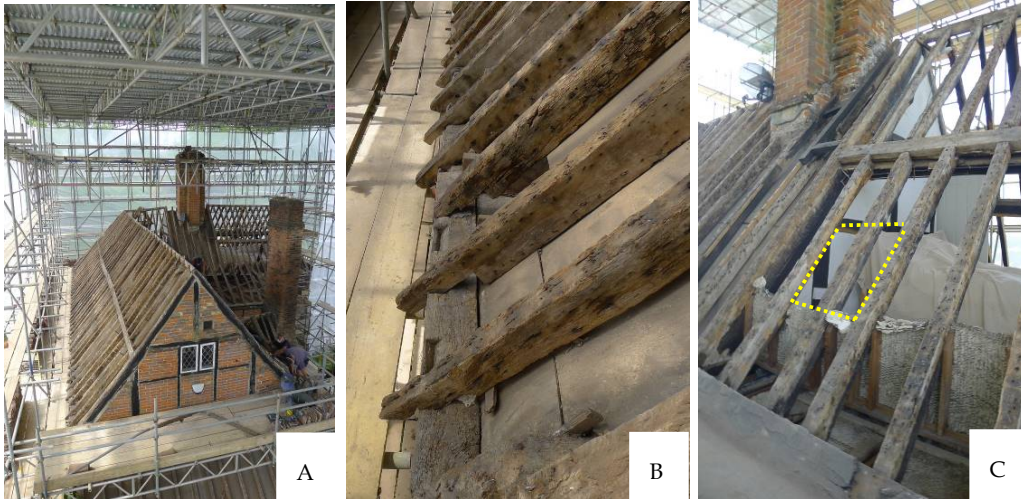
A: View of the south range roof stripped of roof coverings - view from the east.

B: Detail of the feet of common rafters showing adaptations to provide birds-mouth joints with the wall plate.

C: Detail of east slope to west range; the yellow dashed rectangle shows the proposed location of the egress roof light and that two common rafters will need to be cut and trimmed to accommodate the roof light.

Photos B, D & E show that the common rafters to the roof were adapted within a later phase of alteration to the roof frame, possibly 18<sup>th</sup> century. The common rafters are nailed/spiked in place rather than using traditional joints and have had birds-mouth joints provided so that they could be reused to sit on the wall plates [Photo B]. All of which reflects that the common rafters illustrate a later phase of adaptation to the building.

The repair works that have been carried out to the building included the stripping of the roof coverings. This has revealed that most of the common rafters to the roofs of the building have been reused and adapted.

In total four common rafters, that are re-used timbers, will need to be cut and trimmed to make the openings to accommodate the new roof lights. The adapted common rafters will remain in-situ and the proposed works will be able to be understood as a further adaptation of an existing timber.

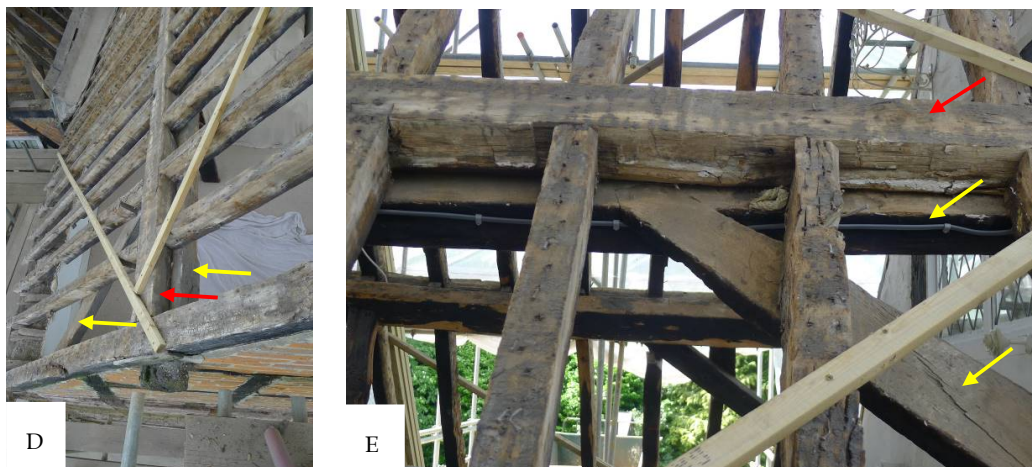
D: Detail from above of the east slope of the west range. Note the original purlin and brace [yellow arrows] and the later purlin [red arrow] showing a history of adaptation and alteration to the roof frame.

E: Detail of the northern end to the east slope of the west range. Note the original purlin and brace [yellow arrows] and the later purlin [red arrow].

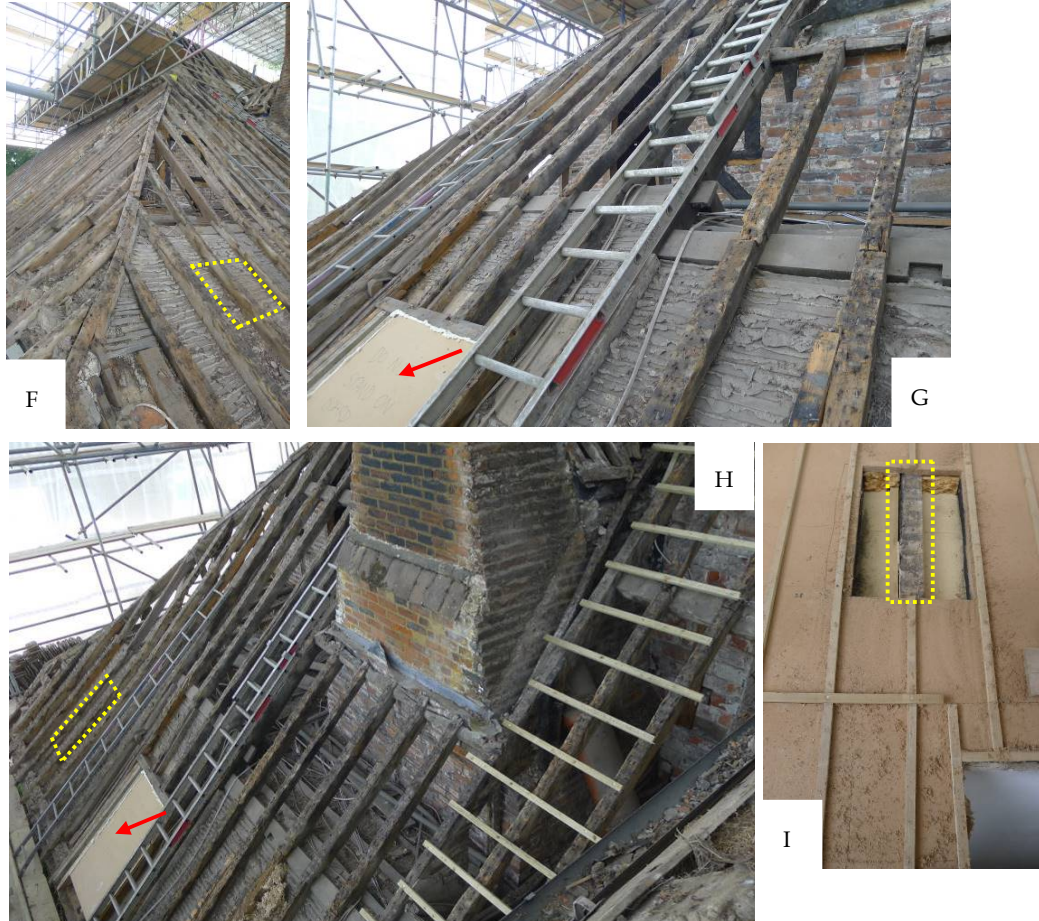
It is highly unlikely that the common rafters were reused in their original location. Repair and replacement is evident, with later rafters, to the catslide roof above the kitchen area [Photos F, G & H].

F: Detail of the lower north 'catslide' roof slope to the outshut; the yellow dashed rectangle shows the proposed location of the new roof light opening [ON-N-NEW-RL2] and the single common rafter that will need to be cut and trimmed to accommodate the roof light.

G: Detail of the north 'catslide' roof slope to outshut; showing re-used common rafters.

H: Detail of the lower north 'catslide' roof slope; the yellow dashed rectangle shows the proposed location of the existing roof light [ON-N-RL1]. Note the boarded over existing opening [red arrow].

I: Detail of the new roof light to the upper north slope of the south range [SR-N-NEW-RL2]. The section of the rafter that will need to be cut and trimmed to accommodate the roof light is shown by the yellow dashed rectangle. A bespoke roof light is to be installed so that the window fits between the adjacent common rafters and so an additional rafter does not need to be cut; to minimise the harm.

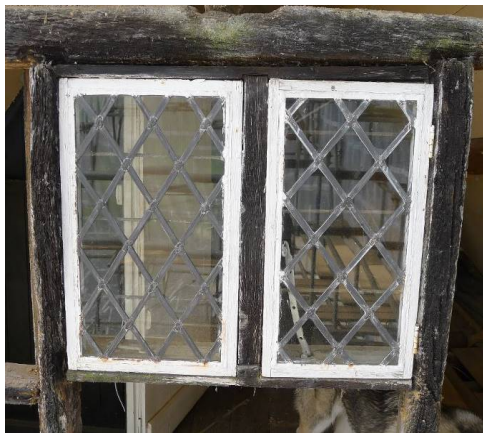
The photo on the left is of the east gable attic window

It is proposed to replace three high level windows that have suffered from decay, as a result of poor construction and a lack of maintenance and repair, most probably the result of the difficulty of gaining access to these windows for repair and decoration.

Combination of poorly constructed timber and metal casement windows that are in a poor condition.

Timber framed metal casements with diamond pattern leadwork. The casements are poorly constructed and have been subject to a history of ad-hoc repair.

The casements are different sizes and in a poor condition.

The proposed replacement of three existing windows with modern metal frame casements with leaded lights to match the existing 'diamond diaper' pattern.

The introduction of double-glazed units will significantly reduce the risks of condensation and associated issues, such as damp and mould growth, particularly as the roofs have been well insulated.

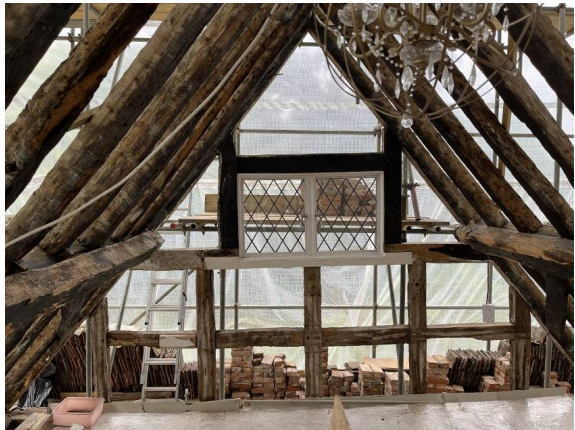
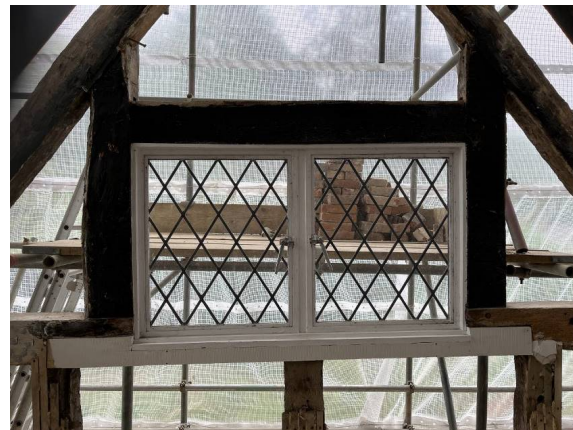
The photos above show an internal view and detail of the north gable attic window. This is a 20<sup>th</sup> century metal casement window with diamond pattern leadwork.

The original collar of the historic timber frame was cut to accommodate this window. The priority within the ongoing repairs was to reinstate the primary structural performance of the collar.

The reinstatement of the missing section of the collar meant that the existing window could not be reinstated in its original location, as the repair has reduced the size of the opening.

This provides an opportunity for a new window, made to fit the opening available, to be introduced. It is proposed that this window be a double-glazed unit that otherwise matches the existing unit as a metal framed casement with leaded lights.

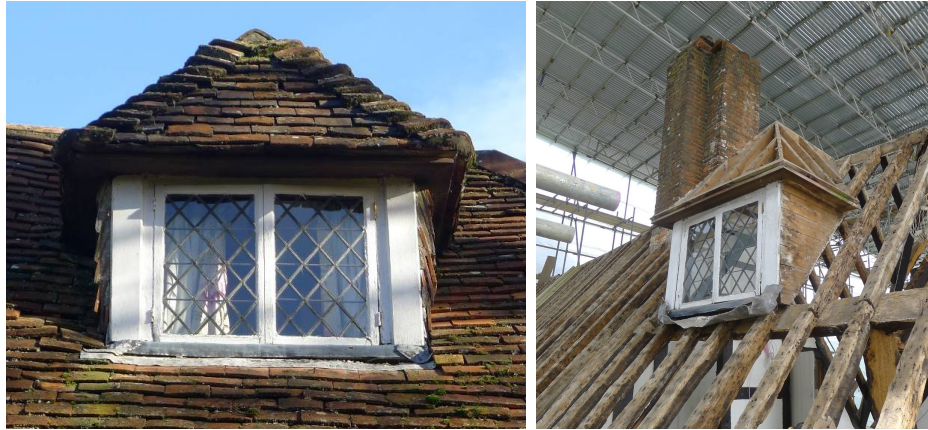
The photos above show the casement window to the west dormer, before repair works [left photo] and in the process of the repair works [right photo]. This is the third window it is proposed to replace.

The dormer was added in the 20<sup>th</sup> century and the window is anticipated as being contemporary with the addition of the dormer.

The timber casements were found to be in a poor condition requiring extensive repair. The casements were of a poor initial construction and detailing and would need to be replaced for a functional weathertight window to serve the dormer. The dormer is elevated and is exposed to the prevailing weather and will need regular maintenance and repair.

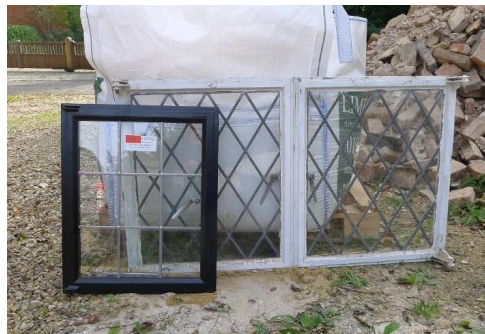
The photo above shows a sample of the proposed replacement metal framed window against the metal casement removed from the north gable. The leadwork can be made to match the diamond/diaper pattern of the existing window. The traditional detailing of the sample window would provide a replacement window that is consistent in materials and appearance whilst the double glazing would provide the benefit of improved thermal performance.

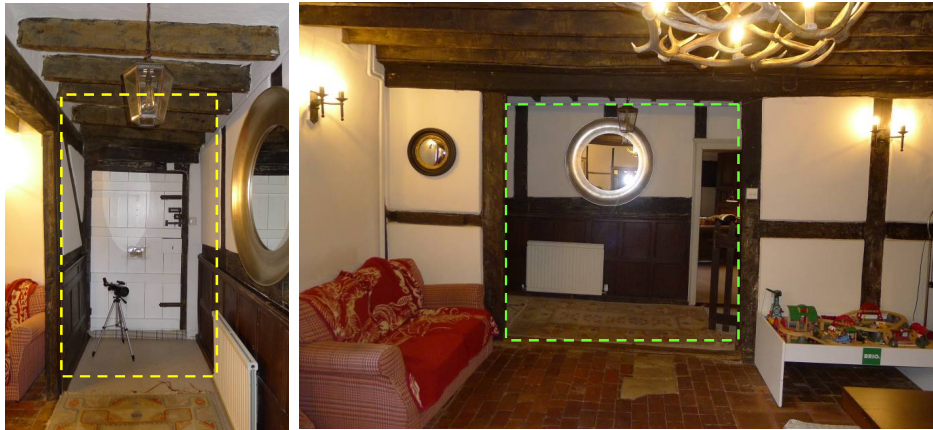
The photo on the left shows the south entrance door within the 'cross passage'. It is proposed that an oak framed glazed door be inserted to create an entrance lobby – approximate location illustrated by the yellow dashed lined rectangle.

The photo on the right shows the existing opening between the dining room and the 'cross passage' where the proposed glazed screen partition and door is to be located, illustrated by the green dashed lined rectangle.

The creation of an entrance lobby will help manage draughts and improve comfort levels.

The introduction of the oak framed glazed partition screen and door will improve comfort levels within the dining room and encourage improved use of this principal room.

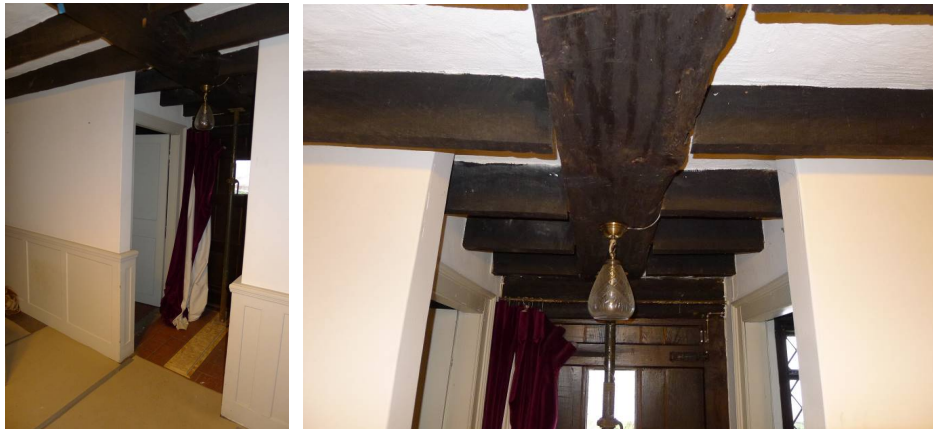
The photos above show a view and a detail of the existing opening where it is proposed to add a door to create an entrance lobby to serve the door to the north gable of the west range.

The ground floor room to the north of the west range has been sub-divided by a solid wall in the 20<sup>th</sup> century to create the WC and a small boot room.

The existing rear/north door is ledged vertical boarded door. It is proposed that the inner door be of a similar design set within a timber frame.

The recently added, 21<sup>st</sup> century, dado panelling on the partition walls will be adapted to accommodate the frame for the door.
