Heritage Impact Assessment

St Cuthberts Vicarage, Billingham

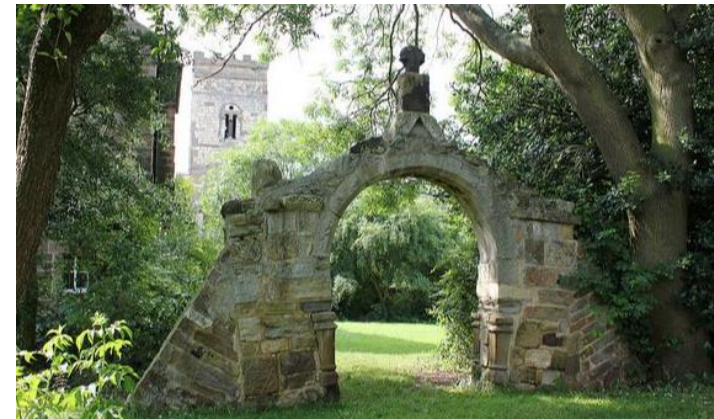
Figure 5 Listed Garden Folly

3.13 The folly shows evidence of weathering and past areas of repair and rebuild. It is unclear when this was established as a ruin within the grounds. Its siting frames the tower of the church from the garden area and forms an interesting garden feature.

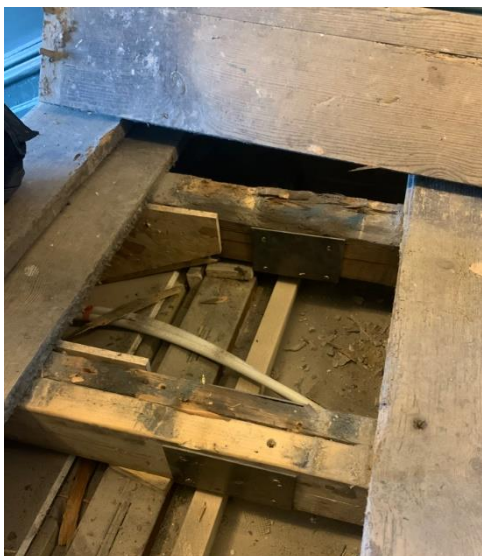
- 3.20 The existing staircase is clearly a historic feature of the house, the client has sought to preserve the existing character of this and ensure it is structurally stable.
- 3.21 The existing staircase shows signs of historic movement and had dropped, creating twist in the timber, on inspection within the floor structure this was as a result of one of the joists being split.
- 3.22 Rather than removal of any historic timbers, a small section of steel has been inserted below the return at first floor level in the floor structure of the staircase. Accessed via removal of the area of plaster on the sloping underside. The steel rests on the existing brick pier ends, which support the stair. Plates have been attached into the existing timbers and affixed to new timbers to hold together. No historic timber work has been removed. Details of this repair work can be seen in Figure 10.

Figure 10 showing steel plates and new timber to support existing historic timbers.

- 3.23 This work has been undertaken to minimise any disturbance to historic fabric and ensure that the staircase is suitably supported. The movement can be seen highlighted in the image below.

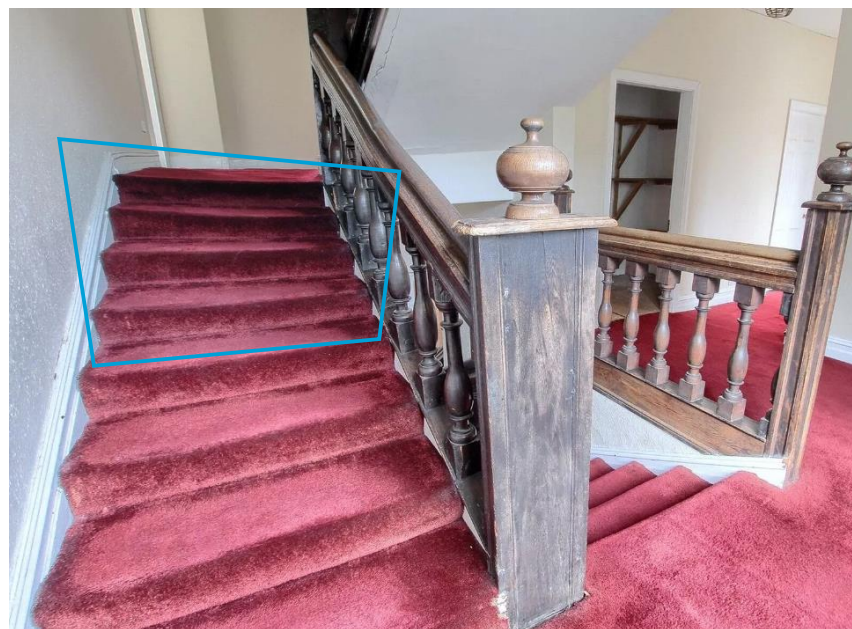
Figure 11 Sale particulars showing the dropping staircase at first floor level now repaired.

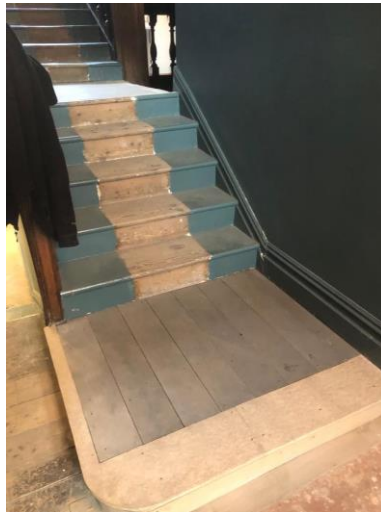
Figure 12 Extended landing stair, original remains evident

3.24 At the lower landing area the existing timber end step has been extended to create an enlarged landing area. The original and landing can be seen in the image below with the new timber surround. This is covered in ply and will be carpeted. This is a fully reversible alteration and has been installed to create an improved area of step off as the previous was relatively 'tight'. As the hallway is large at this point this has not affected the proportions of this space. See figure 12 for this detail.

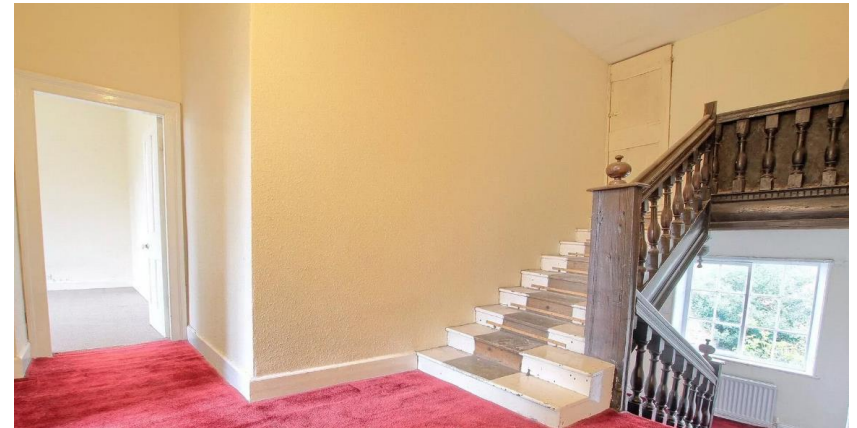
3.26 Additionally at the upper floor level of the staircase (at roof level), presumably the original second floor landing leading to the loft space had been altered previously with the addition of a modern partition which was

notched into the upper banister rail. Presumably this area was altered at some point with the extension to the west. Although the applicant advises that this stud work since removed was all 20th century modern boarding (this can be seen in figure 13 below).

Figure 13 Partition at second floor cutting across historic stair, now removed.

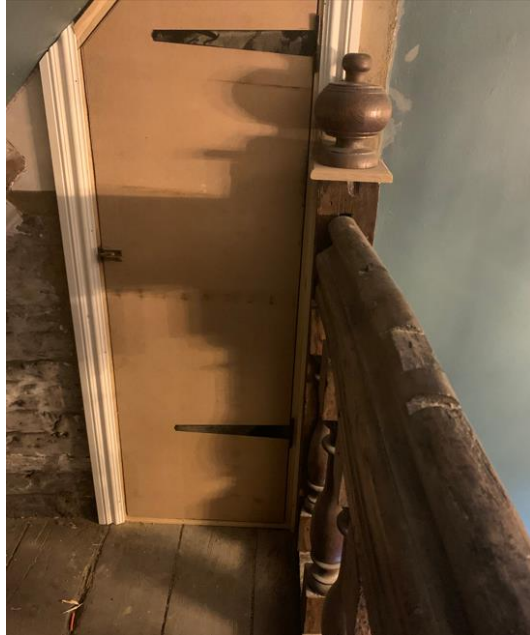
Figure 16. New access into loft area, previously an open space.

Evidence of the notching to the handrail from previous modern partition seen in image above

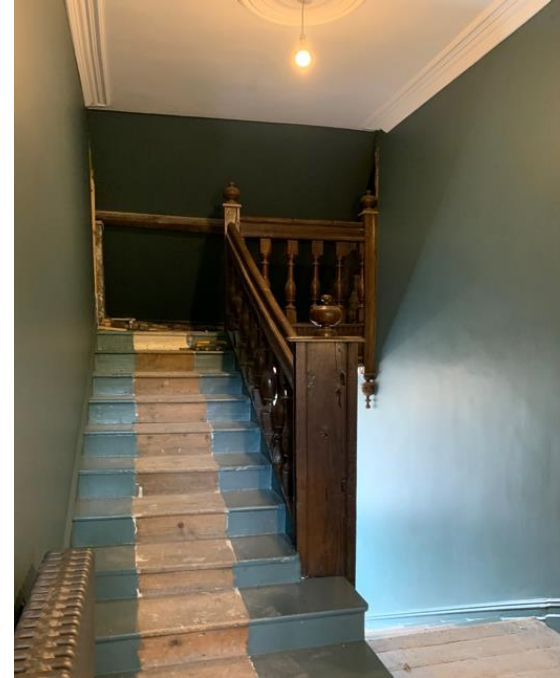
Figure 17. Area at second floor where a landing has been created to allow access into the loft through removal of modern partition.

Historic timber roof members evident and coving retained.

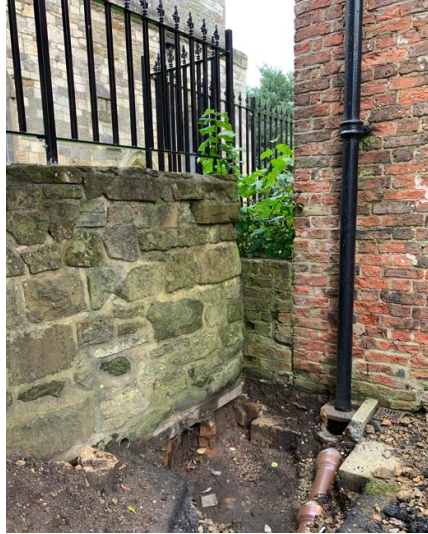
- 3.45 There is drain to the southeast corner of the house which was broken and creating pooling at the corner. This has been exposed to show condition and is clearly broken and modern pipework. The intention is to replace this like for like. The new ensuite bathroom in bedroom 1 will connect into this existing down pipe and foul drain via a dog leg pipe. Whilst there are concerns that these works may disturb burials this is an existing drain located on the vicarage side. Whilst it is recognised that there may be

potential for burials to spill out of the boundary of historic church yard, the client was unaware of this and the drain is an existing situation. Works have ceased in this area and arguably, no formal consent is required to fix the existing drain. The applicant would be happy to accept a watching brief when carrying out the repairs should the Councils archaeologist consider that such a condition is required.

Figure 25 Drain to the south east of the Vicarage to be replaced

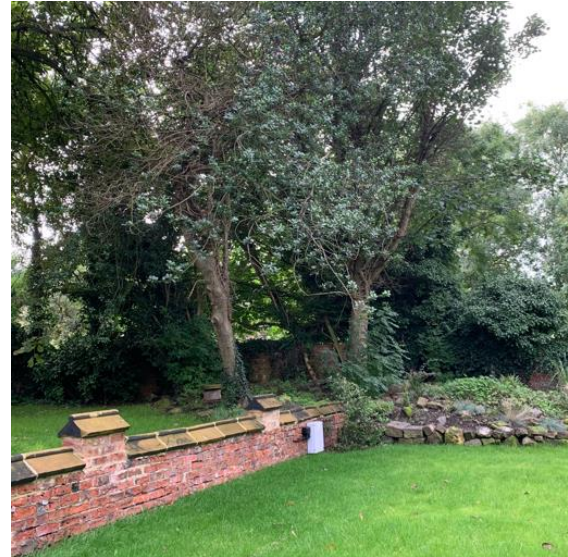
- 3.46 Within the lawned garden area works have been limited to reaffix lost coping stones and repairs to the existing wall which creates a small terrace across the lawn (and is evident on historic maps) As well as the installation of a cabling for an electrical point for garden equipment to the lower end of the terrace (seen in image 26 below).

Figure 26 garden wall with repairs to copings and electrical box installed.

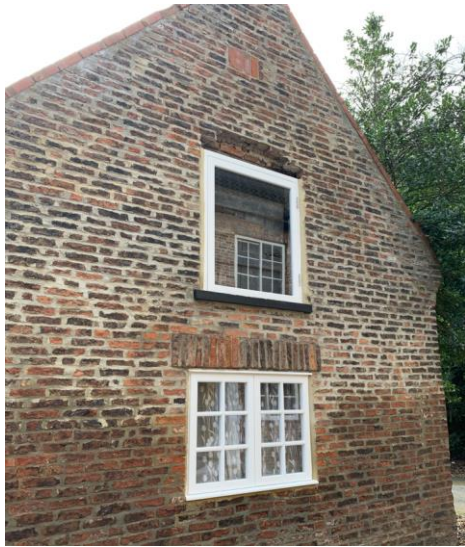
Figure 28 Gable end of outbuilding showing replaced windows.

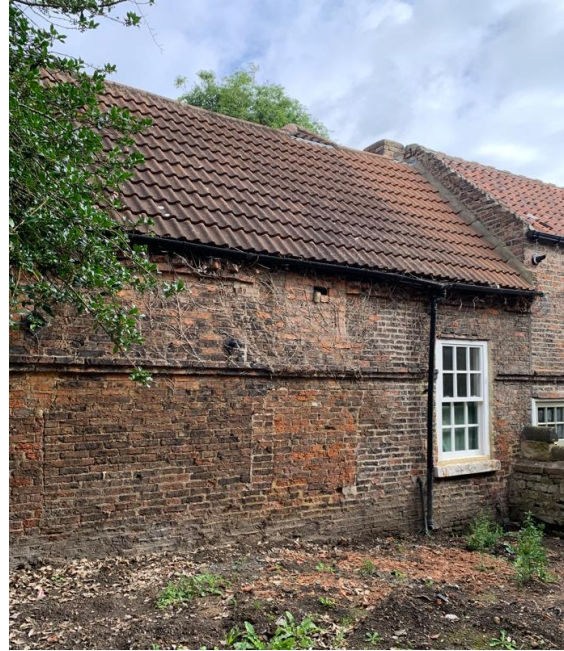
Figure 29 Church Road elevation of out building showing changes to openings.

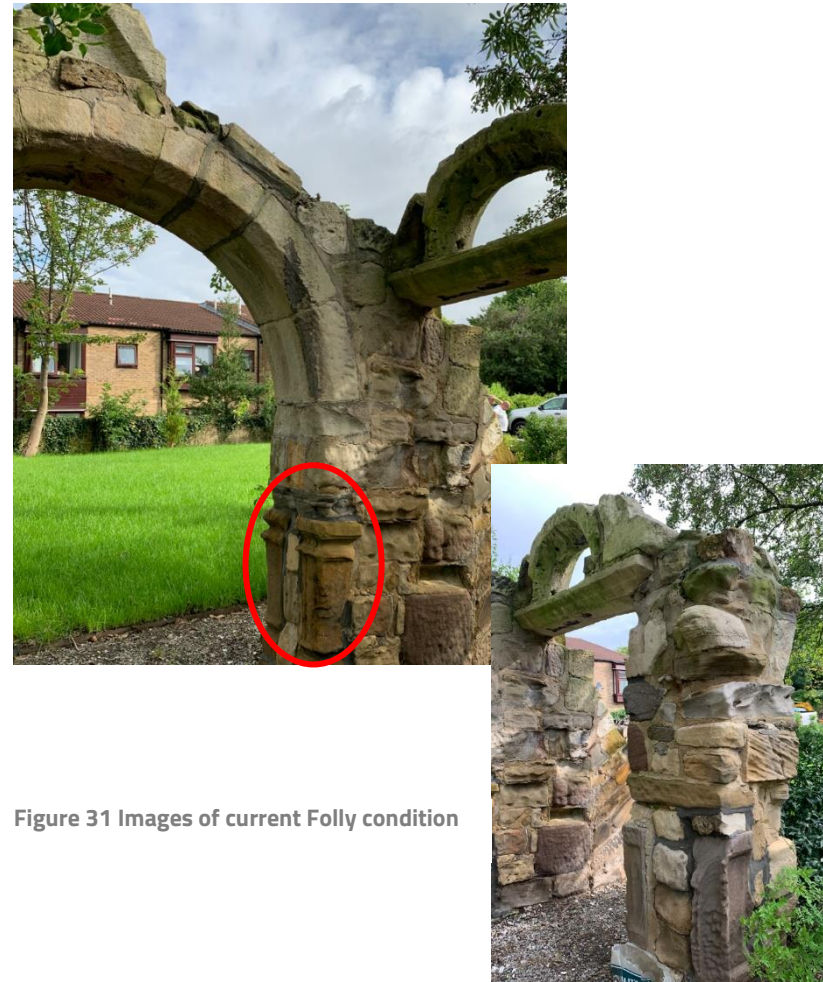
- 3.54 The folly is a historic structure grade II listed in its own right. As a collection of reused historic stonework it shows evidence of past rebuilding. It is a collection of historic stonework arranged in a somewhat ad hoc manner. There is a mix of repointing and mortar types evident in the structure.
- 3.55 The applicant has only reattached a couple of stones where they were found to have fallen from the structure. The mortar is lime based but a coloured dye has been added to look to match the neighbouring mortar colour. This is rather dark in tone and gives a dark grey appearance to the mortar. However, is starting to weather, and as a result of the darker mortar does not appear as a recent repair. The location of the repair is highlighted opposite.
- 3.56 It is not intended to carry out any further works to this structure and its condition will be monitored.

Figure 31 Images of current Folly condition

- 4.11 Repair works have also been carried out to the listed Folly, although the extent of this is very limited, to securing a few loose elements of stonework back into place to prevent further deterioration of the structure.
