# ARBORICULTURAL REPORT

to BS 5837:2012 at:

***Newall Carr Rd,  
Otley  
LS21 2ER***

Reference: AWA3792

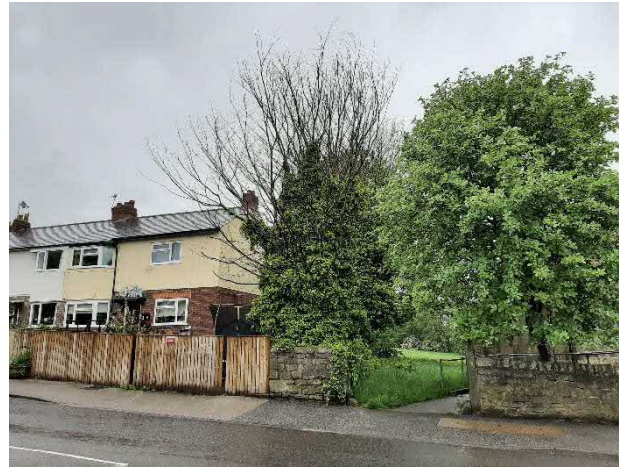
- 3.2.4 Situated at the north-west boundary, close to the church, are Elms T1 and T2, Sycamore T3 and G4. T1 and T2 are in poor condition, with T1 appearing dead at time of survey with obvious dead wood and form consistent with Dutch Elm disease. T2 only has sporadic leaf cover in the upper canopy and occasional prominent sections of dead wood, and as such likely has very limited long-term value. T3 was in better condition, and so has moderate value and good long-term prospects.

- 3.2.10 T1 is dead, and T2 is in significant decline. Both trees should be removed regardless of any new development (as detailed in Appendix 4).
- 3.2.11 Some trees were covered in dense Ivy or were inaccessible (as detailed in appendix 4) in such cases measurements were estimated and the condition values are indicative only.

Photo 2: T1, at the roadside, dead and covered in ivy

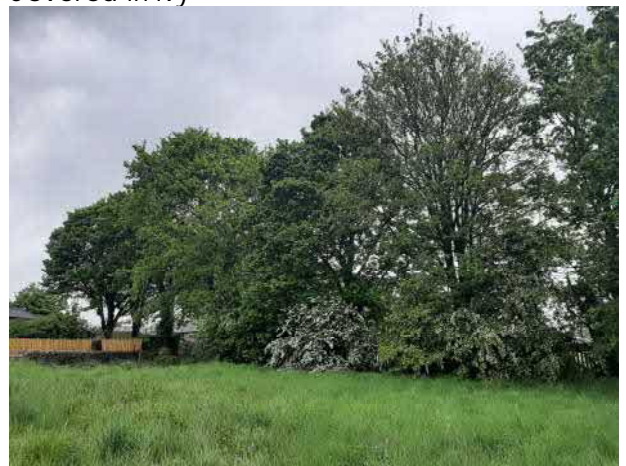
- 3.2.6 Beyond the eastern boundary, situated in the school playing field, are Sycamores T11 to T15. These are large, prominent trees in the surveyed area and wider landscape, with good collectively amenity value. In the understory of T11 to T15, situated within the boundary of the surveyed area, is Hawthorn hedge group G16, which provides good screening.

Photo 4: T11 to T15, with understory G16, at the eastern boundary

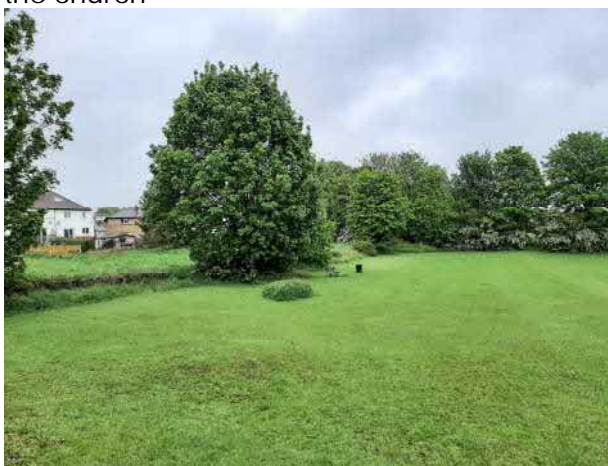
- 3.2.7 Along the southern boundary are trees T17 to T23, T25 to T27, and shrub group G30. Collectively, the trees at the southern boundary provide reasonable screening from the adjacent public open space. T20, T26 and T27 are of more moderate individual value, with good long-term prospects. A number of the trees are situated close to a retaining wall, with T22 causing notable damage. Further damage is foreseeable in the longer term, and as such T22 has limited long-term value.

Photo 5: Trees at the southern boundary, as viewed from the adjacent public open space

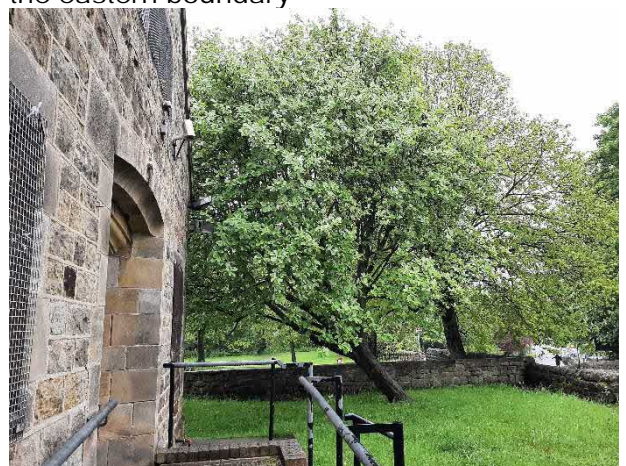
- 3.2.8 At the western boundary are Whitebeams T28 and T29. T28 has a significant lean at base, and while the canopy is growing to correct this imbalance, in the short or medium term failure is foreseeable. T29 has a number of tight unions with included bark, with limited reaction growth, and so partial failure is foreseeable.

Photo 6: Leaning tree T28

T28	Whitebeam	<i>Sorbus aria</i>	Early-mature	9	1	430	No	2	3.5	6.5	5	2.5	Exposed roots	Single stemmed, Significant lean, at base, Tight union with partially included bark	Unbalanced, Growth correcting lean	Mower damage to roots. Some parts of crown previously topped or failed	Good	Poor	10 to 20 yrs	C	No works required
T29	Whitebeam	<i>Sorbus aria</i>	Early-mature	9.5	1	400	No	2	4	4	1.5	3.5	Exposed roots	Single stemmed at base, Multiple stemmed at 1m, Tight union with partially included bark, Stubs, Pruning wounds from crown lifting	Slightly unbalanced	Tight unions fused, so measured low. Limited reaction at tight unions, partial failure likely in 10-20 years	Good	Fair	10 to 20 yrs	C	No works required
