1. Summary

Bat and Barn Owl Assessment – CEC4307 – The Meadow, Brill

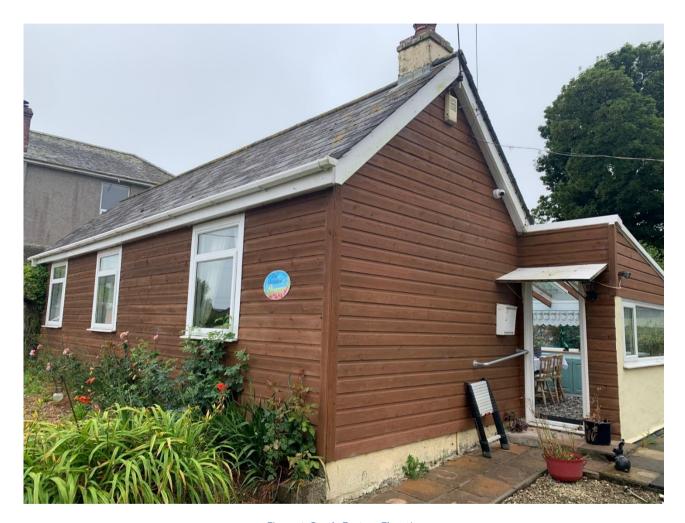
Figure 1: South-Eastern Elevation

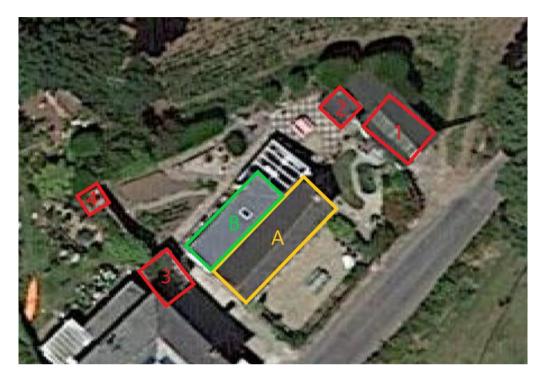
Figure 2: Buildings assessed

The main residential building is divided into sections A and B as shown in figure 2.

- A. Section A is timber framed with a UPVC shiplap clad exterior and a concrete base. The roof covering is composite tiles which is underlined with bitumen felt the building has UPVC facias and soffits which are both sealed with no access for use by roosting bats. The building has a loft cavity which is partially boarded. A search of the loft space, including the boarded areas, insulation, felt on the gable ends and around the chimney stack was conducted; no evidence of bats could be found.
- B. Section B is an extension from the main building. It is built with cavity block wall with a rendered exterior. The building has a sloped fibreglass roof with no roof void and PVC facias and soffits. The building is well sealed and no access points for bats were noted.

There are four outbuildings on the property that can be seen in *Figure 2*:

This is a rendered, single skin block built building which is covered with a corrugated metal roof with two sheets of corrugated plastic sheeting. The building has metal facias and a garage door on the south-east elevation. There were no gaps on the metal facias large enough for bats to access and no evidence of bats was noted.

The bike shed is built from a single skin block with a ply roof lined which is covered with roofing felt; there is a small window on the south-west elevation. Although there are some gaps within the roofing felt, these will not provide access for bats and a search of the interior showed no signs of use by bats.

The workshop is a lean-to building adjoining the neighbouring property and is constructed from rendered single skin block and is covered with a corrugated plastic roof. There are wooden facias, which are sealed and a small window on the north-east elevation. The interior and exterior were searched; no evidence of use by of bats was found The building has is ivy growing over the roof from an adjacent wall, but the stems are insufficient to support bats.

The woodshed is a lean-to structure adjoining the boundary wall which is covered with a corrugated metal roof and single skin block walls. The building is generally unused apart from the storage of logs and a signage board. The interior and exterior of the building was searched, including the signage board and stored logs; no evidence of use by bats was noted.

No sign of nesting birds was recorded within the building at the time of the survey though there is a large ivy patch growing over outbuilding 3 (see *figure 2*). It is recommended to clear the ivy surrounding the building carefully by hand. If any active nests are discovered they should be left undisturbed until the young have fledged as they are protected against taking, damage or destruction under the Wildlife and Countryside Act 1981. Works are less likely to be delayed if work is avoided between March and July (the peak nesting season).

Although no current evidence of roosting bats was found it cannot be assumed that bats are not present when works commence. Care should therefore be taken during the work as bats could roost unseen deep within crevices in the structure, particularly under ridge tiles, beneath wall plates, or between or above lintels. If any bats are discovered during the work they must not be handled: works must stop immediately and advice sought from CEC (tel 01872 245510).
