## Arboricultural Impact Assessment

**613-615 Green Lanes Palmers Green London  
N13 4EP**

**Vivendi Architects Ltd**

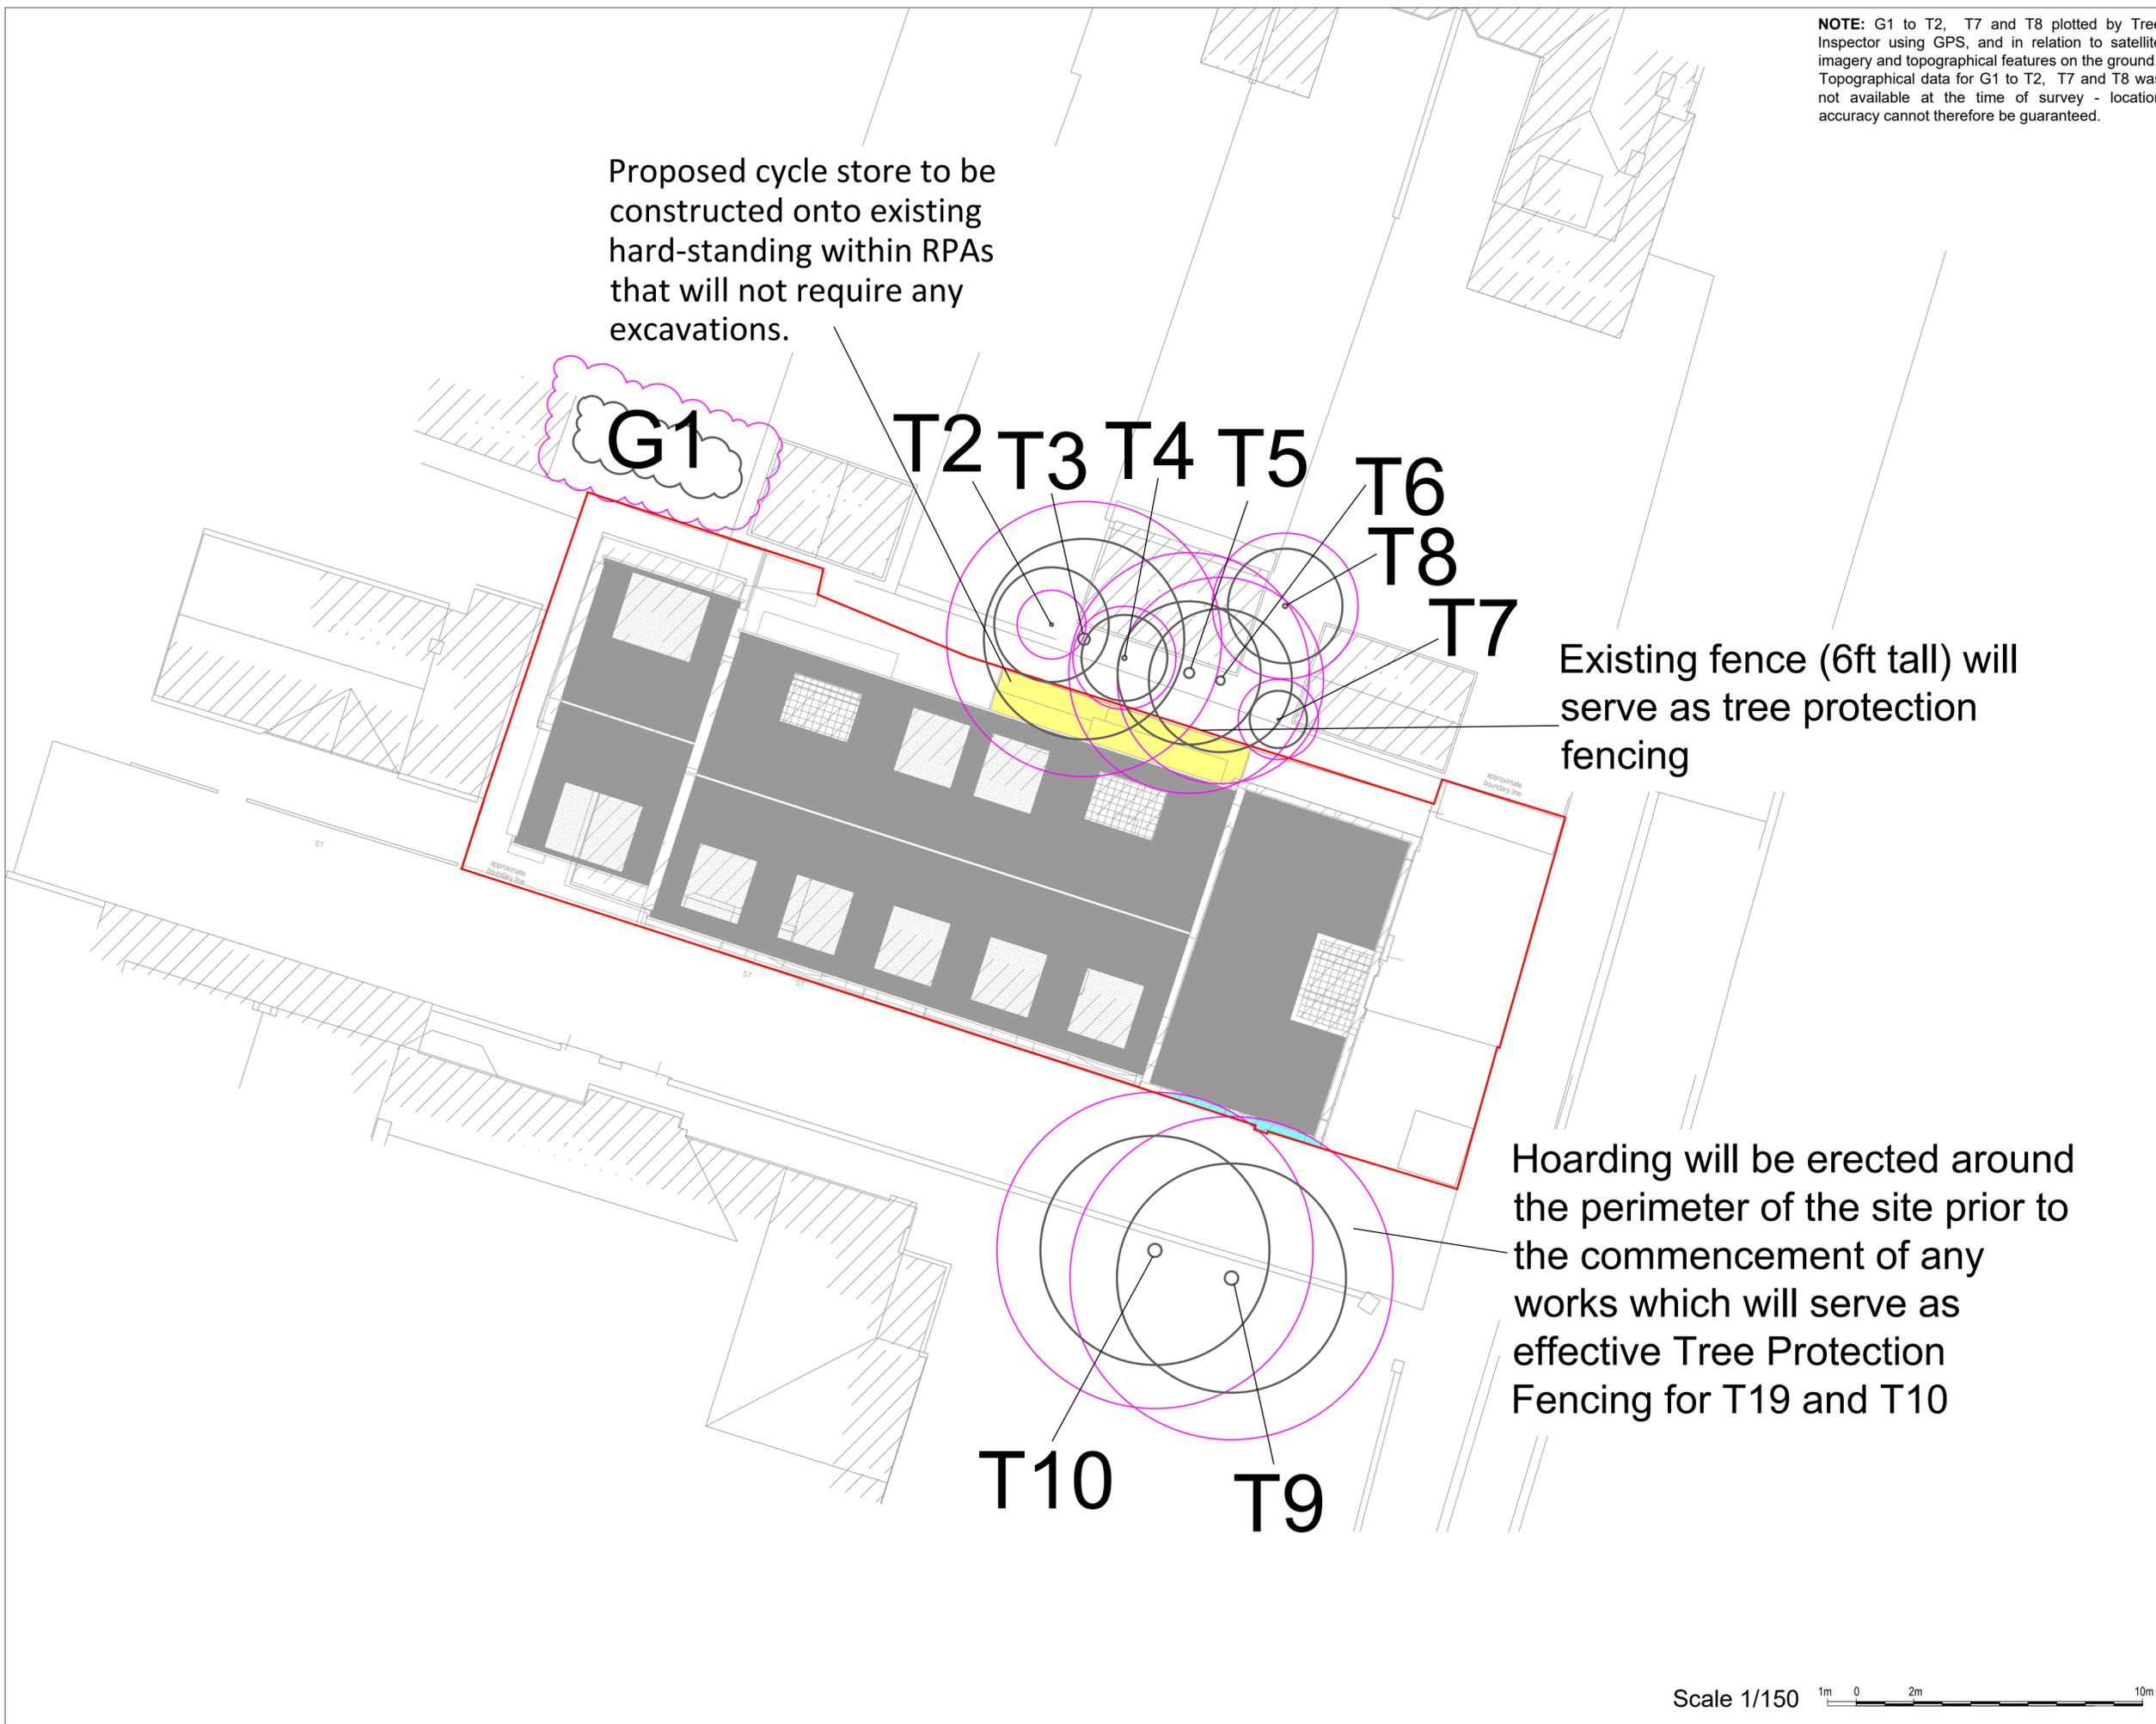
Existing fence (6ft tall) will serve as tree protection fencing

Hoarding will be erected around the perimeter of the site prior to the commencement of any works which will serve as effective Tree Protection Fencing for T19 and T10
