ARBORICULTURAL SURVEY, IMPACT ASSESSMENT AND PROTECTION PLAN

CONSTRUCTION OF A SINGLE STOREY SIDE EXTENSION

LECKHAMPTON VILLAGE HALL, CHURCH ROAD, CHELTENHAM

MHP ref: 19111_LECKHAMPTON VILLAGE HALL_TS AIA TPP_V2

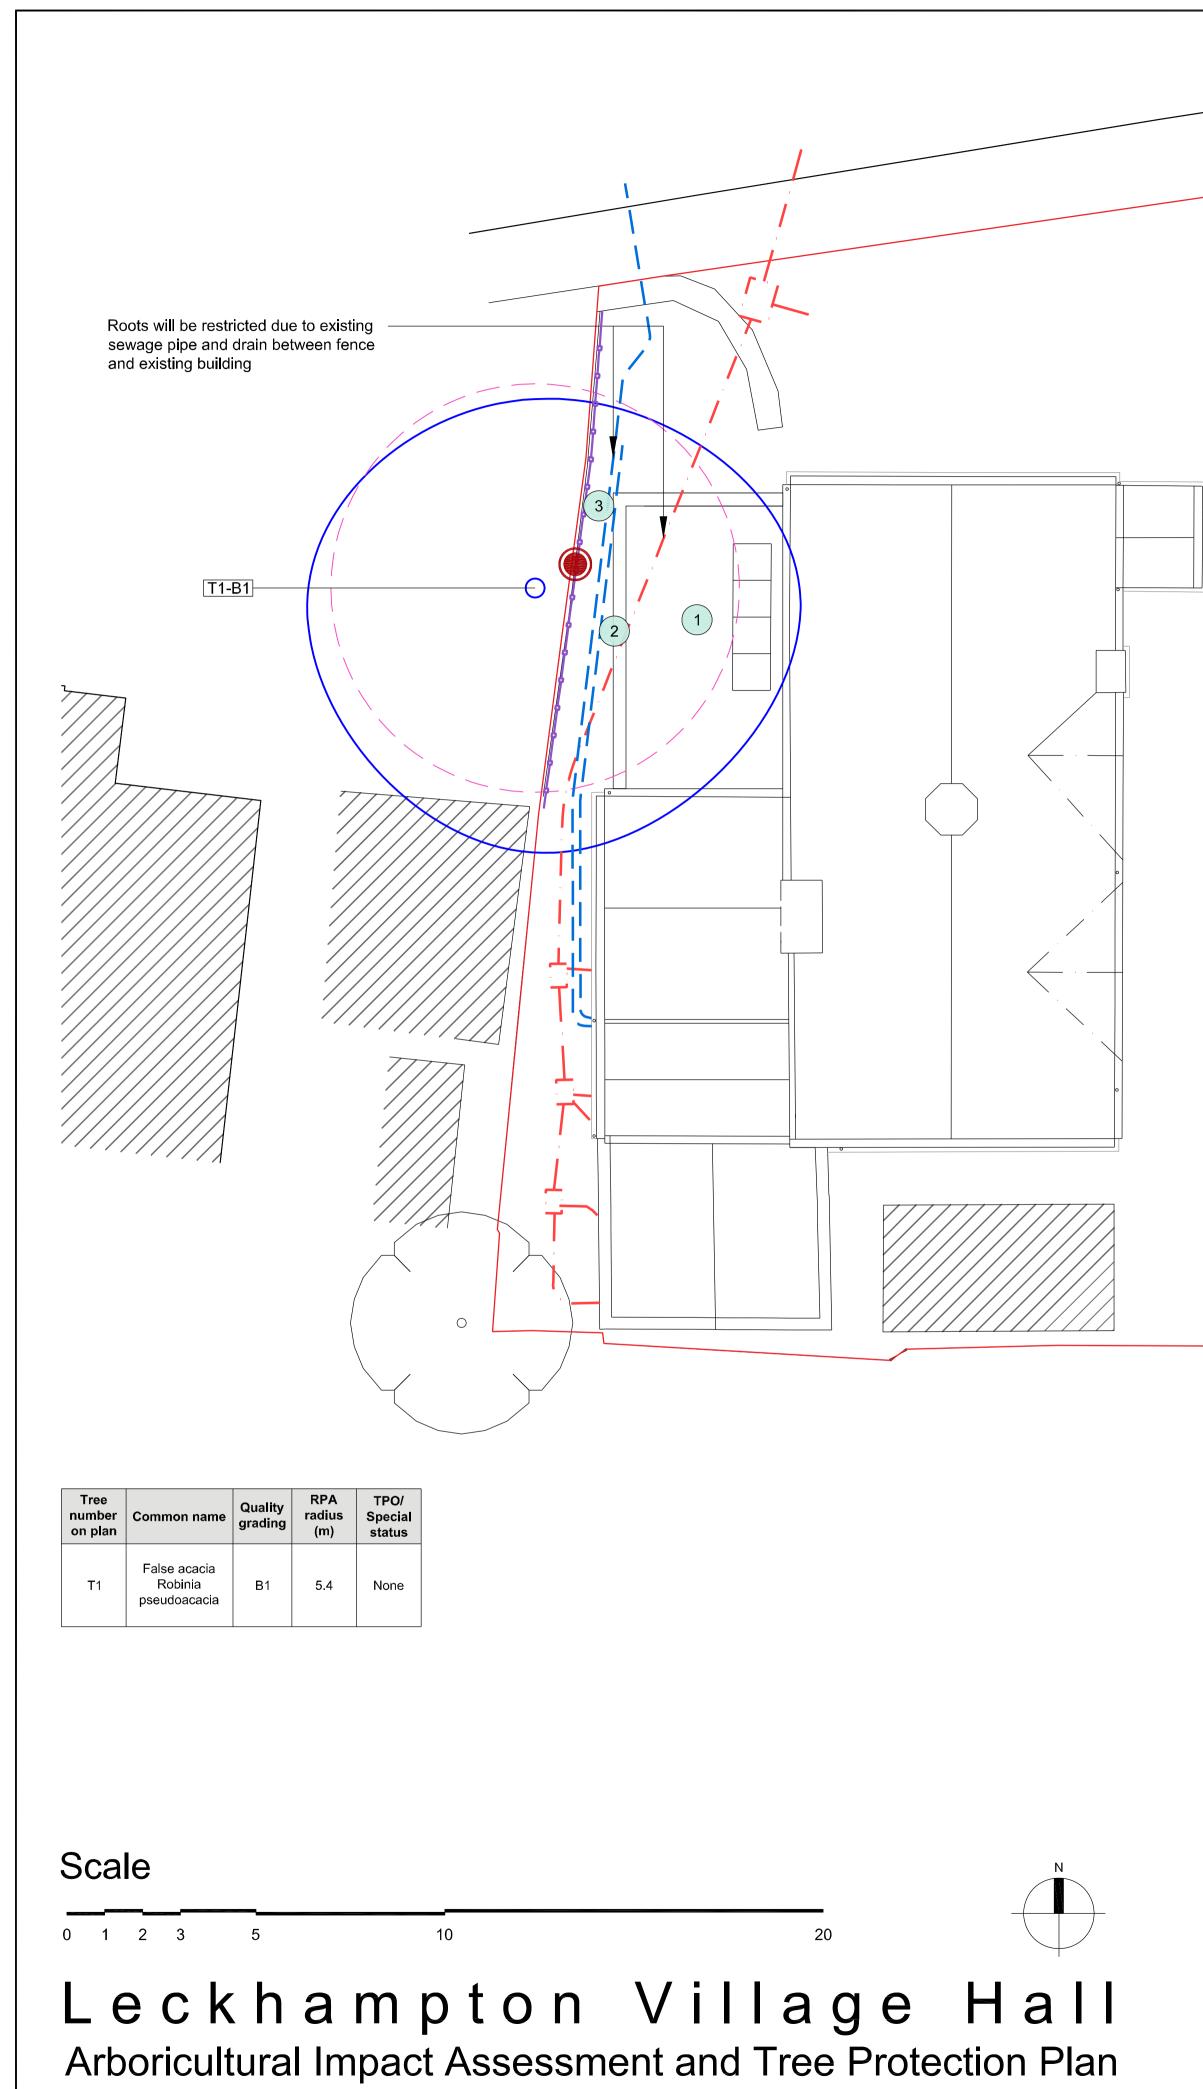
APPENDIX 1 – ARBORICULTURAL IMPACT ASSESSMENT AND TREE PROTECTION PLAN

- 4.4.4 The AIA table shows that the proposals are likely to only have a low level of physiological impact on the tree. There will be a neutral impact on the tree's public visual amenity value. Overall, the level of harm associated with the proposals is not considered to be significant.

- 4.4.5 The tree protection elements of the plan further demonstrate that the proposals are feasible from an arboricultural perspective.
