9th November 2023

Ref: Repeat Ecological Appraisal (PEA) – The Dairy, Waterlooville

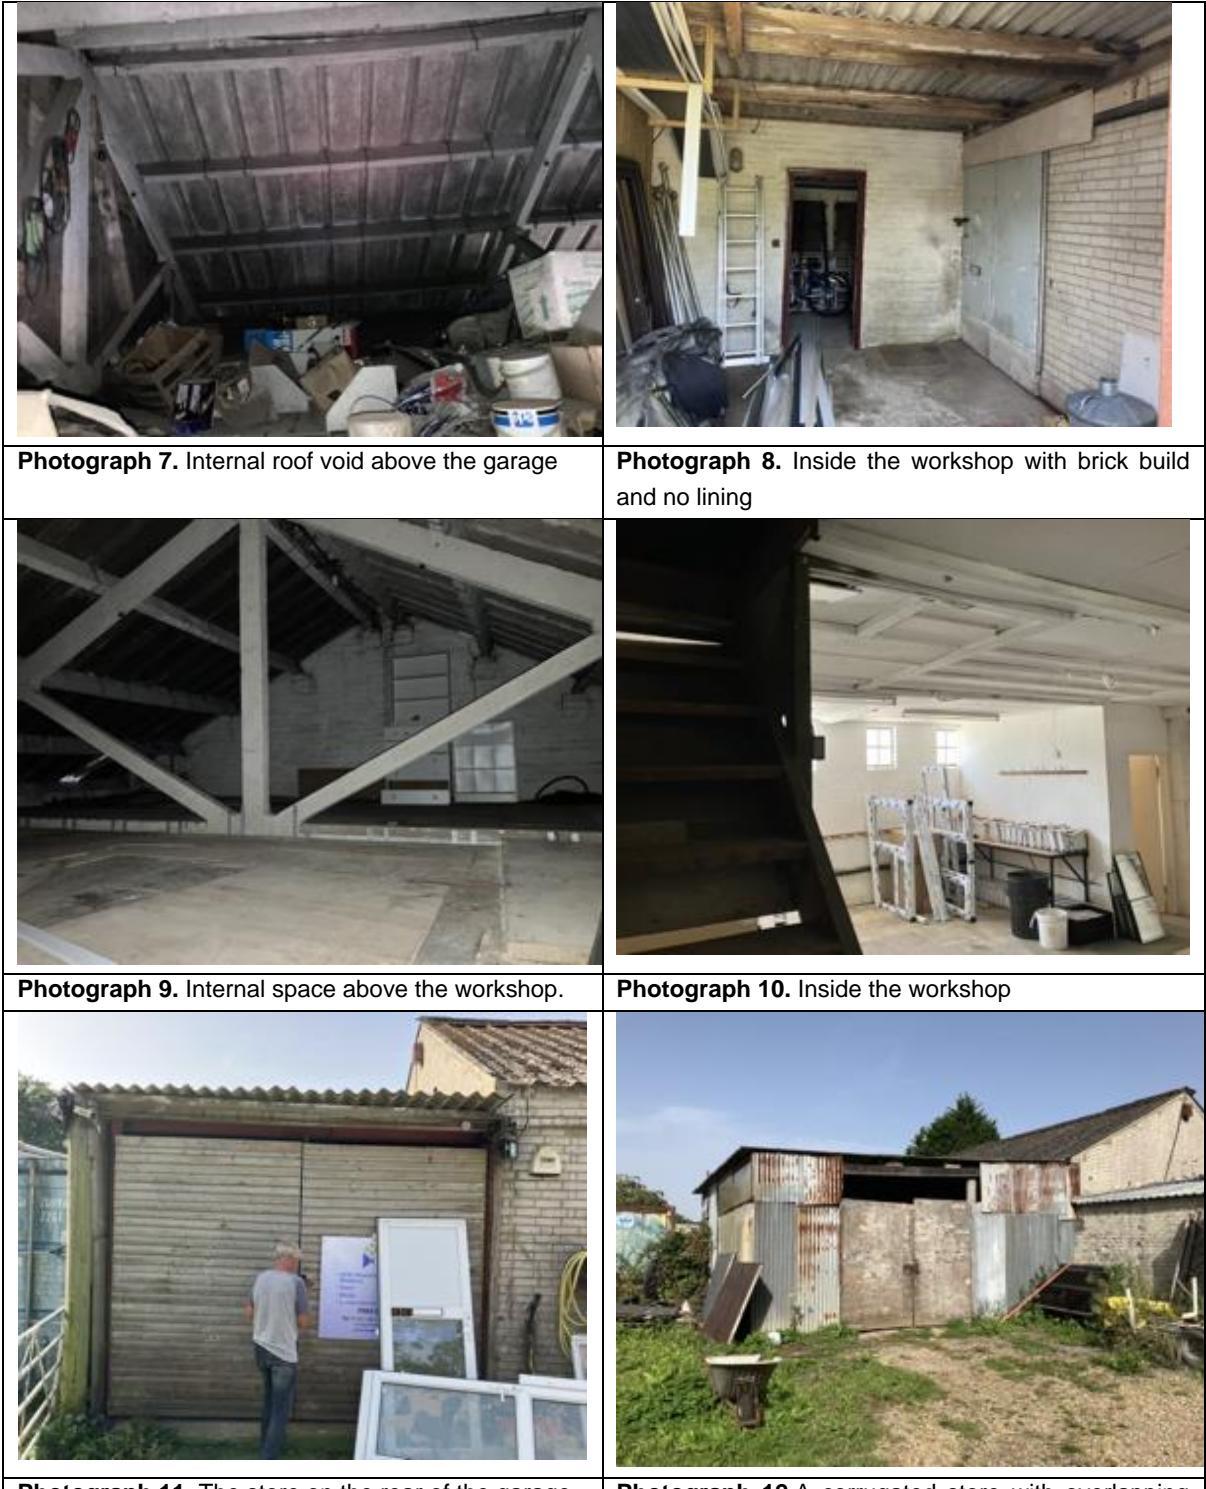
Photograph 11. The store on the rear of the garage and workshop with a large gap at the top but tight weatherboarding.

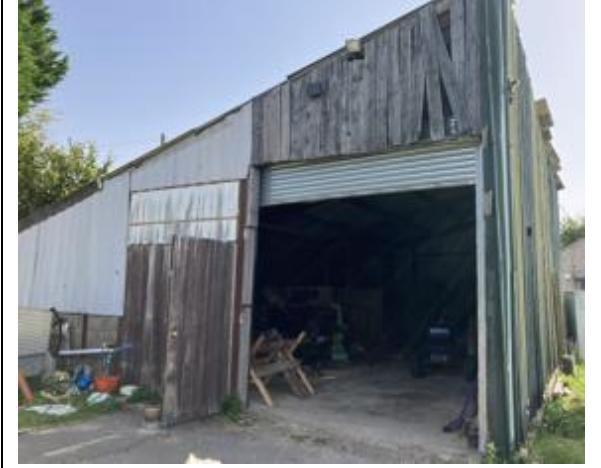
Photograph 14. Internal view of the agricultural barn

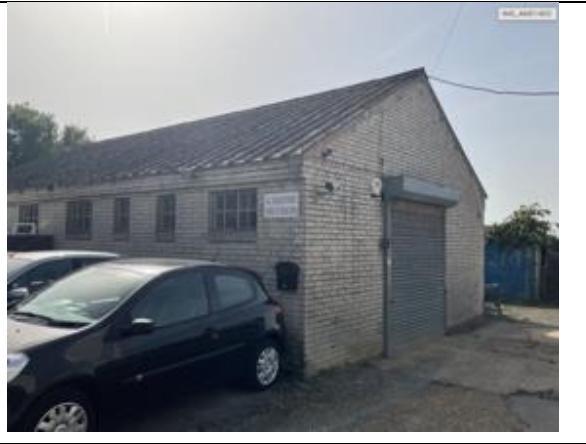
n the **Photograph 16.** Brick build garage, with metal shutter door.
