Tree Survey Report

By: Alicia Morton-Thurtle
AMT Tree Surgeons
October 2023

Site: Drinnick Road, Nanpean, PL26 7YN Cornwall
Client: Garden Buildings Cornwall

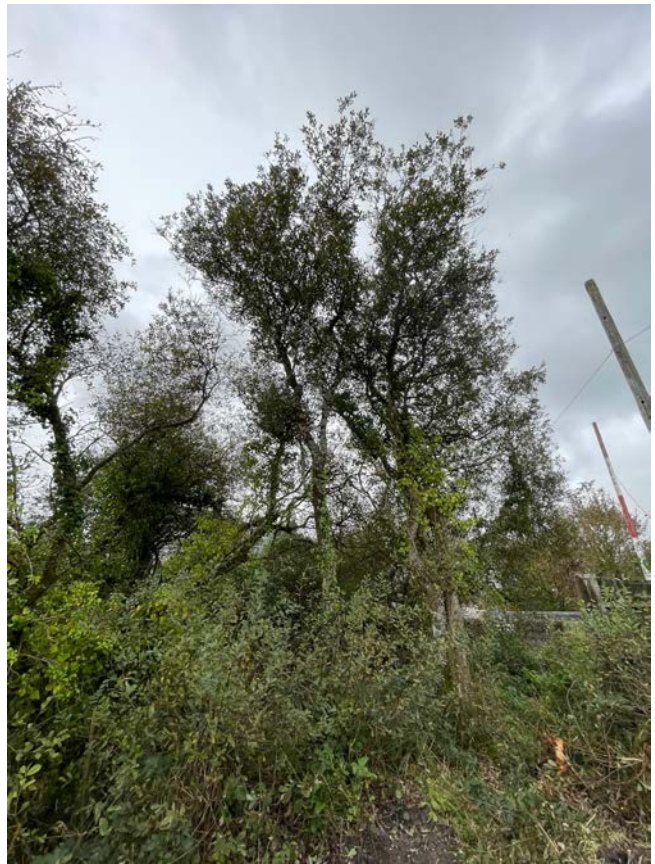
(Left to right, T3, T2 and T5)

T003	Goat Willow (<i>Salix caprea</i>)	1	9	0.5	N 0.5, E 0.5, S 1, W 1	2.5	MA	20-40	Suppressed by T002, Ivy present on stem. No deadwood/wounds/decay noted.	Fair	1.9	B2	Removal of Ivy from Stem.
T004	Goat Willow (<i>Salix caprea</i>)	1	Less than 1	n/a	N 0.5, E 0.5, S 0.5, W 0.5	n/a	MA	Less than 20	Recently poorly coppiced. Large areas of bark damage. Some re-growth from this year present.	Poor	<1	U	Removal of Coppiced Tree.
T005	Goat Willow (<i>Salix caprea</i>)	1	Less than 1	n/a	N 0.5, E 0.5, S 0.5, W 0.5	n/a	MA	Less than 20	Recently poorly coppiced. Large damage to remaining bark, evidence of stem-ripping that has descended into the remains of the stem. Small amount of re-growth.	Poor	<1	U	Removal of Coppiced Tree.
T006	Hawthorn (<i>Crataegus monogyna</i>)	1	4	0.5	N 1.5, E 1, S 1, W 1	N 2, E 1.5, S 1.5, W 1.5	MA	<40	Some evidence of old pruning/limbs cut. Dense tree, good overall vigour.	Good	1.9	B1	Crown raise to clear bank height, removal of smaller secondary stems on West side of tree.

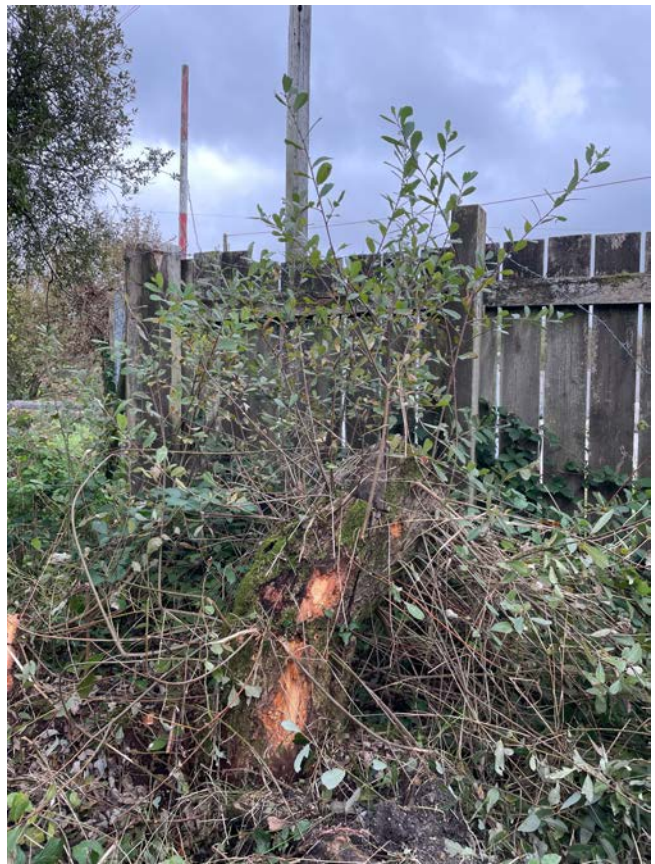
Ref	Reason for Removal	Description of Tree Work
T004	Little to no forward amenity value for the property. Poorly coppiced with substantial bark damage.	Remaining stump removed to ground level
T005	Little to no forward amenity value for the property. Poorly coppiced with substantial bark damage.	Remaining stump removed to ground level.

T4 showing bark damage

The trees in the U Category (along with those in Category C that cannot be usefully kept), should be removed prior to construction work. At this time, T004 and T005 are recommended for removal.

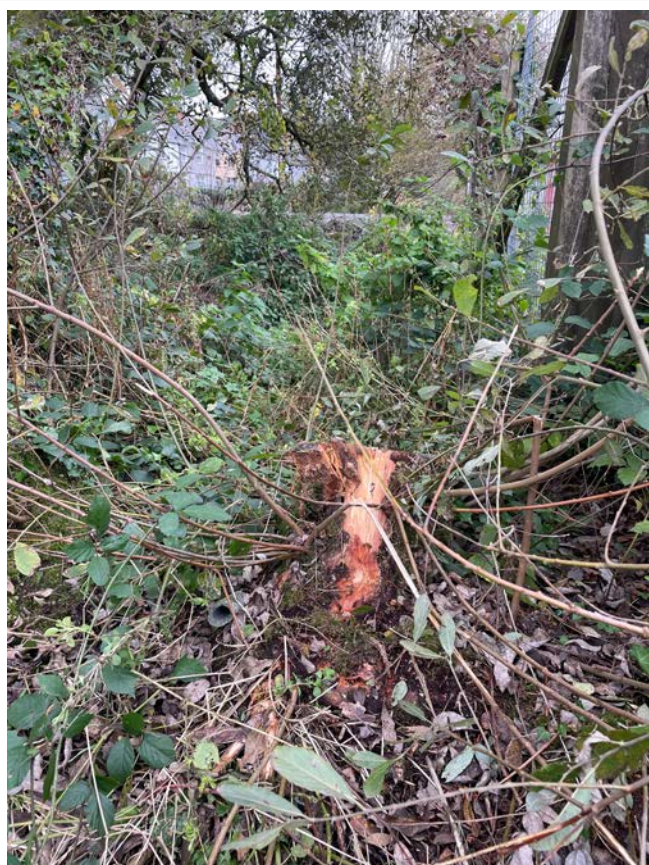
T5 showing bark damage

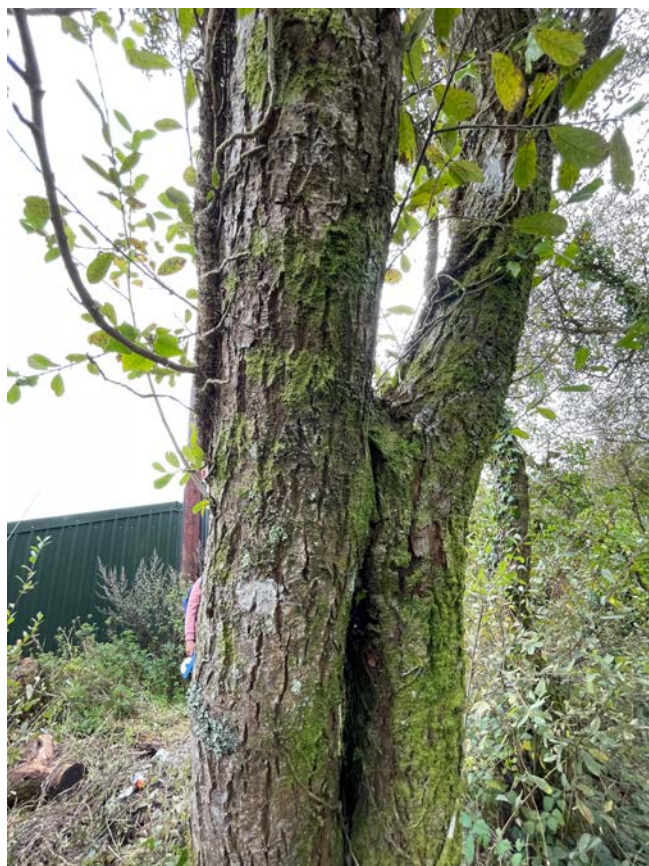
Reference Number	Species (Common Name)	Number of Stems	Height (m)	Stem circumference (m)	Branch Spread (m), N, E, S, W	Height of crown Clearance (m)	Age Class	Estimated remaining contribution (Years)	Structural Conditions, (Wounds, decay, deadwood)	Physiological Condition	Root Protection Area (radius equivalent)	BS: 5837 Category Grading	Recommendations
T001	Goat Willow (<i>Salix caprea</i>)	1	6	0.75	N 3, E 1, S 0, W 1	1.5	MA	Less than 20	Heavy North facing lean perpendicular to the river. Ivy on stem. Suppressed by neighbouring trees. No deadwood/wounds/decay noted.	Fair	2.76	C1	Monitor North West Lean (Not graded U for removal as amenity value for T001, T002 and T003 as a group). Removal of Ivy from stem
T002	Goat Willow (<i>Salix caprea</i>)	2	9	Stem 1: 0.65, Stem 2: 0.6	N 1.5, E 1, S 0.5, W 1	2	MA	20-40	Small areas of deadwood present, two points of natural braking between the two stems. Slight stem enlargement at base. Ivy present, good overall vigour. Some evidence of old pruning.	Fair	2.4	B2	Monitor 2 points of natural bracing present in tree. Removal of Ivy from stems.

T002 Natural Bracing

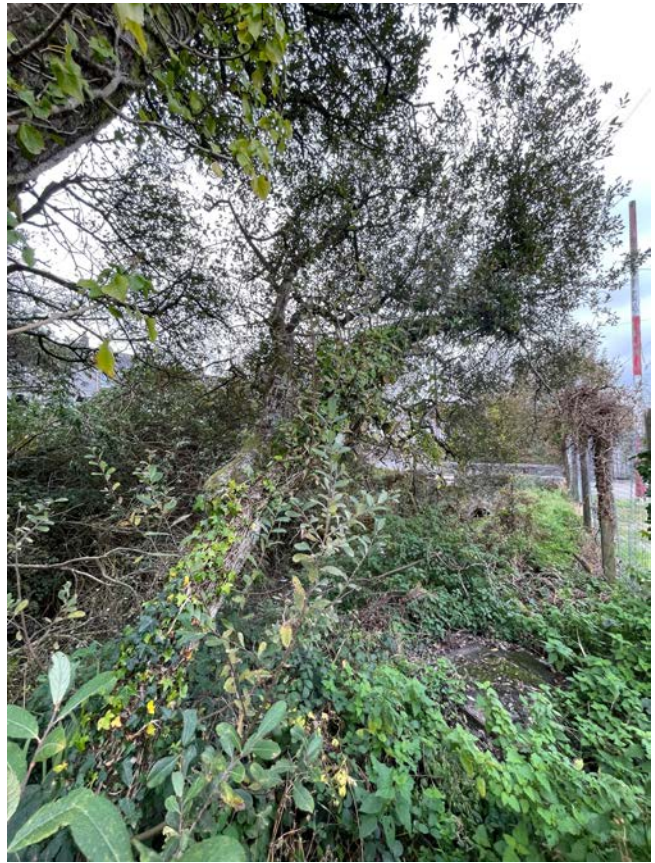
T001 Showing the steep Northwards lean and ivy present on stem

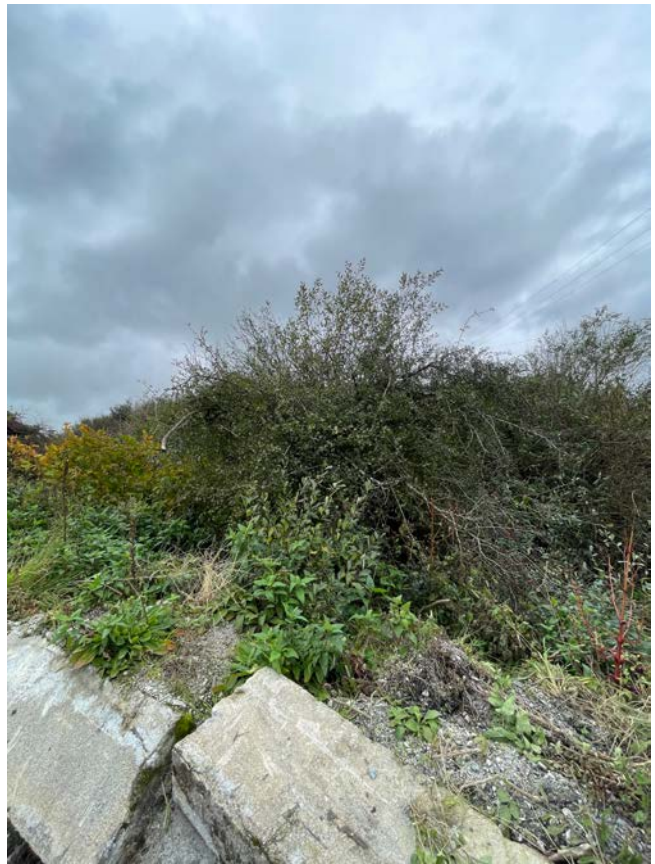
T006

T-6 This tree adds visual-perceptual and bio-physical benefits to the plot. The tree is considered to be in good health and in Appendix 2 Tree Data is marked as B1 for this reason. The proposed development falls within the RPA of this tree where it is situated on a bank alongside the river Fal, and without proper ground protection/use of specialised foundations there is a chance that construction activities or the use of heavy machinery in this area may cause a detrimental impact to this tree. A tree protection fence must be placed as shown in the Tree Protection Plan to mitigate potential branch, soil and root disruption during work.

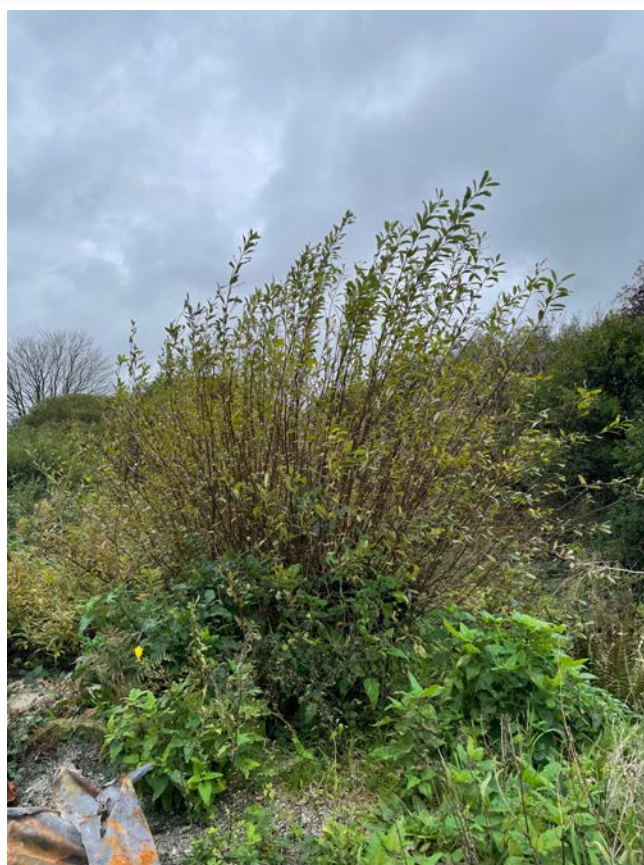
T-7 This goat willow does not presently add major visual benefits presently to the sight, but the proper forward management of this coppiced tree could potentially then add visual-perceptive benefits to the area. Again, the proposed development falls within the RPA of this tree and as mentioned above there is a chance for constructive activities to cause damage. A tree protection fence must be placed as shown in the Tree Protection Plan to mitigate potential branch, soil and root disruption during work.

T007	Goat Willow (<i>Salix caprea</i>)	1	2	n/a	N 1, E 1, S 1, W 1	N 1, E 1, S 1, W 1	MA	20-40	Coppiced tree. Good overall vigour. Some ground level competition with plant matter.	Fair	1	B1	Maintenance of Coppices.
T008	Goat Willow (<i>Salix caprea</i>)	2	2.5	Stem 1: 1.1, Stem 2: 1.1	N 1, E 1, S 1, W 1	N 1, E 1, S 1, W 1	M	20-40	Coppiced tree. Ivy and brambles on and surrounding both stems. Fair vigour.	Fair	4.2	C1	Maintenance of Coppices Removal of Ivy. Monitor tree for vigour.
T009	Goat Willow (<i>Salix caprea</i>)	3	2.5	Stem 1: 1.9, Stem 2: 1.3, Stem 3: 1.3	N 1, E 1, S 1, W 1	N 1, E 1, S 1, W 1	M	20-40	Coppiced tree. Stems covered in Ivy and brambles. Good overall re-generation. Dense canopy and good vigour.	Good	7.2	B1	Maintenance of Coppices.

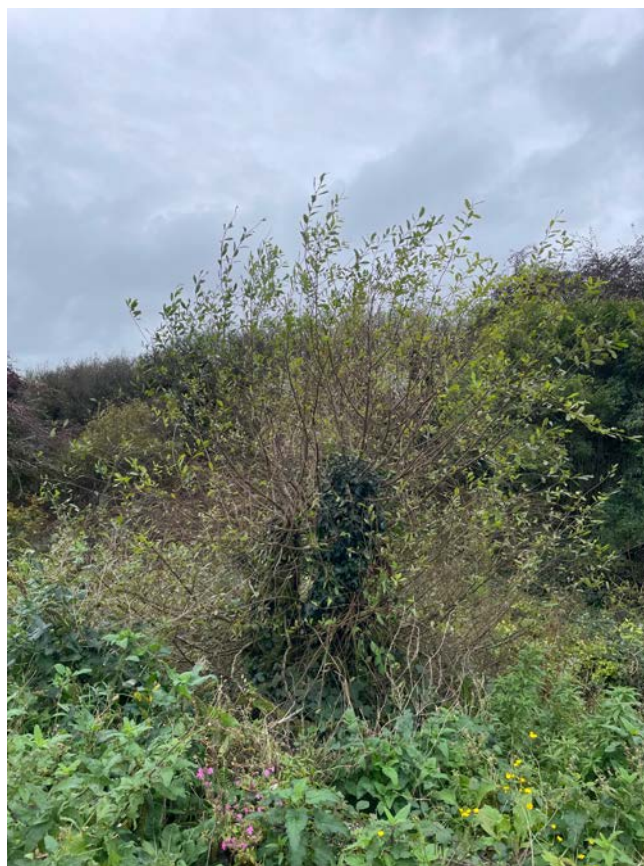
T-8 Coppiced Goat Willow, the RPA of this tree falls within the proposed development. Along with the other trees mentioned in this impact appraisal a BS 5837 protective fencing will be used to mitigate damage to both the branches and roots during the construction stage.

T008, Photographic evidence of ivy on both stems

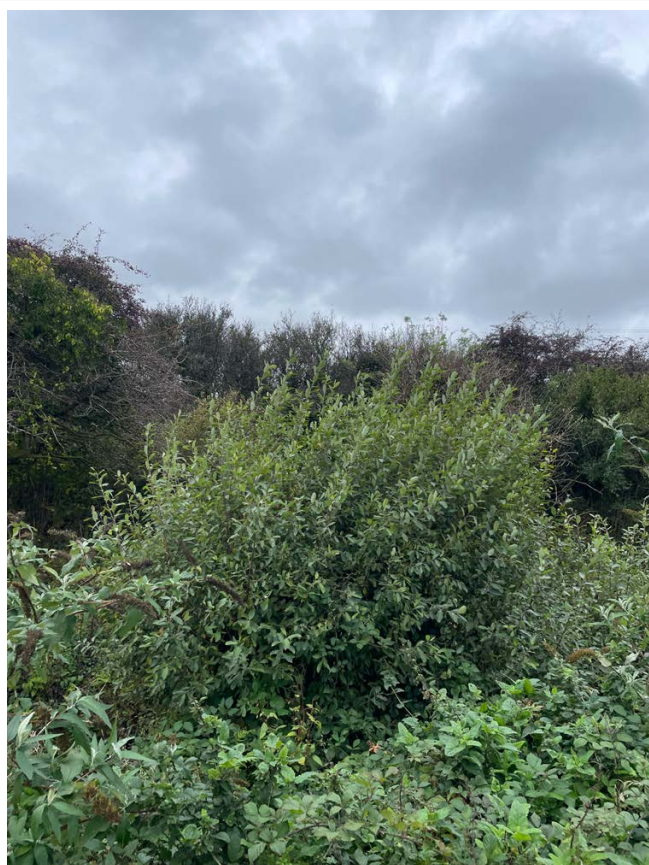
T009

T-9 This goat willow, in the future with correct care and management could add visual and aesthetic benefits to the site, as well as prevent soil erosion to the bank. Along with T-7, this trees RPA is within the proposed development and as such a tree protection fence must be placed as shown in the Tree Protection Plan to mitigate potential branch, soil and root disruption during the construction phase.
