ARBORICULTURAL IMPACT ASSESSMENT REPORT
BS 5837:2012 'Trees in relation to design, demolition and construction. Recommendations'

26 Beech Hill, Hadley Wood EN4 0JP

DATE: December 2023
OUR REF: SHA 1699 AIA

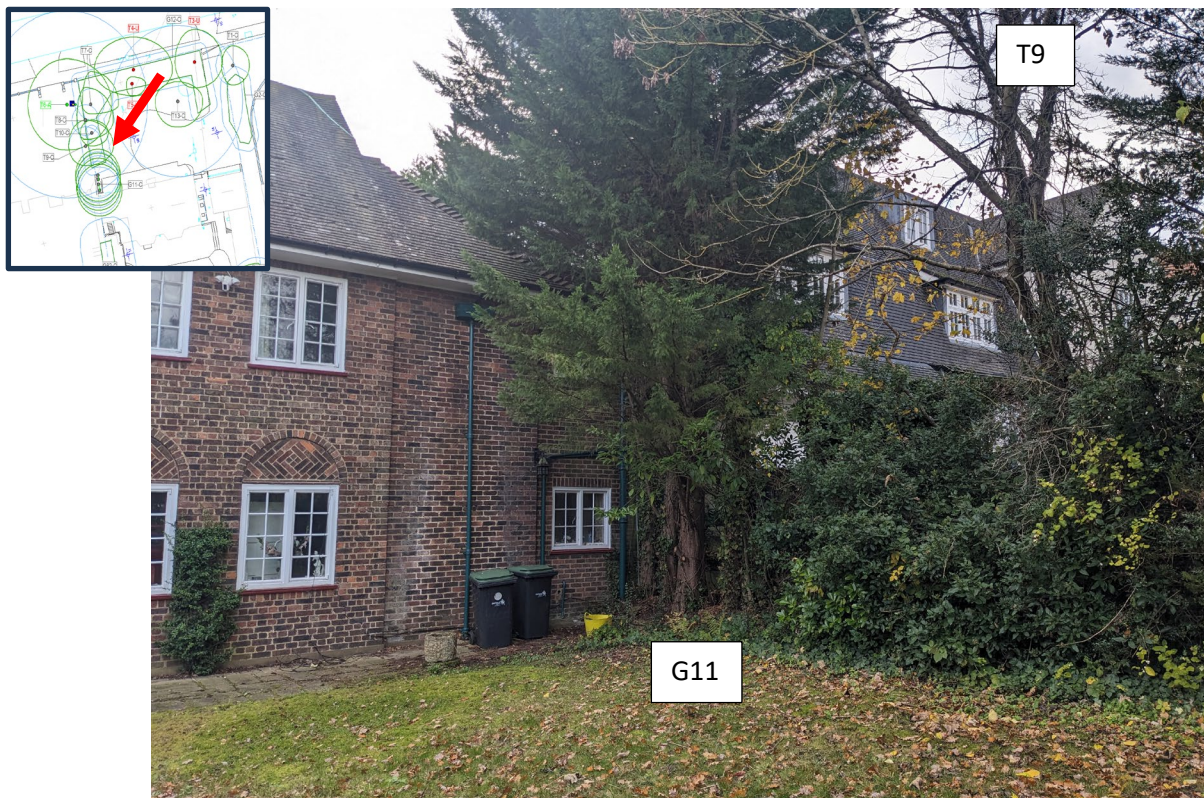
4.4. *Trees in the front garden:* The front garden vegetation is fairly unmanaged. Two mature cherry trees (T3-U and T4-U) have significant structural and physiological faults as detailed in the tree survey sheets at appendix 1. These trees are growing through a varied group of mixed shrubs (G12 – C). On the western boundary are a closely grown group of early mature conifers very close to the house and neighbouring property. Offsite, there is a mature high quality oak (T6 -A) with low quality semi-mature ash on the site side (T7 – T9 C). The prominent tree is a mature oak (T13-C) which has been heavily pruned resulting in poor form, powdery mildew (*Erysiphe alphitoides*) and sub-optimal crown architecture.

Photo 1 of T9 and G11 looking south-west

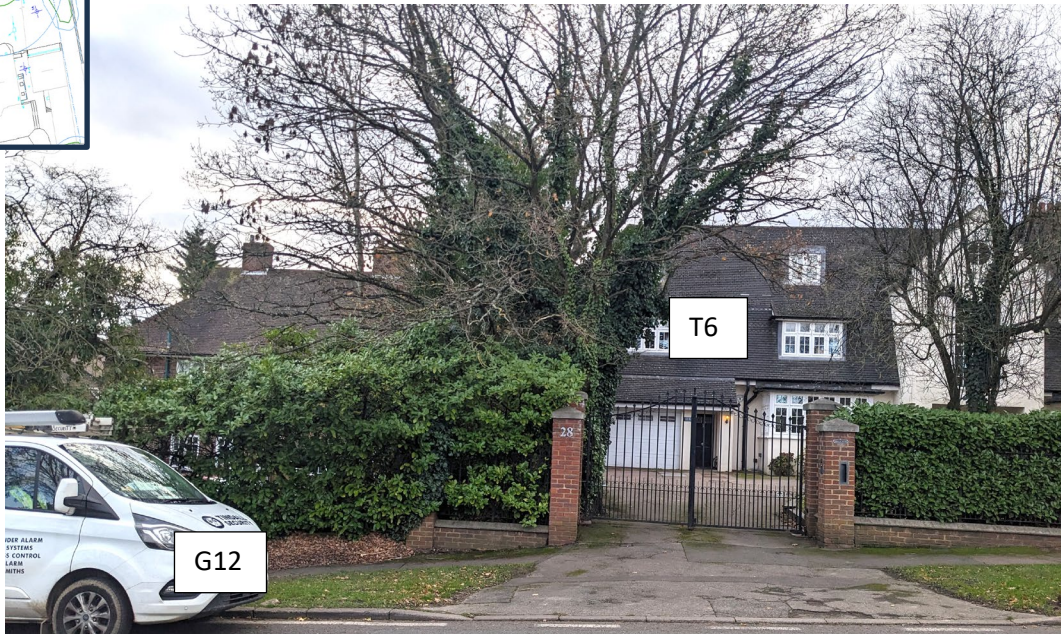
Photo 2 of T6 oak looking towards the neighbouring property

6.5 *Impact on the crowns* - The large oak offsite oak tree T6 will need to be very lightly crown lifted to ensure access under the crown on the site side. This is detailed at appendix 4 in the tree surgery schedule.

6.6 *Impact on the roots* –The root protection area of T6 is within the site and the proposed drive. During the demolition and construction phase the ground will be protected by robust ground mats/cellular confinement system to take heavy loads. Suitable products are found at appendix 5. There can be no excavation in this area, therefore any drainage and services must be outside the root protection area. The new hard surfacing in this area will be a minimal dig and porous construction and be carried out in accordance with an Arboricultural Method Statement (AMS) to be further refined post planning. A draft is found at appendix 6.

- 8.2. That the arboricultural method statements are developed further in respect of drainage and hard surfacing near the offsite oak T6 and are observed by all site personnel and supervised at key stages by the project arboricultural consultant. Short supervision reports are to be written after each inspection as a record of compliance and audit trail to the Local Authority.

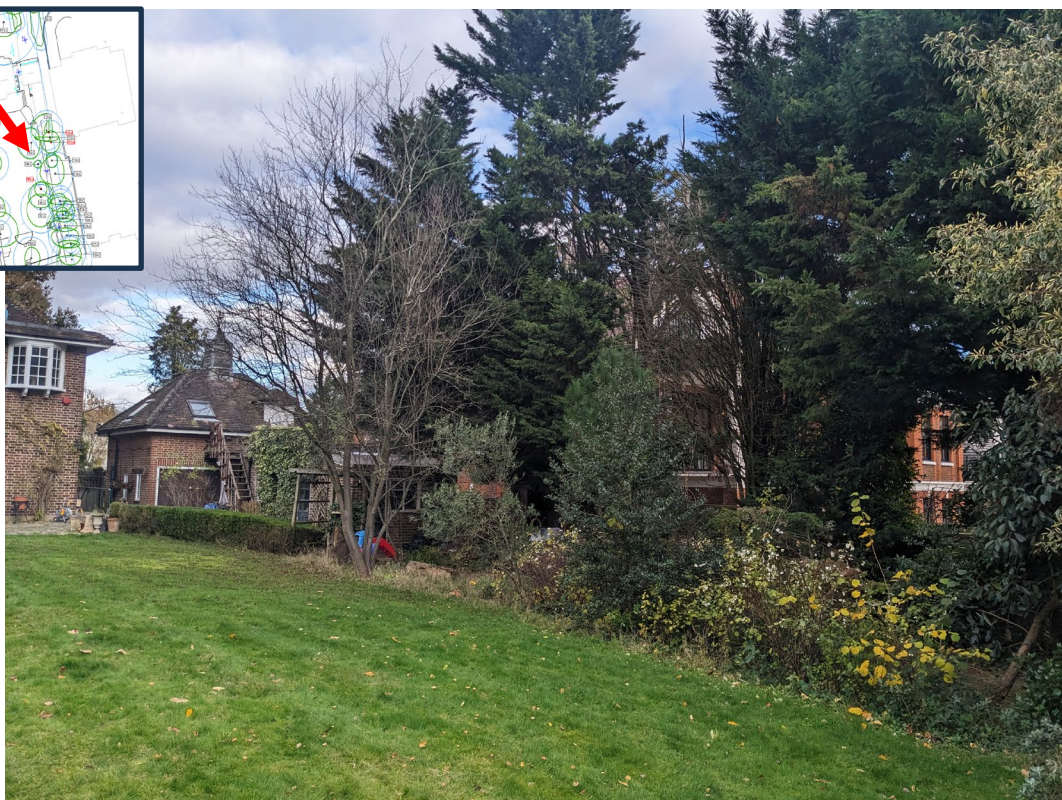
4.5. *Trees in the northern part of the rear garden:* The eastern boundary is dominated by a closely planted group of early mature/mature Leyland cypress at c.20m high (T16-C – T29-C). Many have been harshly pruned resulting in very little live foliage on the eastern side. They are rather oppressive creating dense shading. The northern 2 trees are very close to the neighbouring property.

Photo 3 of the northern part of the eastern boundary in the rear garden

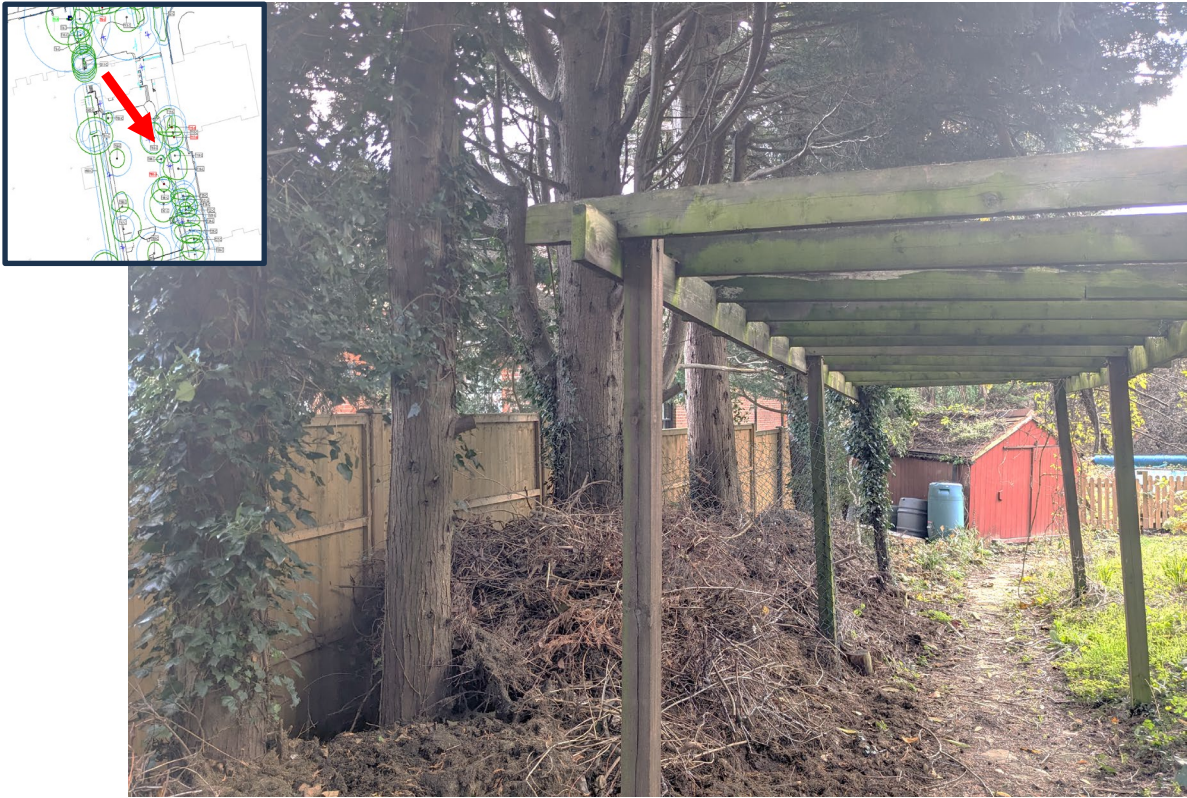
Photo 4 of the eastern boundary showing a section of the tall conifers.

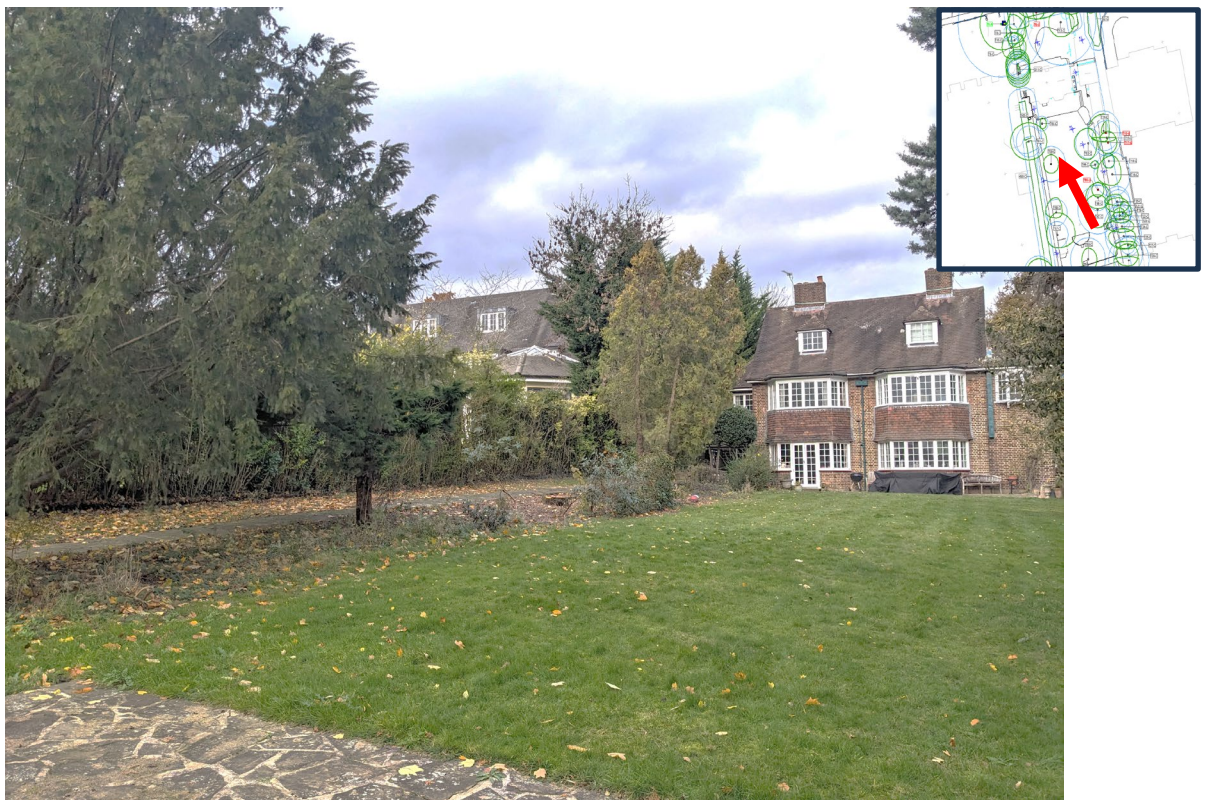
Photo 5 of the north-western boundary of the rear garden

- 4.6. On the western side is a privet hedge (G50-C). Nearer the property, and number 28, is a dense line of 20m tall Leyland cypress (G62-C) which are closely planted and faced back. Between the privet hedge and cypress group is an early mature ash (T61-C) which has some crown dieback. The location of G62 is inappropriate so close to the properties. Between the boundaries are low quality evergreen trees.

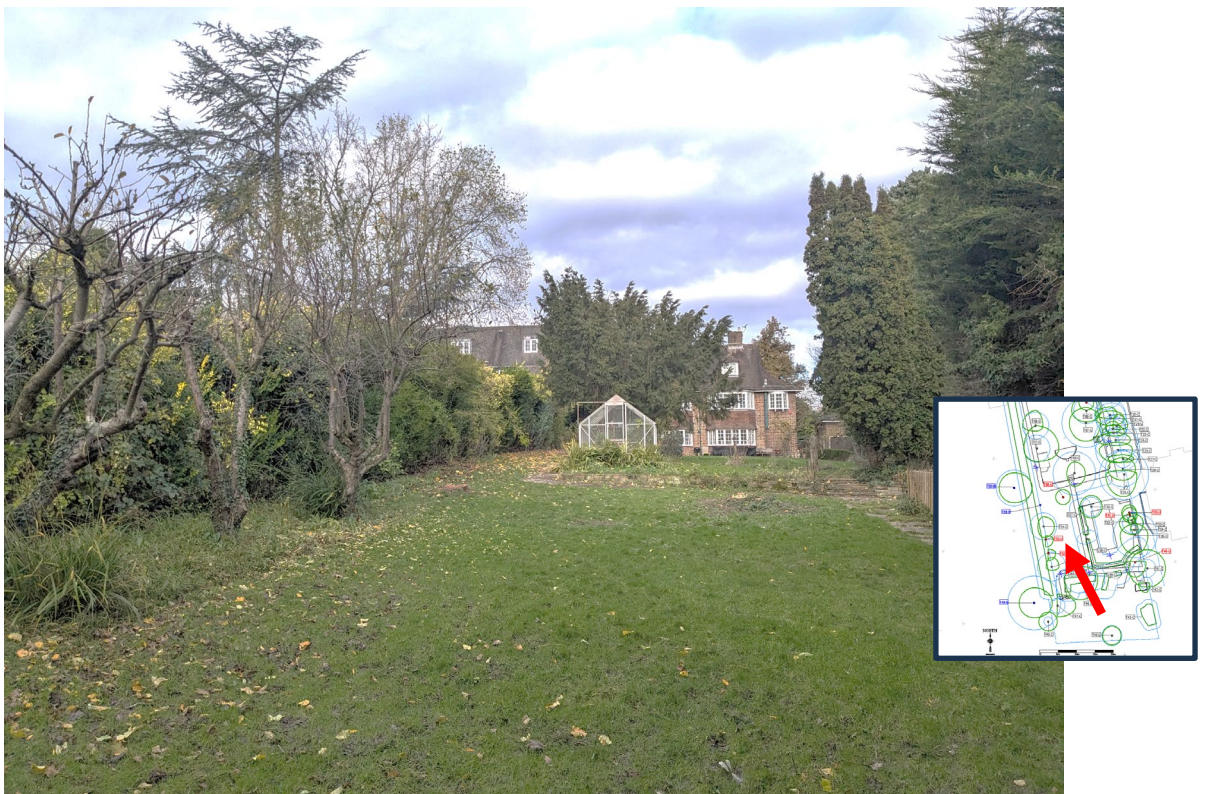
- 4.8. On the western side is the privet hedge; fronted by low quality small apple trees (T51 & T54-C and T52-T53-U). A derelict swimming pool is screened by a line of 15m tall Leyland cypress (G36 & G37-C) which continue to enclose the southern part of the garden (G39 & G44-C).

Photo 6 of the low quality apple trees T51-T54 looking towards the privet hedge and conifers beyond. Looking north.

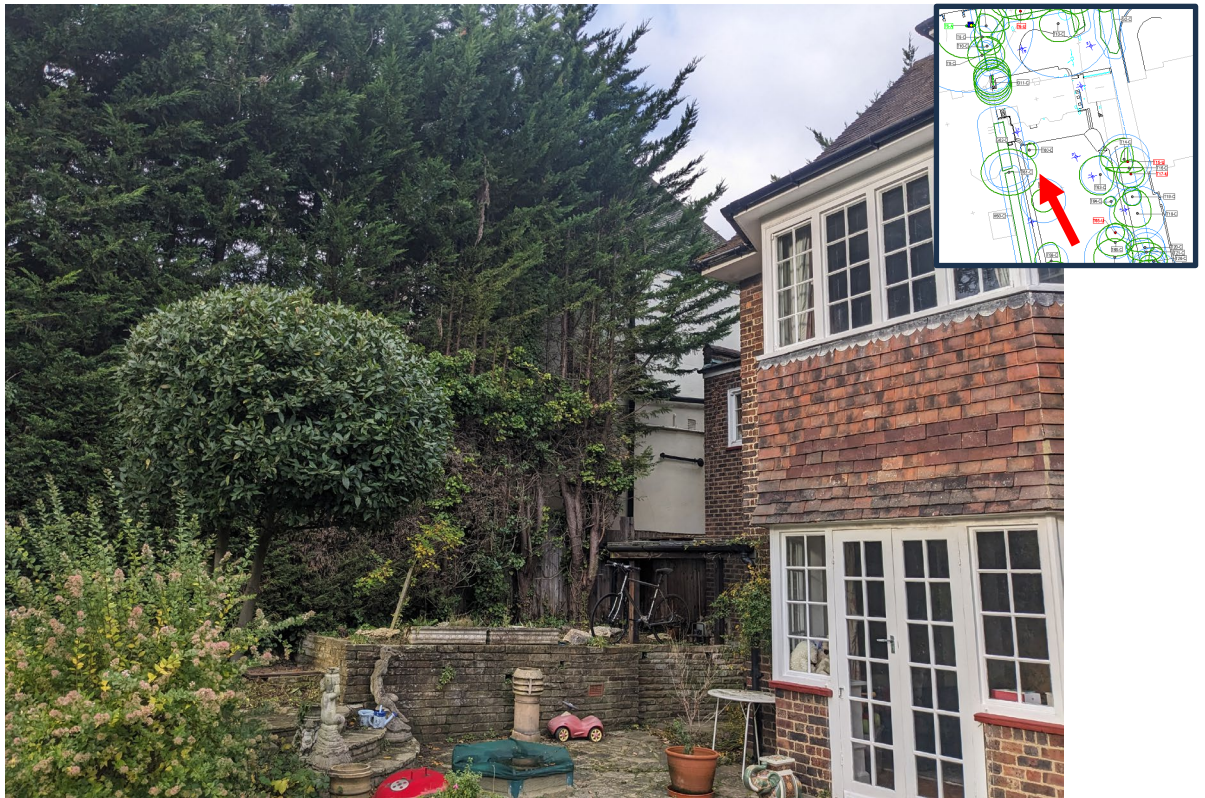
Photo 7 of the conifers G62

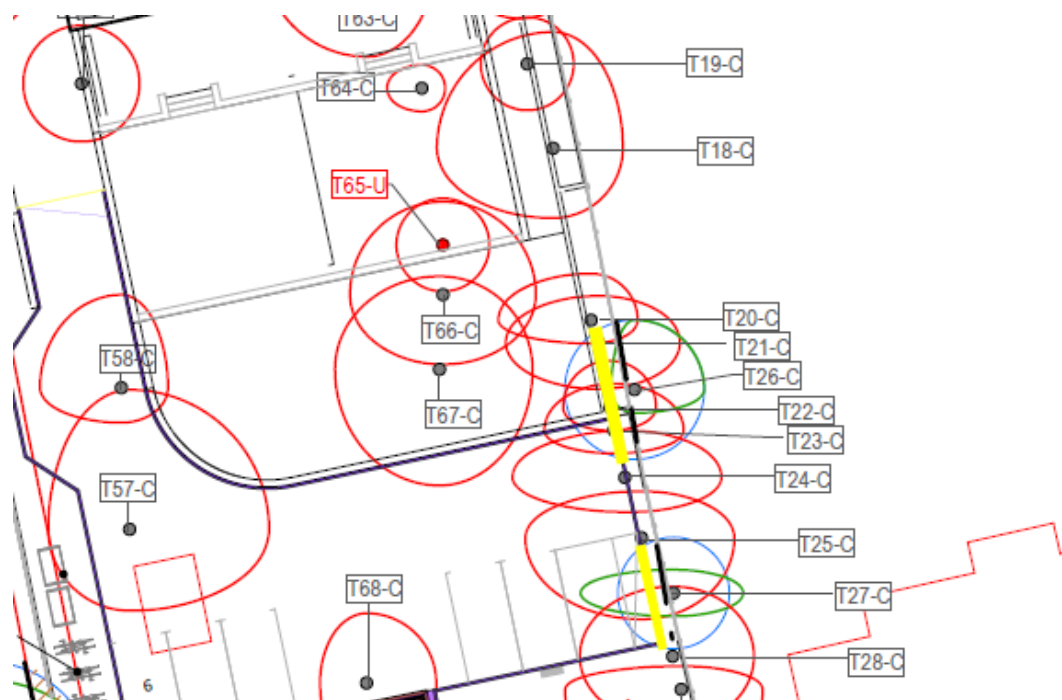
Plan 2 – extract from SHA 1699 TPP. Do not scale, north is vertical.

There are two semi-mature sycamores growing offsite close to the boundary (T26-C and T27-C). It is highly likely that the larger conifers will be restricting the actual rooting of these trees into the site and that they root preferentially east into the garden in which they are growing. There may need to be excavation in the area highlighted yellow, however, given the likely rooting pattern, this is highly unlikely to be an issue.
