BS5837 Arboricultural Impact Assessment & Method Statement

31A Wood Lane, Fleet, Hampshire, GU51 3EA

Job Reference: 05014R

December 2023

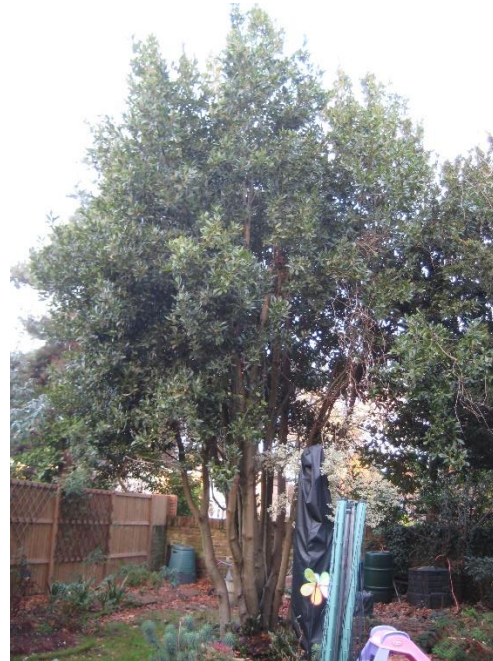
5.3.1 No tree pruning or removal works are required to facilitate the proposal. The client has indicated a desire to remove T5 (Bay Laurel). This is a low-quality example of the species formed of multiple stems with weak V union formation evident. The tree therefore has a limited retention span without repeat pruning management which significantly reduces the overall size and amenity the tree can provide. Furthermore, to the west of this tree is a good example of a Persian Ironwood tree, this provides significantly more and unusual garden amenity and removal of T5 will open views to this tree for the clients. It is noted that Hart Council have recently raised no comment or objections to the complete removal of over 100 mature Oak trees the subject of TPO 462. The TPO is noted to T5 but in relative terms the amenity provided by this tree (compared to an Oak woodland) is minimal and in the interests of consistency it is difficult to see how an objection can be raised to the proposed removal works.

Fig 8 – T5 (Bay Laurel) proposed for removal to enhance views of T6 (Persian Ironwood) and maximise garden area. Note multiple stem form.

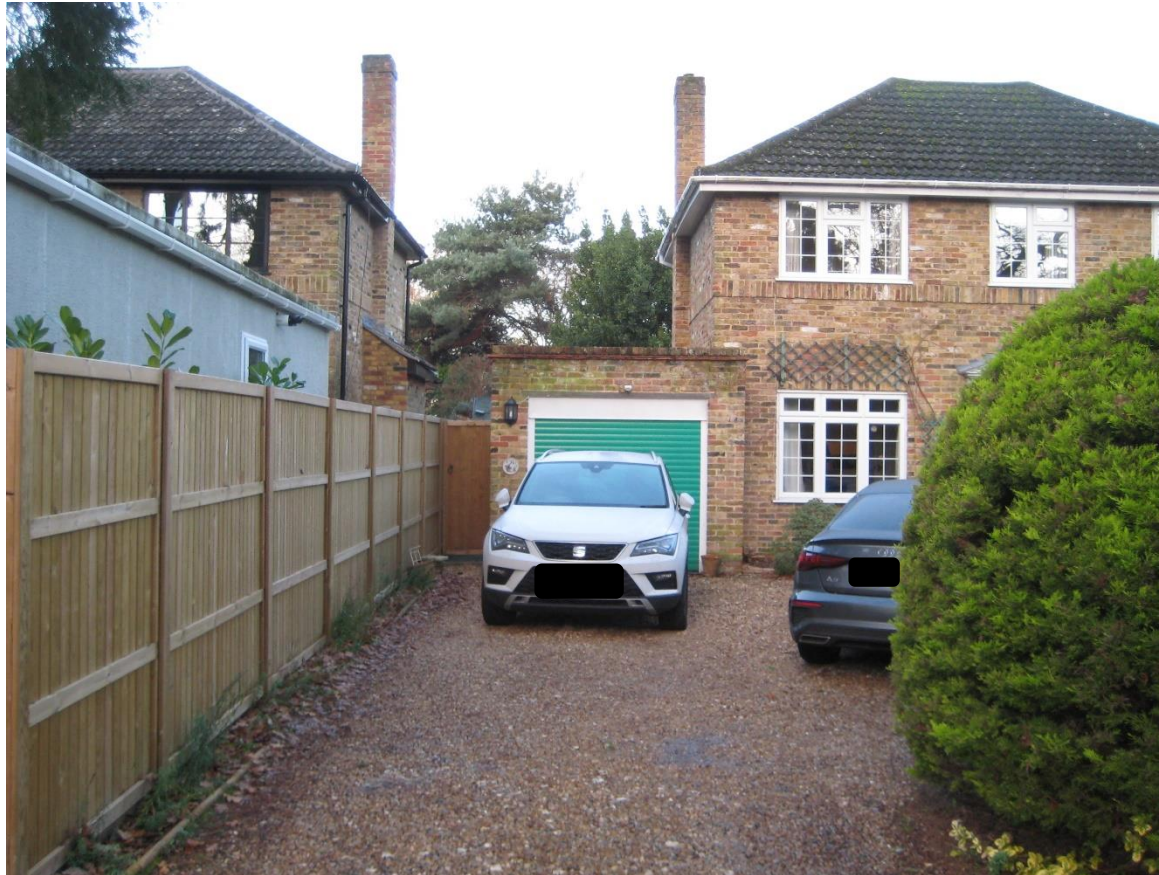
Fig 10 – Existing front driveway area. Temporary ground protection will supplement this given likely parking/ site storage. Note: Garage to be demolished is visible.

5.4.4 The existing driveway is inconsistent and the temporary ground protection seeks to supplement this allowing material storage/ parking.

5.4.5 The temporary ground protection should be laid prior to any on site activity and be to a suitable specification relative to the access requirements/ machinery/ personnel movements.

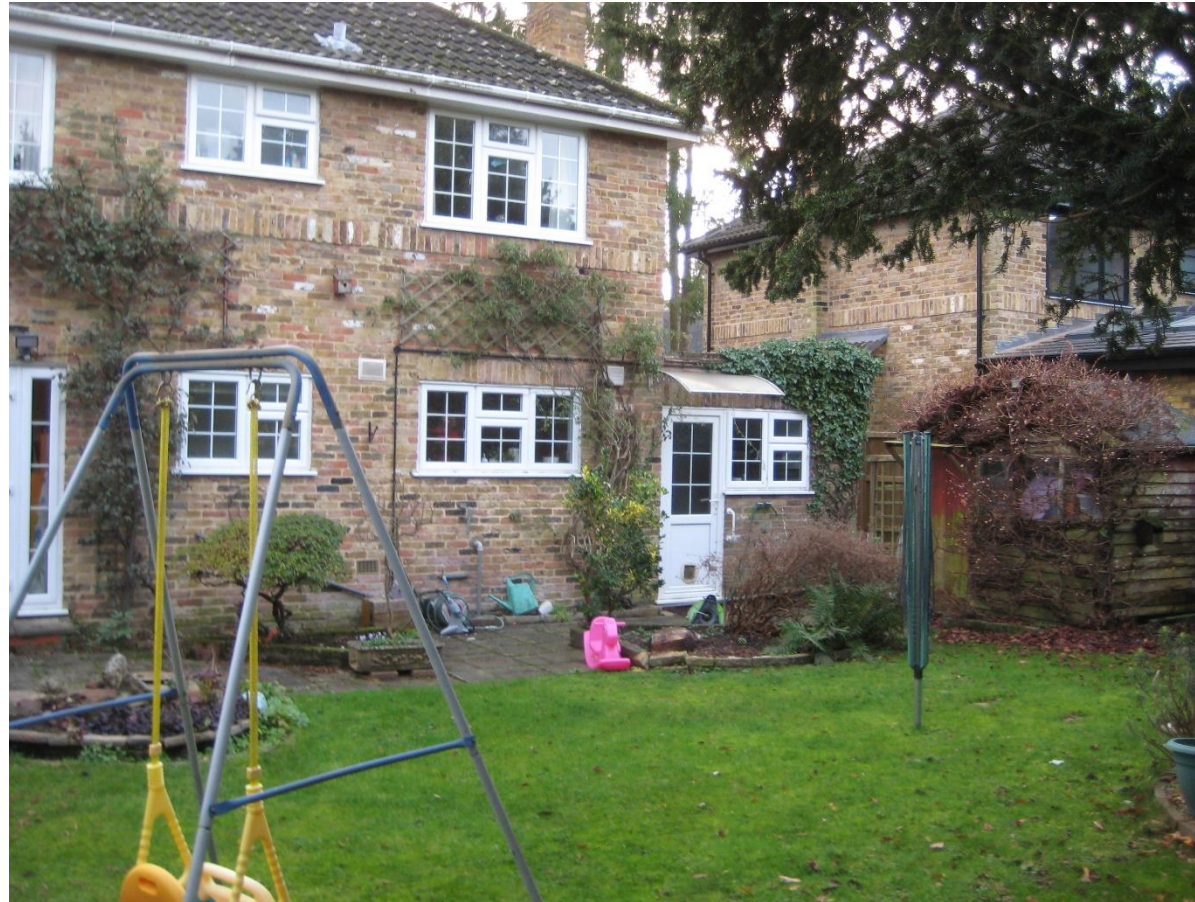
Image 1 – Looking towards area of side extension from rear garden.
