**BS 5837:2012**  
**Arboricultural Report**

**21 The Green, Southgate, N14 7AB**

**November 2023**

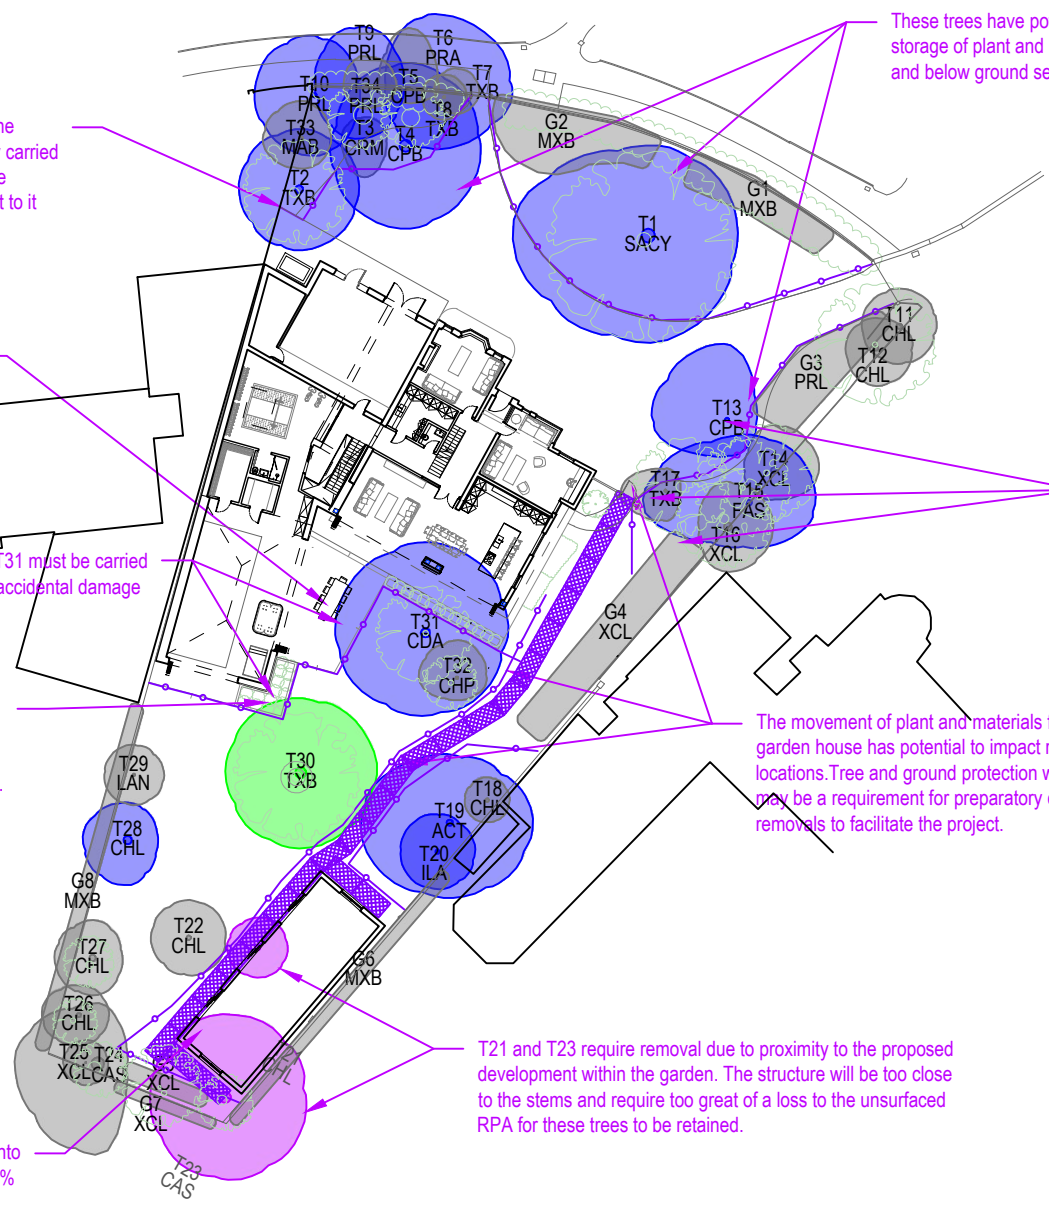
T21 and T23 require removal due to proximity to the proposed development within the garden. The structure will be too close to the stems and require too great of a loss to the unsurfaced RPA for these trees to be retained.

Any excavation within the RPA of T30 and T31 must be carried out using a hand dig methodology to avoid accidental damage to the root structure of these trees..
