WOODLANDS SERVICE STATION, FLEETWOOD

Preliminary Bat Roost Assessment Report

August 2023

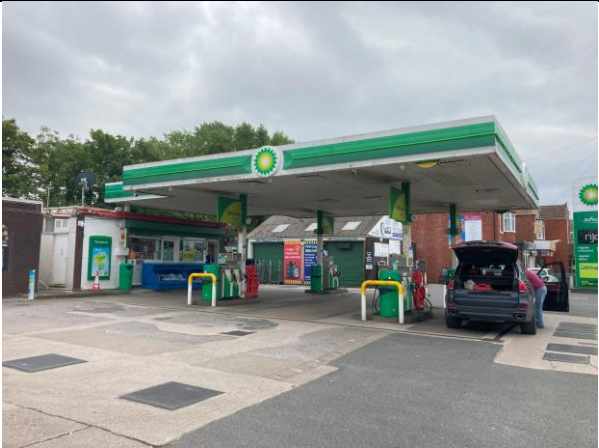
- 3.2.1. The site consisted of a total of four buildings which included a service station, MOT garage, a car wash area and a small shed.
- 3.2.2. The service station is an active shop which internally consists of a flat roof and there was no roof void present within the internal aspect of the building. The ceiling was well sealed throughout, the walls were all vaulted and well-sealed throughout the internal aspect. There were no roosting opportunities identified and no droppings or feeding remains were identified throughout. The eastern aspect of the building consisted of large glass windows and doors; a shutter was identified above this area which keeps the building well sealed when closed. The external aspect of the building consisted of red brick walls throughout which were all well sealed with no gaps or crevices identified throughout the external aspect. The roof was a flat roof with limited visibility however, this was thoroughly inspected internally, this was all sealed and the roof did not provide any roosting opportunities. The fascia boards were slightly rotten along the northern aspect of the building however they did not create any gaps to support roosting bats. The remainder of the external aspect consisted of a BP petrol station which is currently active. This provided **negligible** bat roosting potential.

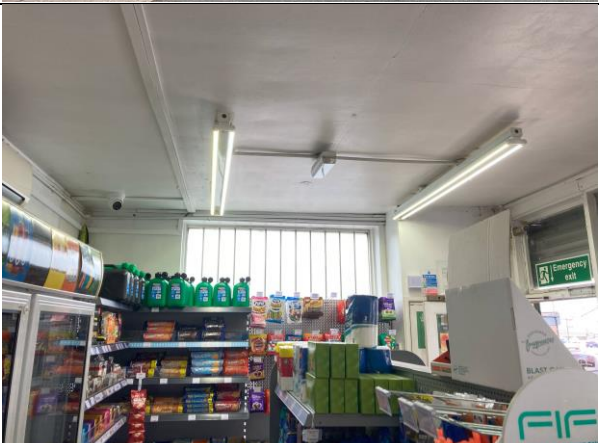
Internal aspect of the petrol station shop

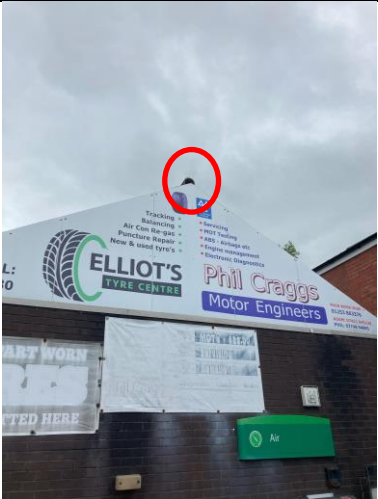
- 3.2.4. Externally all doors and metal shutters were in good condition and there were no gaps or crevices identified along these features. The corrugated metal roof located over the large MOT area was well sealed externally apart from two gaps on the eastern and western ends of the roof which was also visible on the internal inspection of the

External aspect of MOT garage with hole circled.

3.3.1. The following survey identified PRFs and potential external access points in relation to the wooden boards and gaps at both ends of the apex of the MOT garage roof. As such, the MOT garage building was assessed as having **low** bat roosting potential.

- 4.1.2. The MOT building was found to provide low bat roosting potential and therefore, in accordance with Best Practice guidance (Collins, 2016) a minimum of **one further nocturnal survey** should be undertaken between May-August (inclusive) to determine usage by roosting bats.

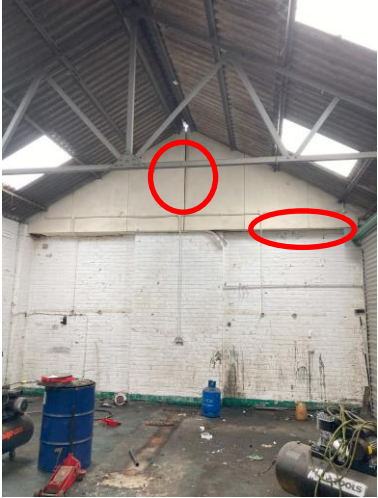
building. The brick work surrounding the building was all well sealed and there were no gaps or crevices identified throughout the brick work. The flat roof located above the office areas also had limited visibility however, the flat roof internally it was all well sealed and there were no gaps identified throughout the office spaces. The presence of gaps allowing external access and PRFs relating to the wooden boards on the western internal aspect provided **Low** bat roosting potential.

Internal aspect of MOT area. Wooden boards located on western aspect provide PRFs

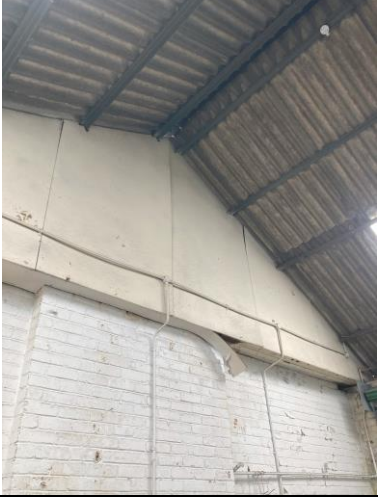
PRF's along the wooden boards.

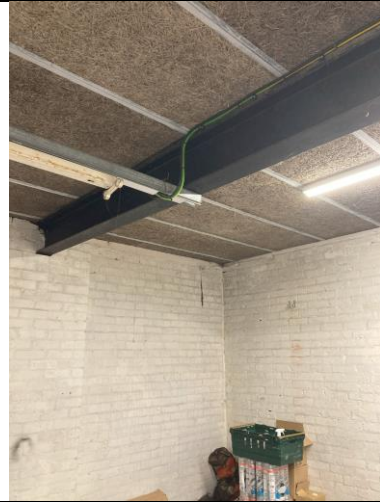
- 3.2.3. An MOT garage was located on the southern aspect of the site. Internally this consisted of one large room, with then small office areas located on the eastern aspect of the building. The large MOT garage consisted of a corrugated metal roof with glass windows and supporting metal beams along the roof. There was no loft void present throughout the MOT area, a total of two gaps were identified. One gap was located on the apex of the eastern aspect and allowed internal access, the second was above the wooden boards located on the western aspect of the building, this did provide internal access into the building. The majority of the wooden boards internally were well sealed however, small gaps were identified along the bottom of the boards which were identified as PRF's. Part of the wooden boarding was lifted away from the wall. This was identified as a PRF. The remainder of the large MOT room was well sealed and did not provide any further access points or roosting features. There were no bat droppings or feeding remains identified within the MOT area. The office spaces located on the eastern aspect of the building consisted of brick walls with a flat roof with supporting metal beams. These were all well sealed throughout and there were no access points identified throughout these rooms. There were no PRF's throughout the office spaces of the building which could support roosting bats.

Office area located adjacent within MOT area.

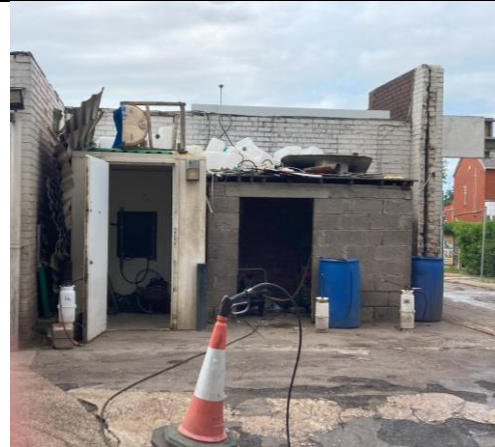
3.2.5. A car wash area was located adjacent to the eastern aspect of the service station, this consisted of one single sheet metal storage unit and one breeze block room which was open with no door. The metal storage unit was all well sealed and did not provide any access points, internally this consisted of metal sheets, this was all sealed with no PRF's identified throughout the storage room. There were no bat droppings or feeding remains identified within this unit, it provided **negligible** bat roosting potential. The smaller breeze block room consisted of well-sealed brickwork on the internal aspect and a flat wooden panel roof, supported by wooden beams. This was all well sealed and there were no gaps or crevices identified within this room. This provided **negligible** bat roosting potential.

Two storage areas in association with the car wash.

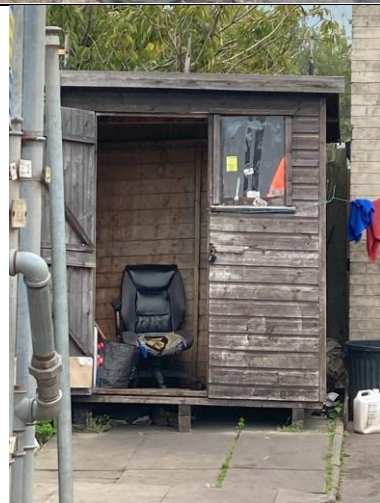
3.2.6. One wooden shed was located on the northern aspect of the site this was a sealed room that did not provide any access points for local bat populations. All wooden panels were all well sealed together and did not provide any PRF's along the external aspect. There were no PRF's identified within the wooden shed and was assessed as providing **negligible** bat roosting potential.

Shed associated with the car wash
