SF2995 Vesper Road, Kirkstall, Leeds

ARBORICULTURAL SURVEY REPORT | BS 5837:2012

Revision D - March 2021

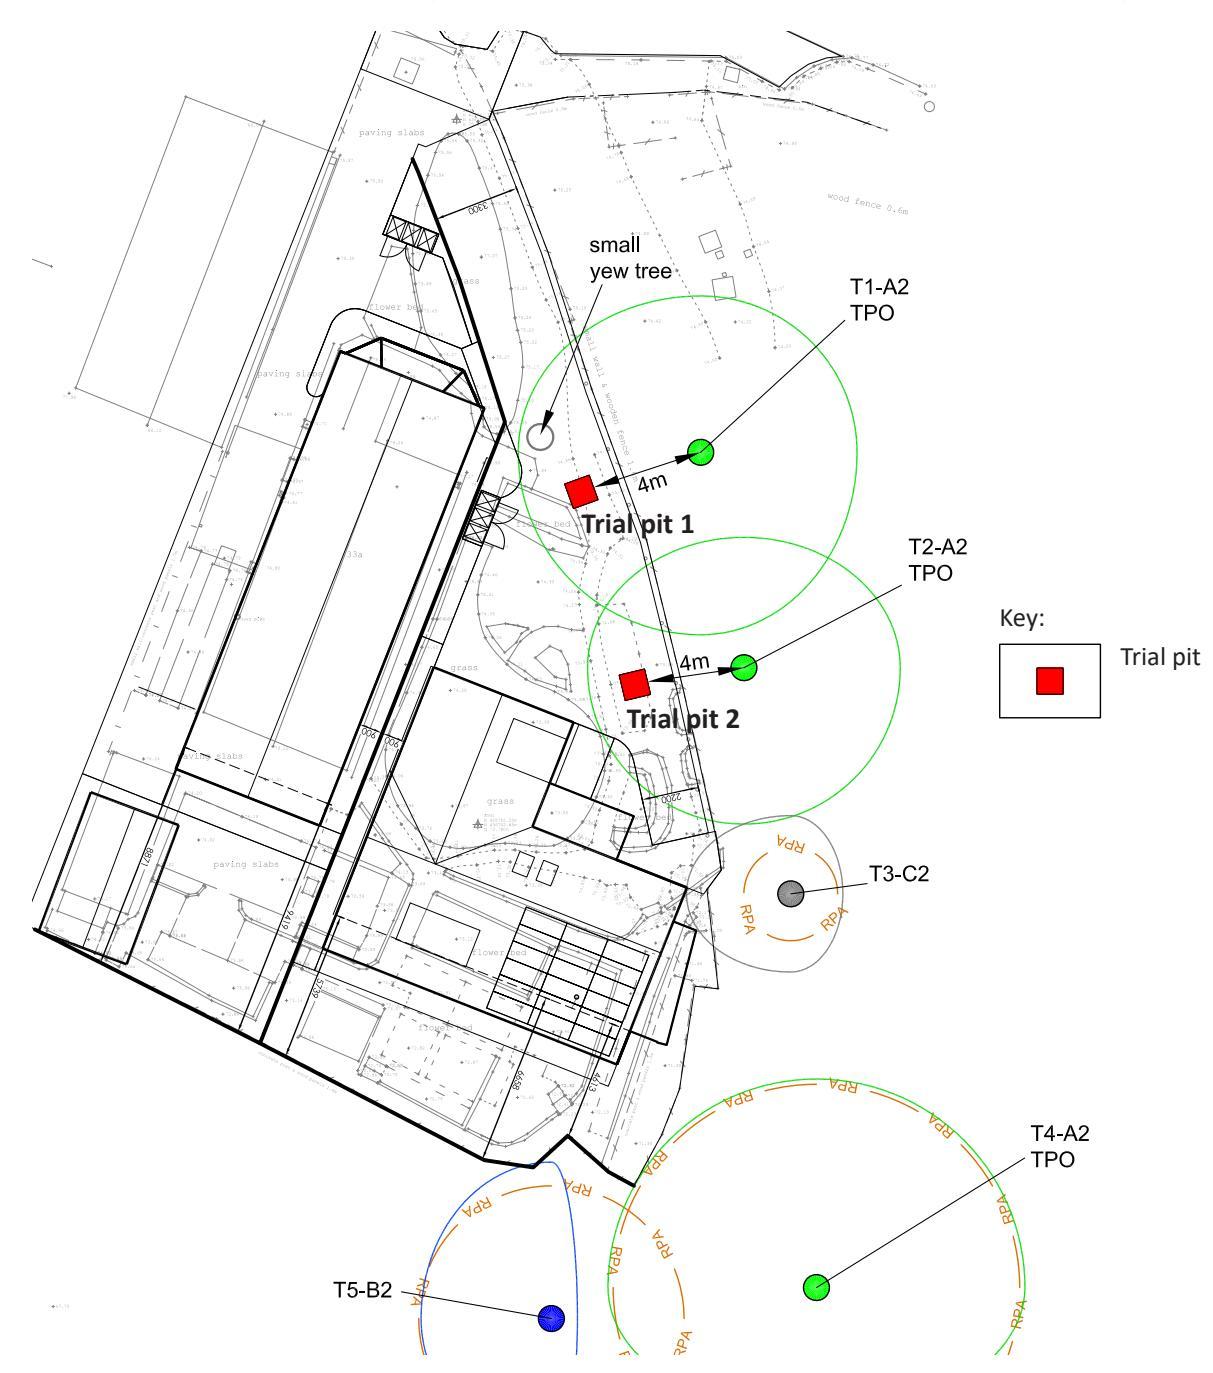
Figure 2- Showing the location of trial pits in relation to the TPO trees and the proposed development.

- 6.3.1 It is considered that the existing raised level of the site and retaining wall will have restricted root growth into the site.
- 6.3.2 Trees T1 and T2 (oak- category A) are located 3m outside the site boundary. The trees are located below a retaining wall, 800/1000mm below the ground level inside the site refer to sections A and B on drawing SF2995 AIA01. Two trial pits were hand excavated within the site garden to check for the presence of any tree roots growing into the site. The locations of the trial pits are shown in Figure 2.

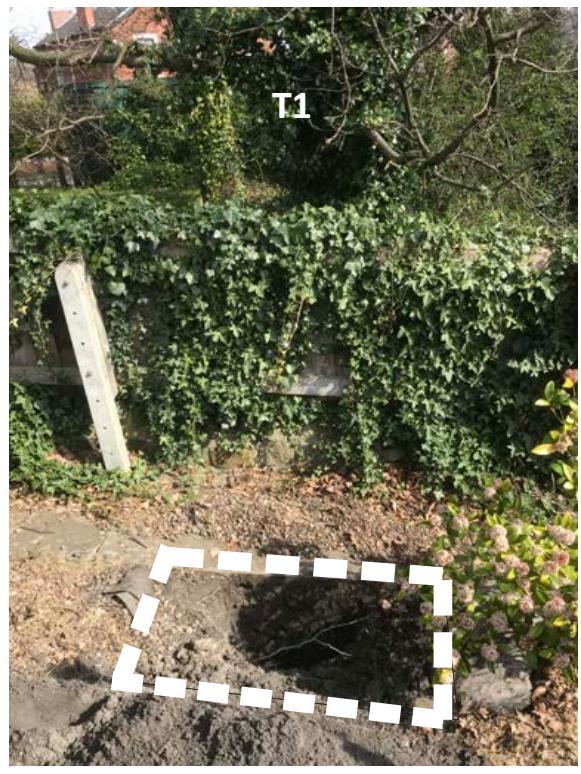
Photo 1

**Trial pit 1:** The first pit was excavated inside the site, 4m from the trunk of T1 (see photo 1). The pit was carefully excavated using hand tools, incrementally removing layers to check for roots. The pit was excavated to a depth of 800mm x 1000mm wide, which revealed one small 10mm diameter root and some fine fibrous roots (see photo 2). Based on the direction of growth and the fork in the root, it was determined that this root was coming from the adjacent small yew tree in the garden, located 2m from the trial pit (see photo 3). There was no sign of any roots growing from the east side of the pit, adjacent to the oak tree (see photo 4- there are no significant roots visible on the right side of the pit from the direction of the oak tree).

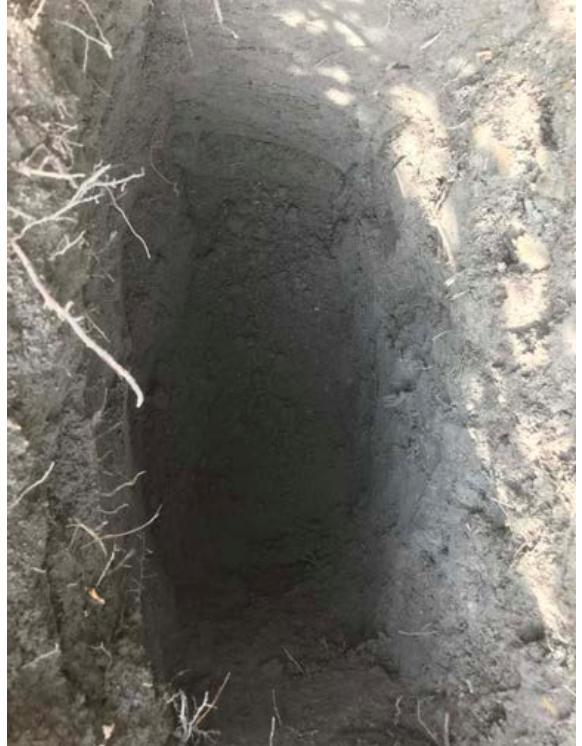
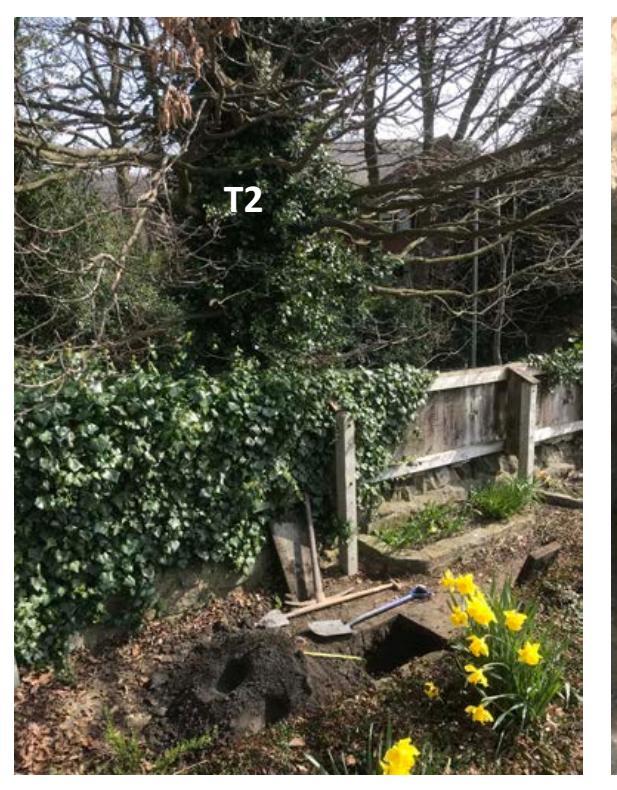
Photo 4

6.3.4 **Trial pit 2:** The second pit was excavated inside the site, 4m from the trunk of T2 (see photo 5). The pit was carefully excavated using hand tools, incrementally removing layers to check for roots. The pit was excavated to a depth of 800mm x 1000mm wide, which revealed one small 10mm diameter root and some fine fibrous roots (see photo 6). Based on the direction of growth and the forks in the root, it was determined that this root was coming from the adjacent shrub bed in the garden, located next to the trial pit. There was no sign of any roots growing from the east side of the pit, adjacent to the oak tree (see photo 6- there are no significant roots visible on the right side of the pit from the direction of the oak tree).

6.3.5 **Conclusion:** Based on the findings of the hand excavated trial pits, there does not appear to be any sign of any significant roots growing into the site from the adjacent oak trees. We have concluded that the existing raised level of the site and retaining wall has restricted root growth into the site. The shape of the RPA should be adjusted to suit the existing site conditions which have influenced root growth. Therefore, the circular shape of the RPA has been modified to a shape of equivalent area to provide adequate protection for the root system- as per section 4.6 BS 5837:2012.

We would recommend that the proposed drive and parking is constructed with a flexible permeable surface and sub base to maintain drainage.

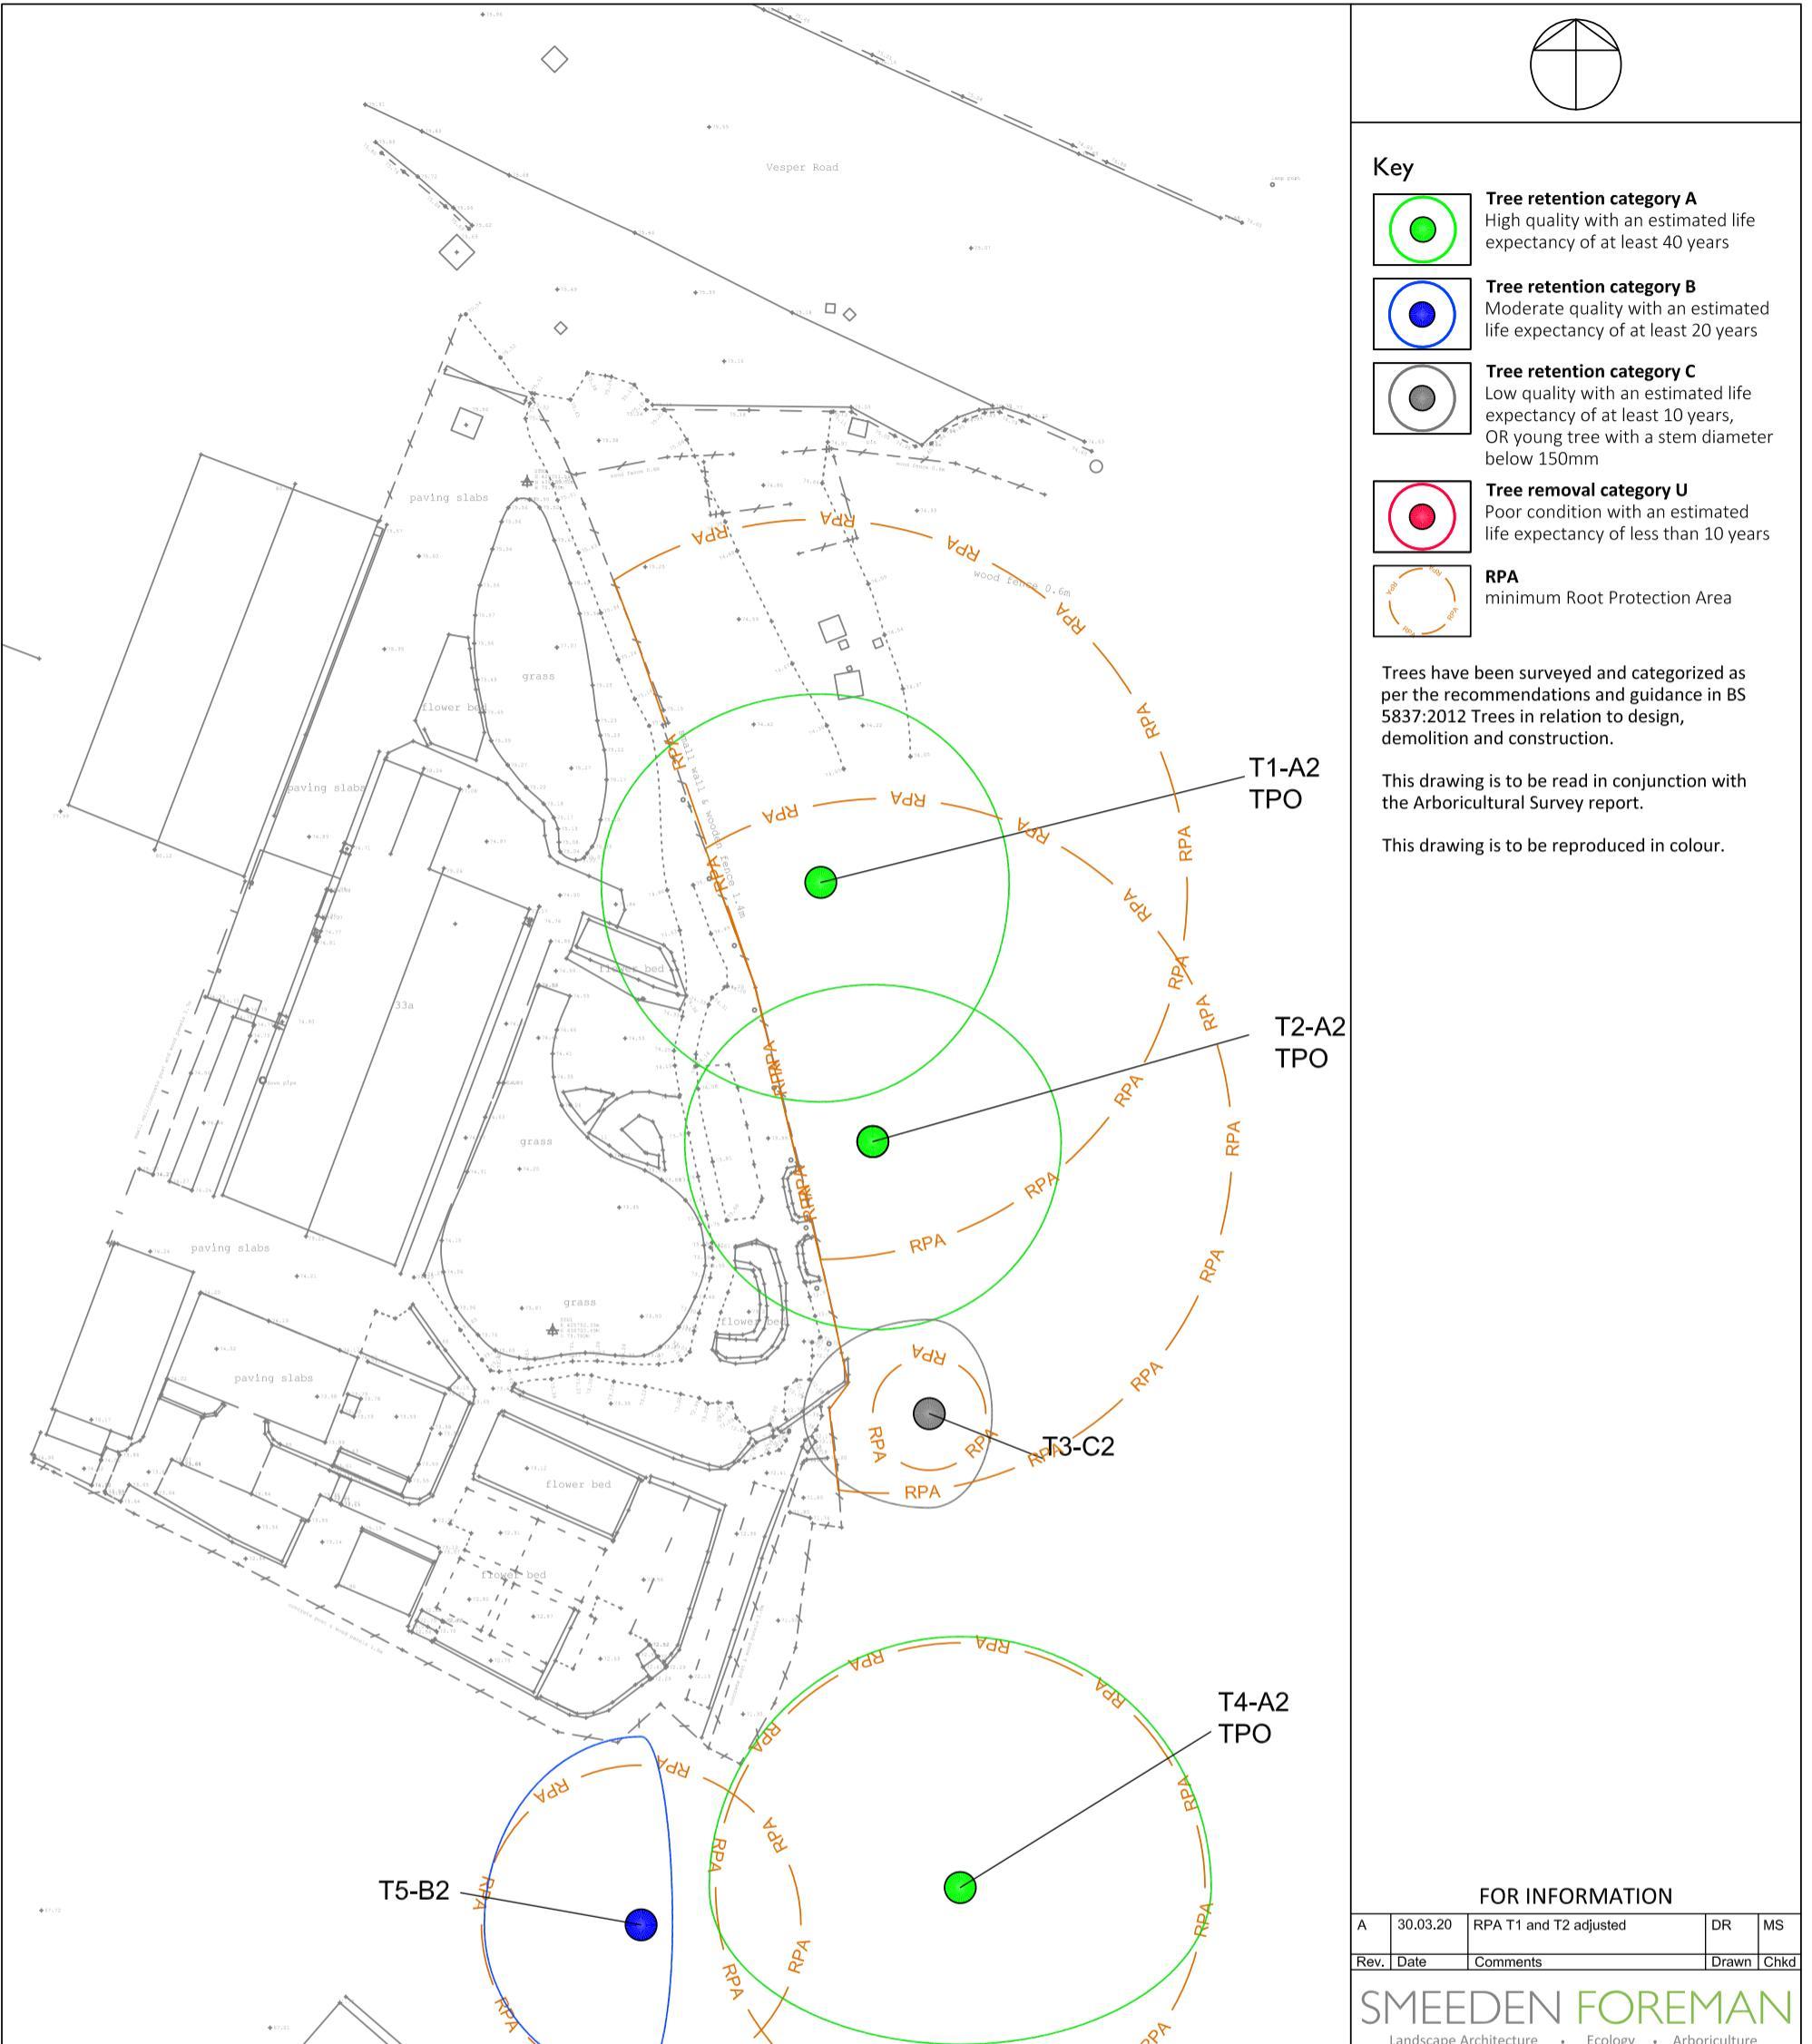
SF2995 TC01 Tree Constraints Plan

- 4.1 The potential for retaining trees on a development site includes the extent of the influence of the tree at the time of survey. Consideration is also given to the effects of future growth within the context of the proposed development. In addition, the potential nuisance caused by shading to new buildings both after construction and also once trees reach their ultimate size is also considered.
- 4.2 The extent to which a tree may represent a constraint to development will depend both upon the location of the trunk and size and nature of the canopy and also the extent of the roots below ground. The tree constraints drawing (SF2995 TC01) plots the location and extent of the tree above ground.

- 5.3 The tree constraints drawing (SF2995 TC01) plots the location and extent of the tree below ground through application of the calculation provided in section 4.6 of the BS5837:2012 Trees in relation to design demolition and construction Recommendations.

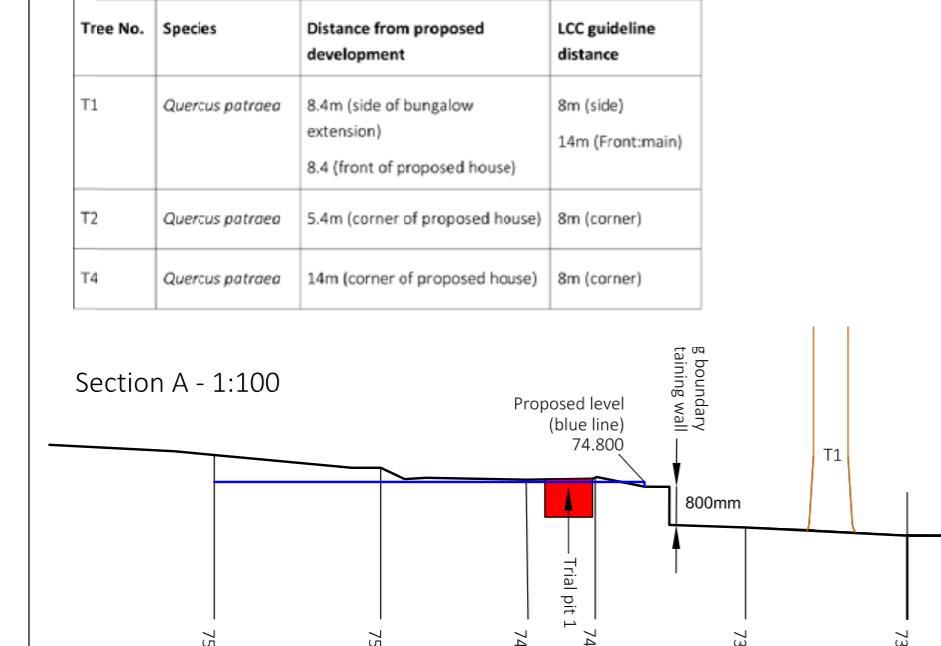
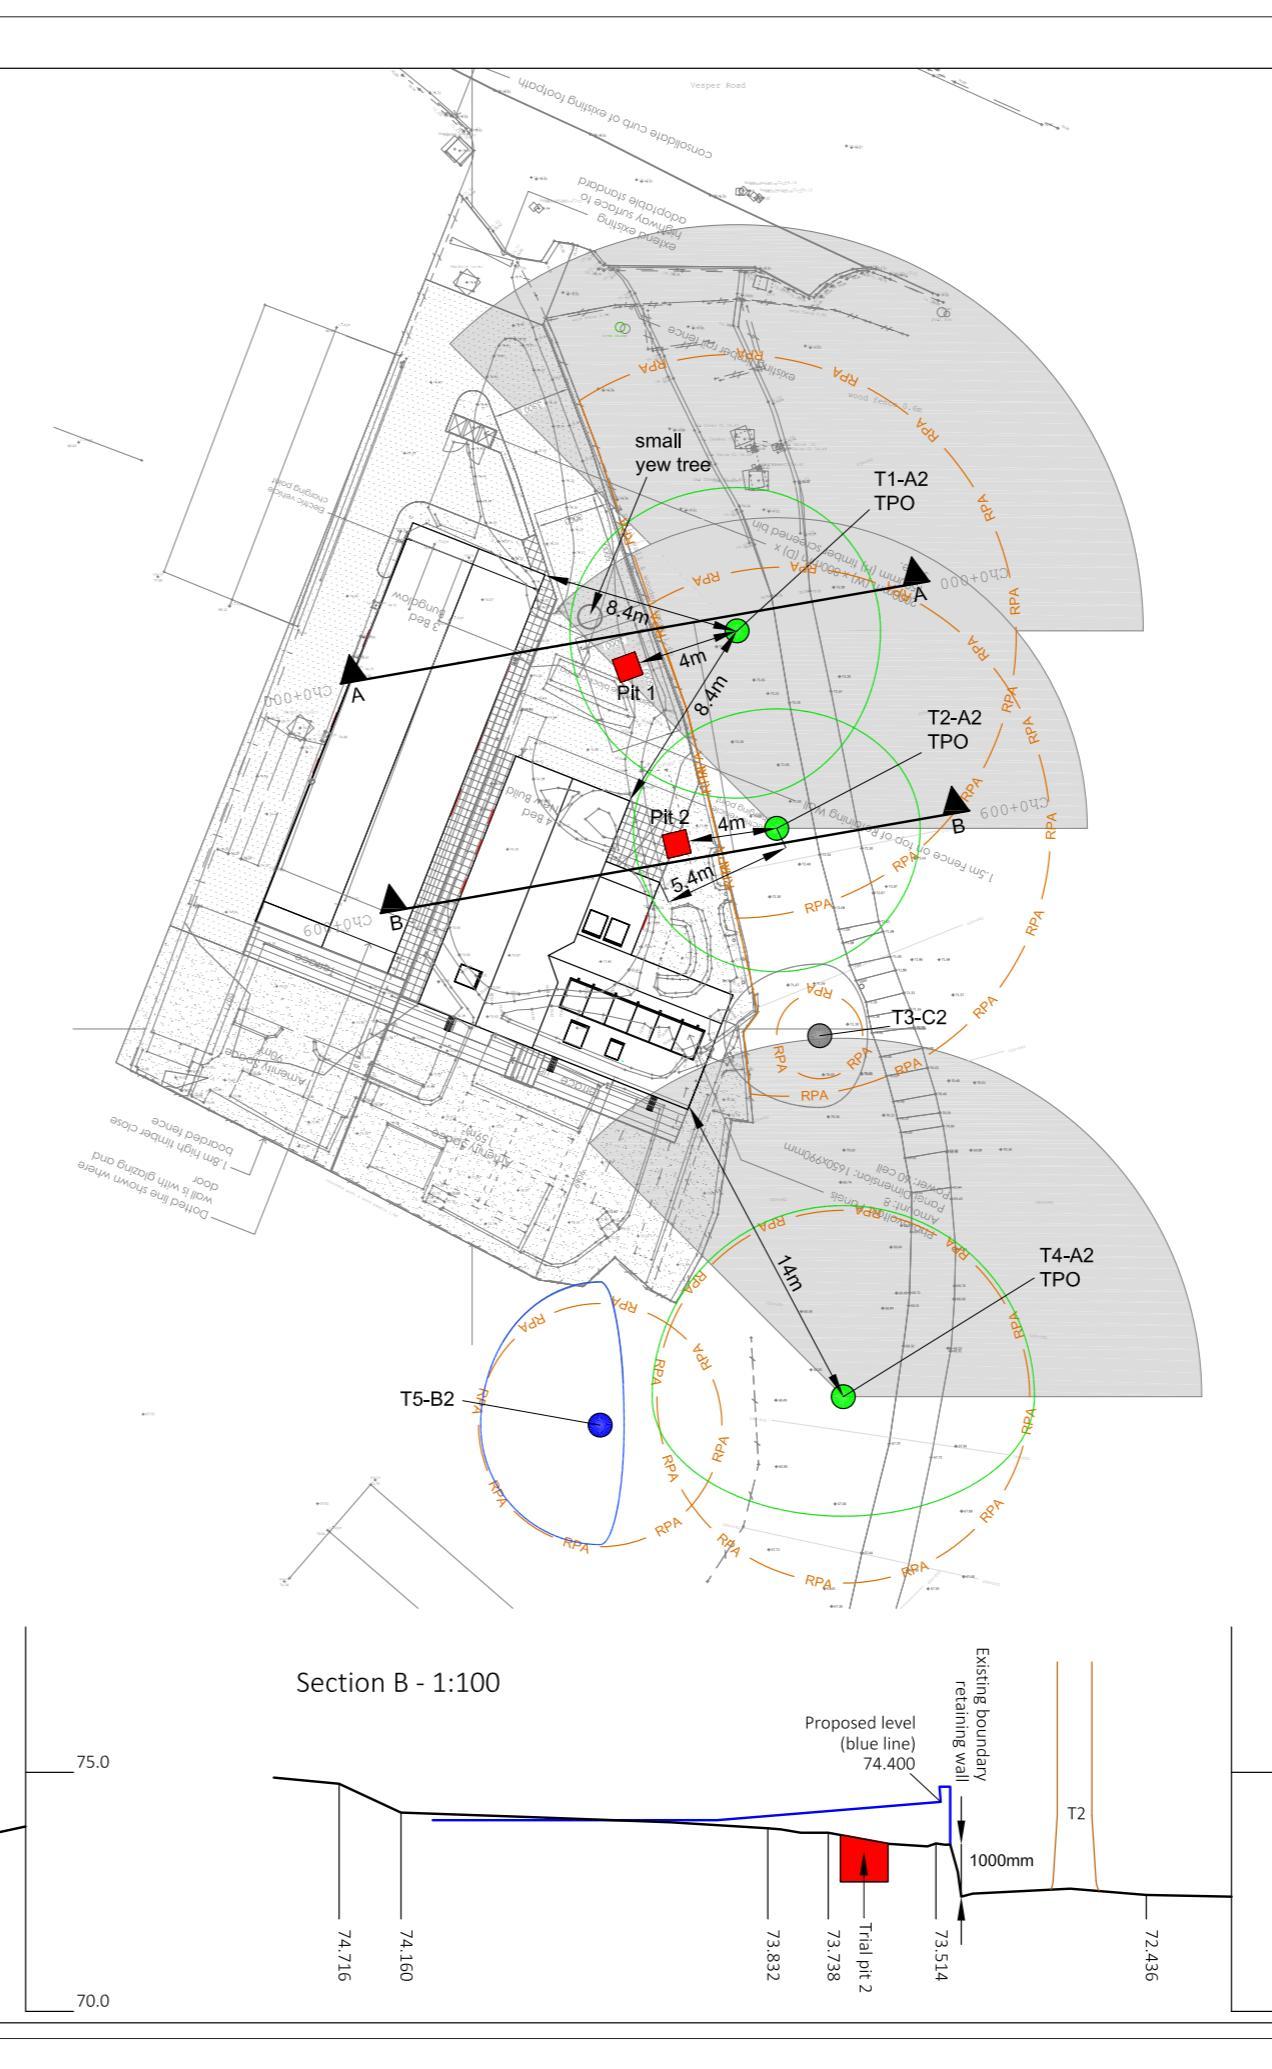
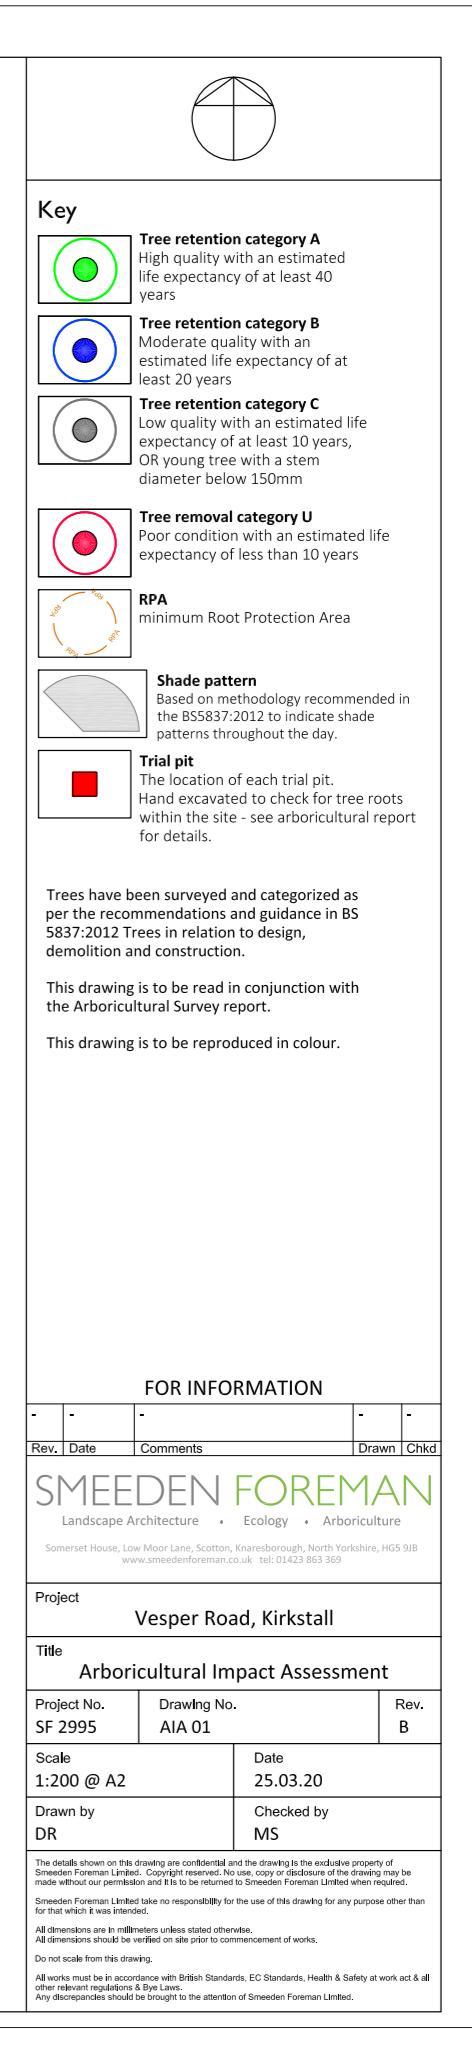
SF2995 AIA01 Arboricultural Impact Assessment Plan

It is considered the existing raised level of the site and retaining wall will have restricted root growth into the site. Sections A and B show the retaining wall and the difference in levels between the site and the TPO trees outside the boundary. A trial pit was hand excavated inside the site adjacent to each TPO tree, to check for the presence of any roots growing into the site. The trial pits did not reveal any root growth that could be attributed to the oak trees. Based on the findings of the hand excavated trial pits, we have concluded that the shape of the RPA should be adjusted to suit the existing site conditions which have influenced root growth - see the arboricultural report for photographic details of the findings and conclusions. Therefore the circular shape of the RPA has been modified to a shape of equivalent area to provide adequate protection for the root system - as per section 4.6 BS 5837:2012. The proposed development of the site will not have an adverse impact on the RPA of the TPO trees.

There would be a minimum 1m clearance between tree T1 and the proposed house and the bungalow. T1 has an existing crown clearance of 4m over the proposed drive, therefore pruning will not be required and development could take place without damage to this tree.

Pruning works to T2 will be required to allow sufficient working space to construct the house without damaging the tree. T2 has an existing crown clearance of 1.5m over the existing site. It is therefore recommended to carry out crown lifting to provide sufficient working space (subject to permission). The pruning works will be supervised on site and will only remove a minimal number of overhanging branches to facilitate the construction. The proposed pruning work will not adversely affect the amenity value or the long-term health of the tree.

Trees  $\dot{T}1$  and T2 are both relatively mature trees with a full canopy which is unlikely to extend much further into the site.

This indicates shade patterns throughout the day. Trees T1 and T2 will not cast any shade over the proposed buildings. Oak tree T4 would cast some early morning shade over the corner of the proposed house (during summer months), however the building would be in full sun throughout the majority of the day.

We would recommend that the proposed drive and parking is constructed with a flexible permeable surface and sub base to maintain drainage.
