Arboricultural Assessment Report

Land off Denford Road, Ringstead,

Report Ref – KD.RNG.ER.003V1

August 2023

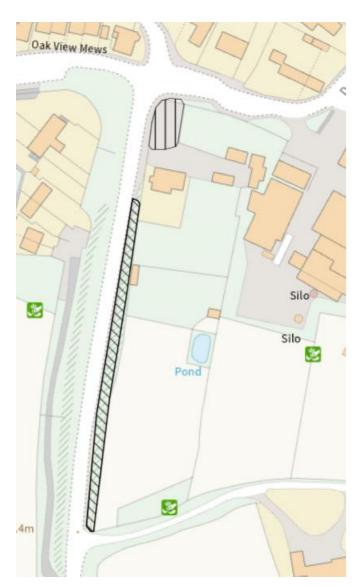
Figure 1 – Tree Preservation Orders onsite

4.3 There are four tree Preservation Orders (TPO's) located within the vicinity of the site boundary. The first is a tree group located outside the north-western corner of the site. The second is a woodland group located along the western boundary. The fourth is a field maple located within a woodland block along the southern boundary. And the fourth is an elm tree located on the eastern site boundary.

4.4 All TPO trees are to be retained as part of the proposed works. Please see Figure 1 below for the specific location of the TPO's onsite.

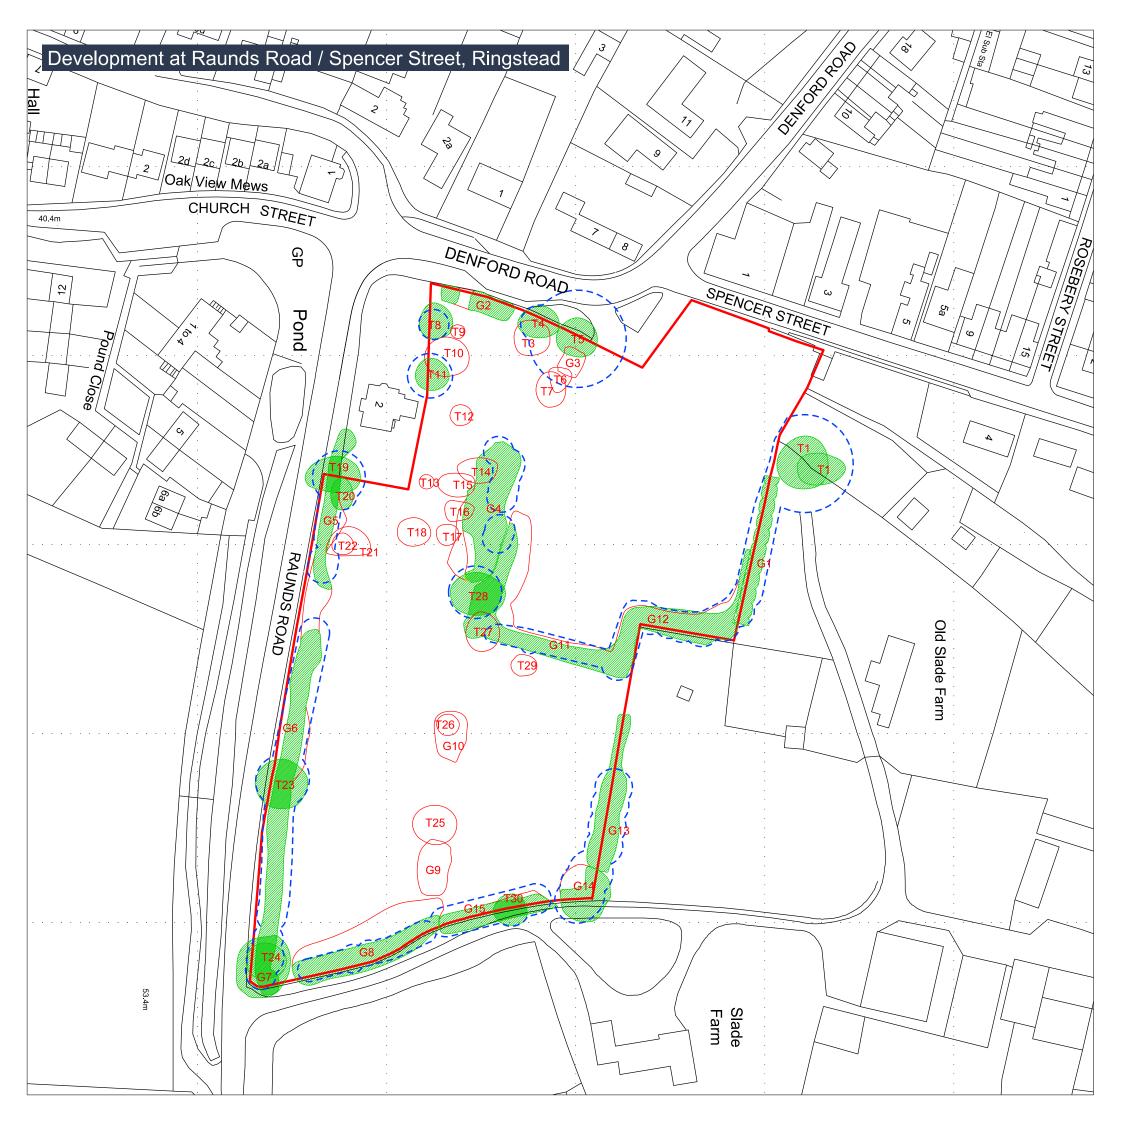
KD.RNG.1.ED.002

- 4.1 A total of 30 trees and 15 groups of trees were assessed as part of the arbouricultural survey. Of the surveyed trees, the following are to be removed as part of the proposals:

- 4.2 As show above, there are a total of 22 trees/tree groups to be removed as part of the proposed works. Of the trees/groups to be removed, 18 were assessed as Category C, three were assessed as Category B and one tree was assessed as a Category U tree.

- 4.5 The following trees/groups will require pruning in order to facilitate the development onsite:
 - G2 removal of 2.5m section to enable footpath link to Denford Road.
 - G4 pruning required to south-east & south-west of group.
 - G6 removal of northern section to provide access road, pruning required area north of T23.

- G8 pruning required to northern part of group.
- G11 pruning required to northern part of the group situated along the bottom of the bank.
- G12 pruning required to northern part of the group situated along the bottom of the bank.
- G14 pruning required to the north-west section of the group.
- G15 pruning required to the north-east section of the group.
- T20 southern crown reduction of 1.2m.

- 6.12 Retained trees will require ground protection around their RPA using a combination of barriers and ground protection.
- 6.13 Heras fencing should be installed in order to protect the RPA of retained trees.
