Arboricultural Impact Assessment

A single floorplate development, split into 4 separate units, to create flexible B2/B8 light industrial use

Lindenwood
Chineham Business Park
Basingstoke
RG24 8QY

Survey Date: 7th July 2023
Report Date: 15th December 2023
Project no: 2125

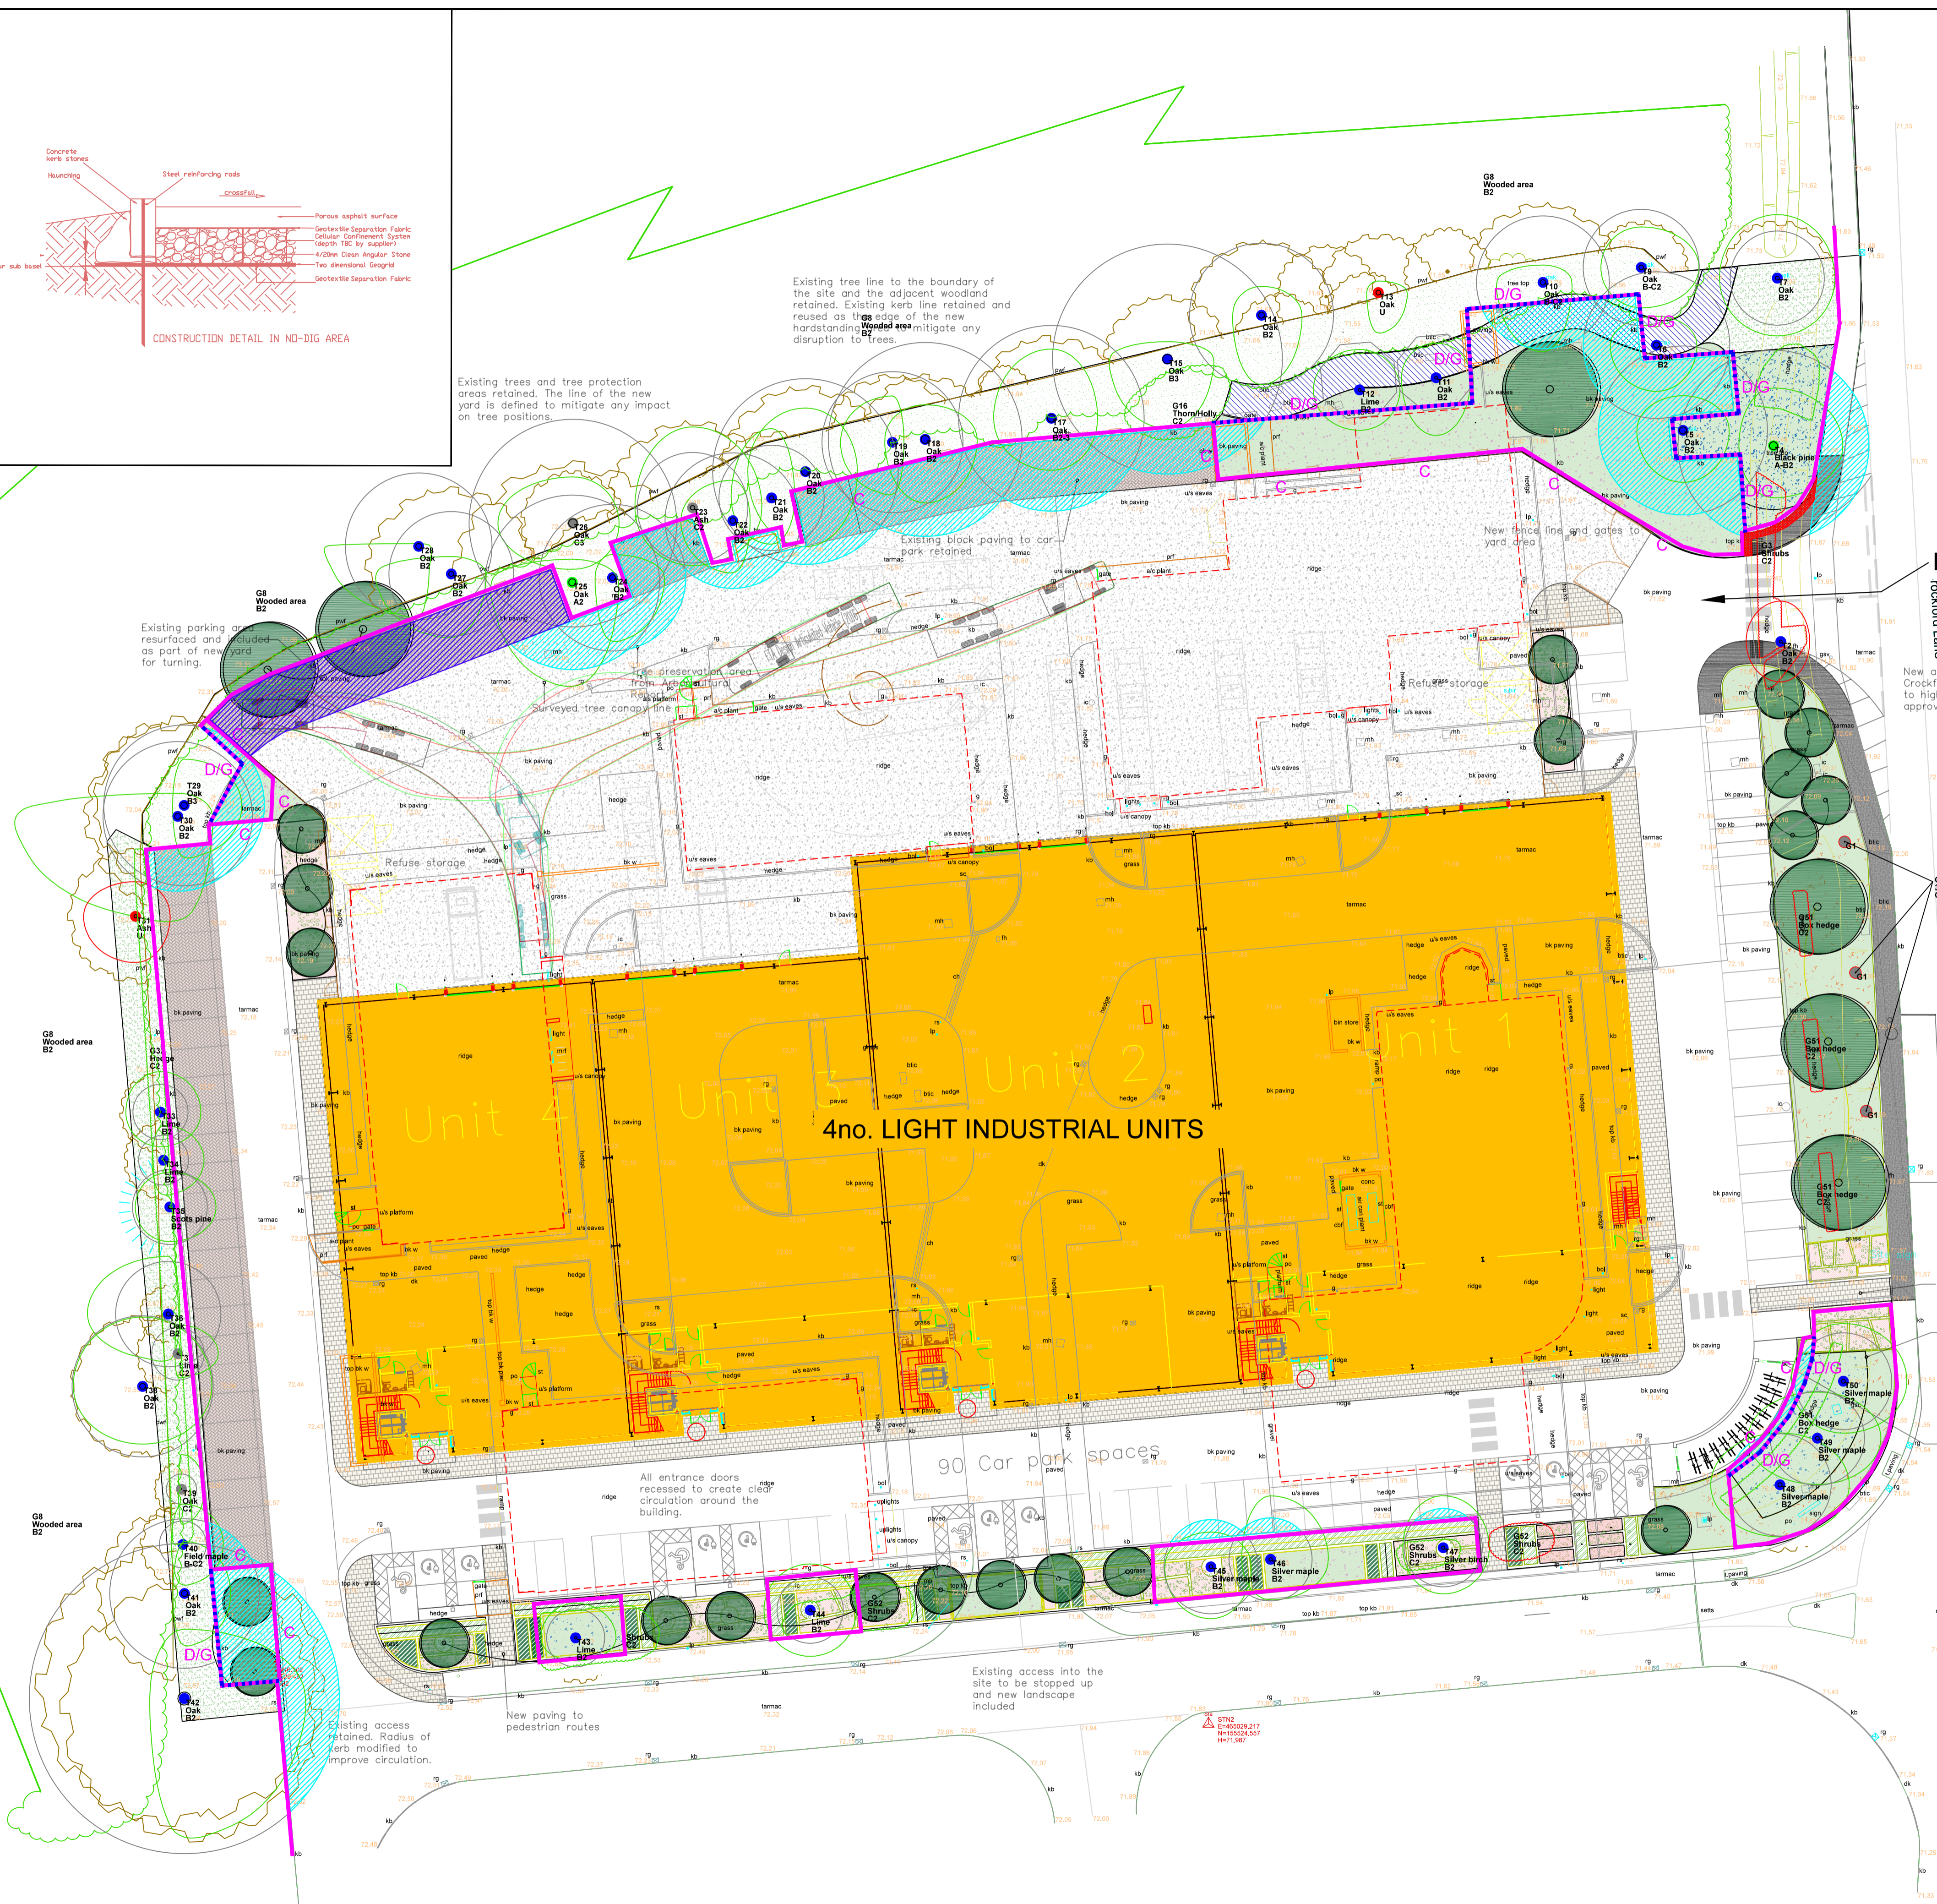
DRAWING TITLE
 TREE PROTECTION PLAN

- T4, where there will be excavation with root loss of approximately 14.2m², or 6.6% of the Root Protection Area.

An extension to the pavement is proposed to provide a crossing point over the new vehicular access. The ground level is banked up in the area for the new section of pavement and excavation is therefore necessary in order to marry up the level of the new section with the existing pavement. Hand Dig excavation and root severance has been specified in order to prevent unnecessary damage and to minimise the area of wounding of retained roots. The amount of projected root loss is considered to be too small to produce a noticeable adverse impact on the tree.

- 5.8.1 The ground level is to be reduced in the Root Protection Area of the black pine, T4, to facilitate the construction of an extension to the pavement. The Hand Dig trench, shown cross-hatched red on the Tree Protection Plan, must be dug to the formation level of the new pavement by hand, neatly severing any roots found, using secateurs or other sharp bladed tool. Following severance of the tree roots within the trench, any further excavation required, outside the hand dug trench, can be carried out with an excavator. On no account must an excavator be used within the Root Protection Area until the roots have been severed along the line of the hand dig trench.

- 5.8.2 Exposed tree roots must be covered with hessian to protect them from damage by desiccation or frosting until such time as the works are completed and the roots are covered by soil to the back of the new kerb.

- 5.8.3 Heavy-duty polythene must be used to line the side of the trench adjacent to the tree, before any cementitious product is used, to avoid the toxic effects of cement on tree roots.

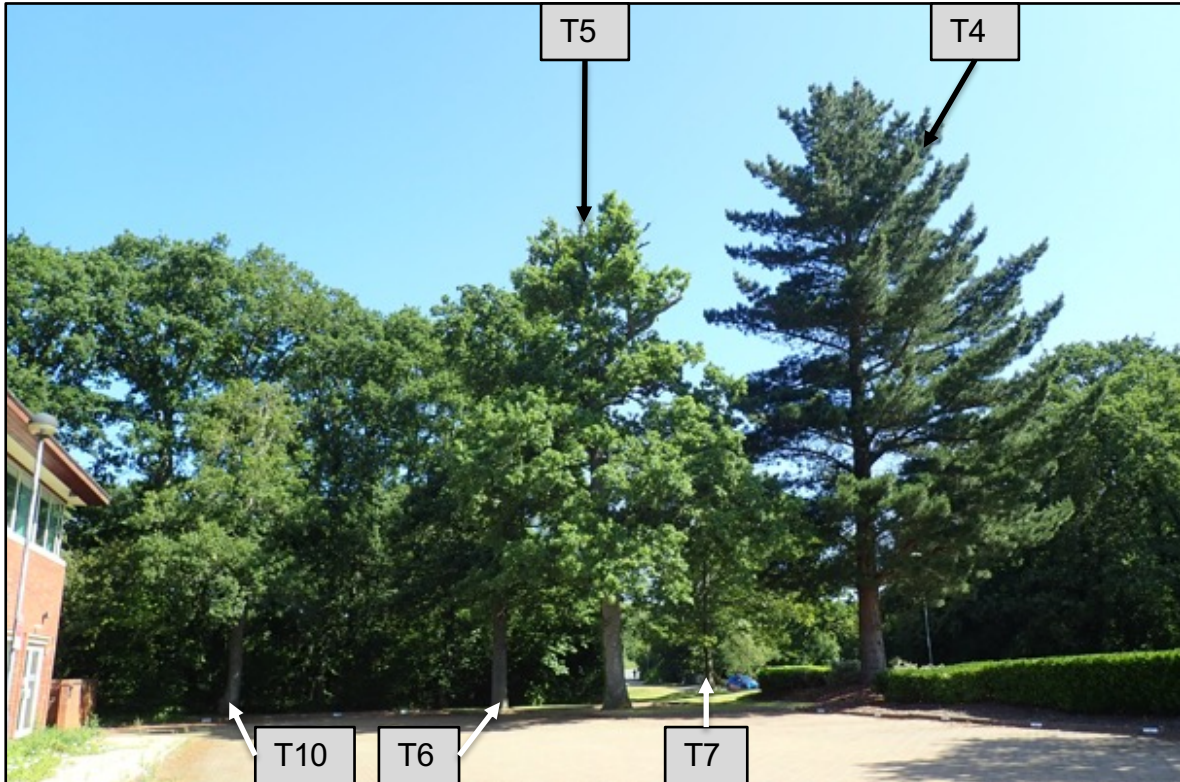
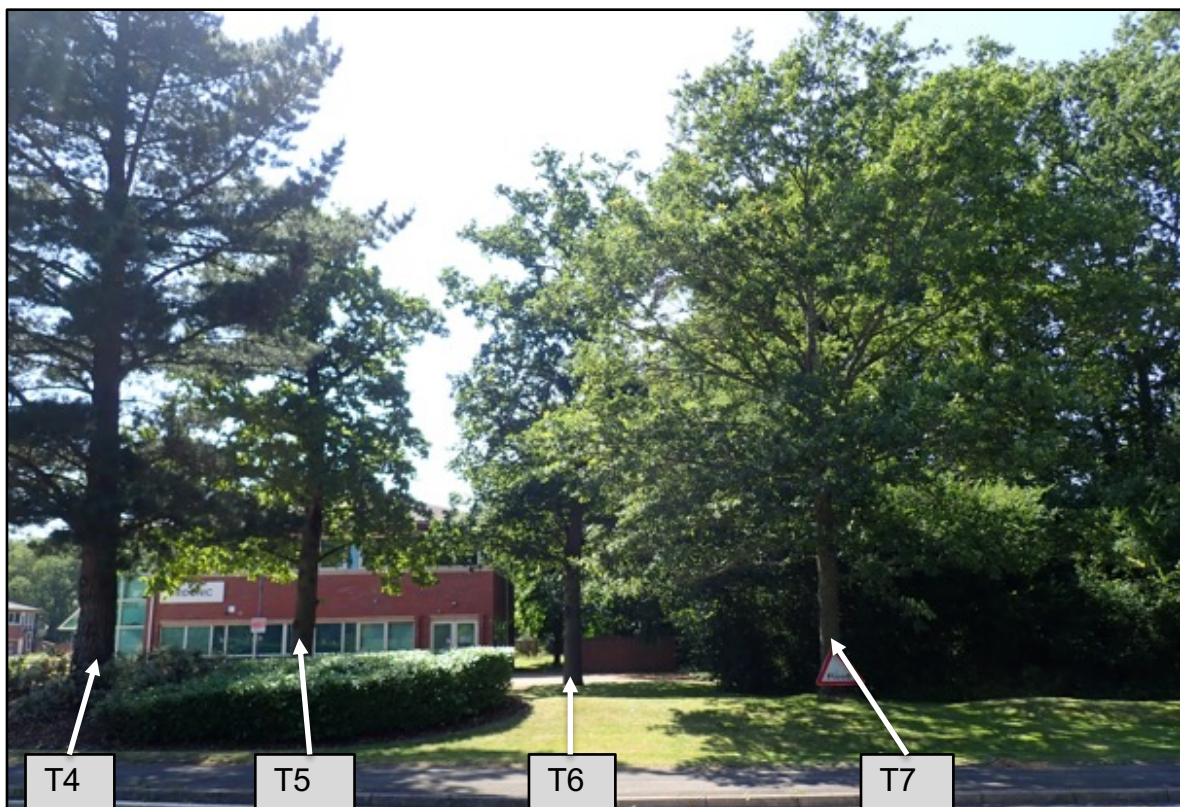
Above: Trees in northeast corner of site, viewed from south.

Below: Trees in northeast corner of site, viewed from Crockford Lane

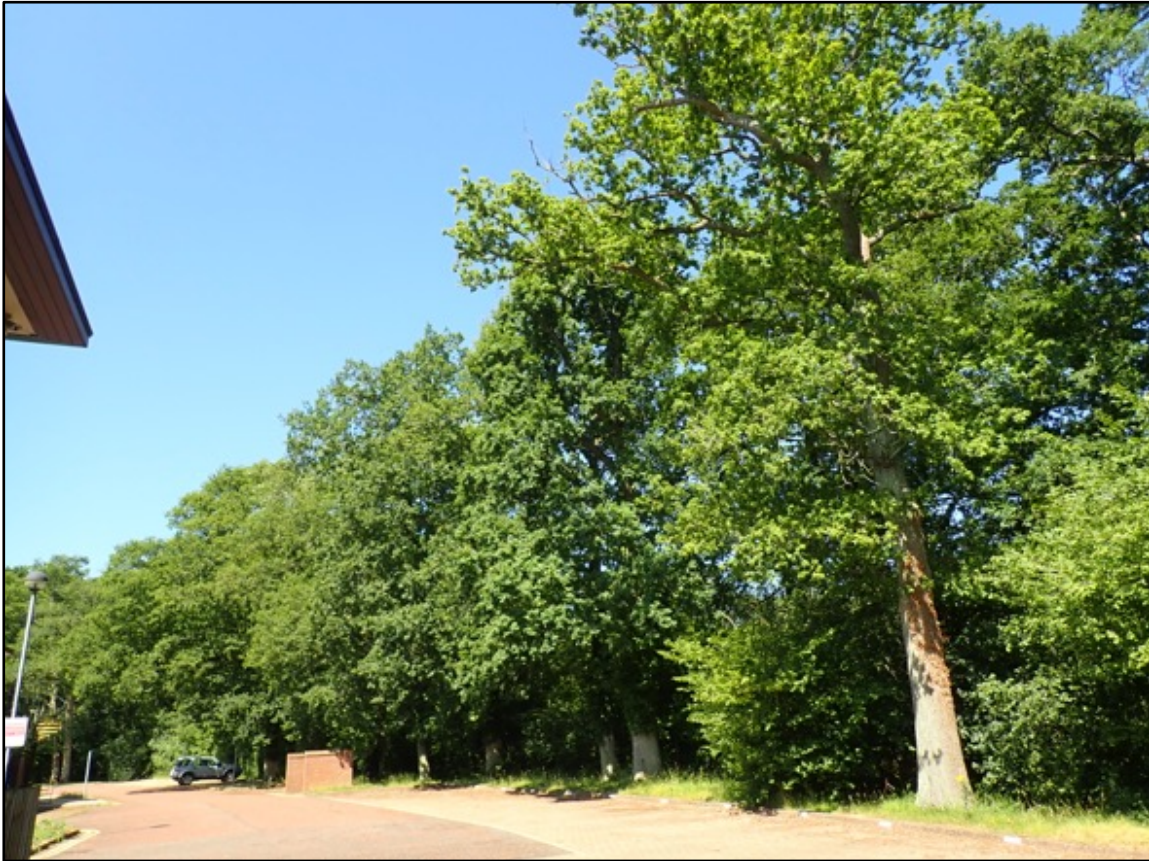
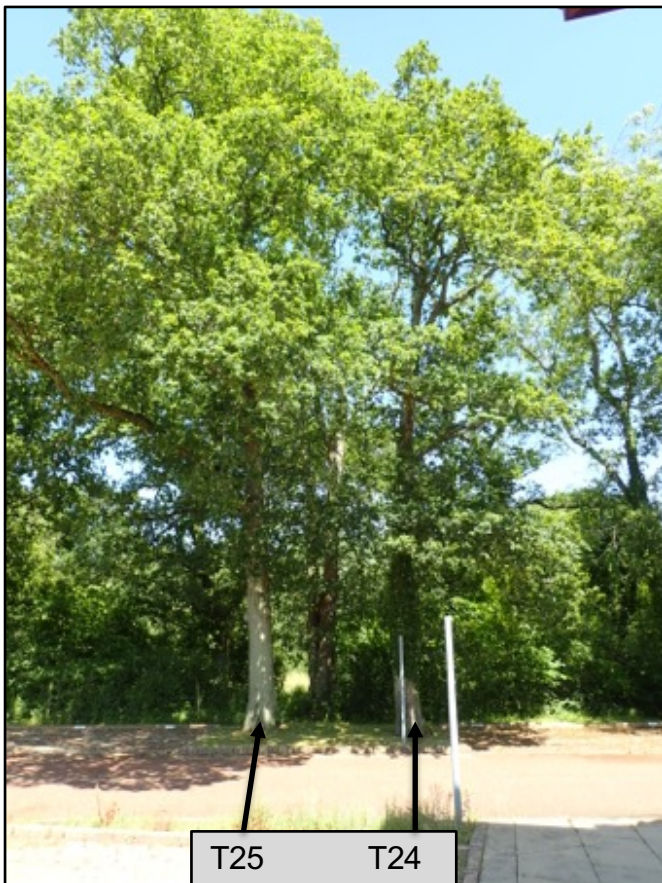
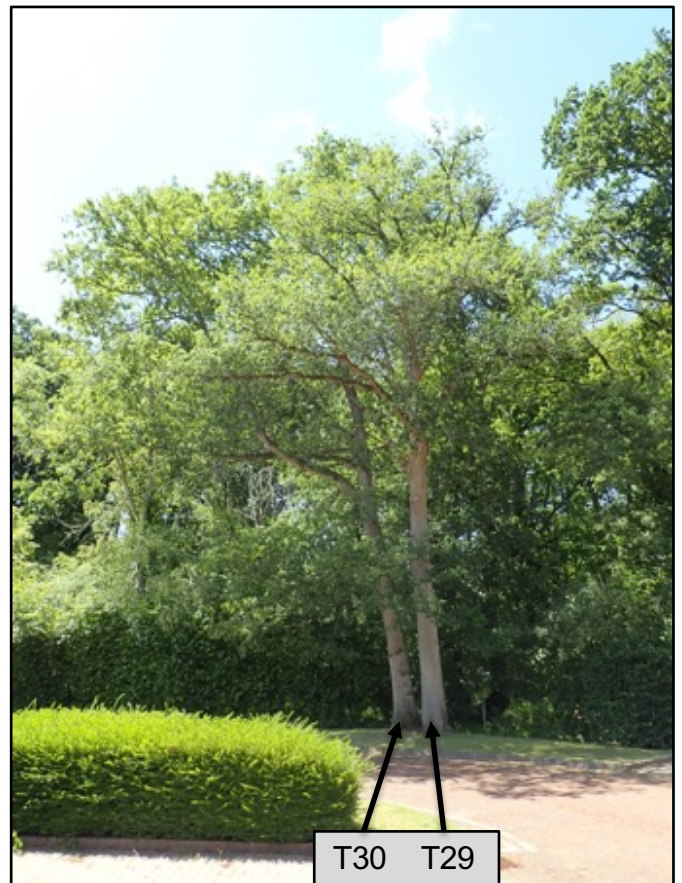
Above: View of trees along northern edge of site. Below: Trees in between car parking spaces

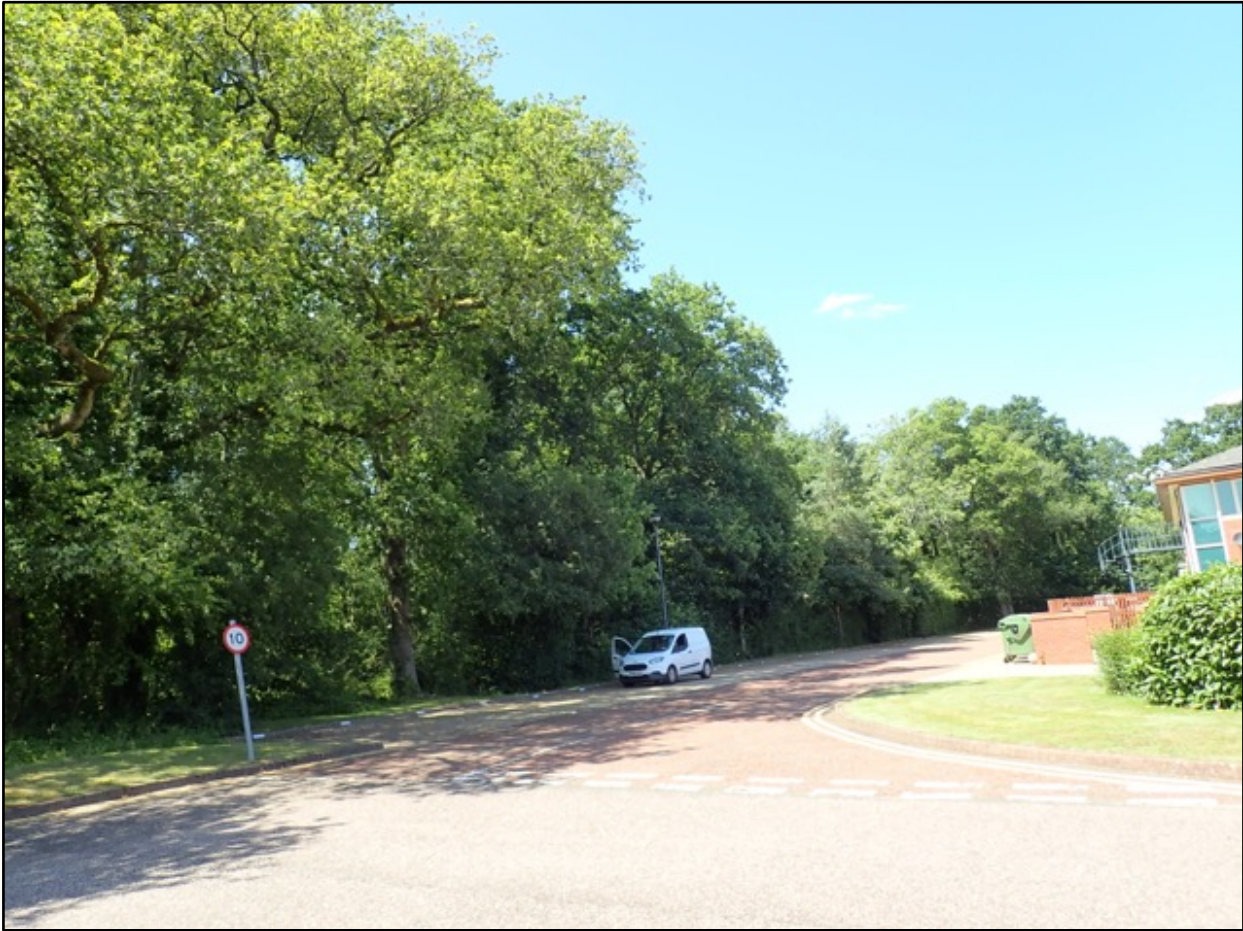
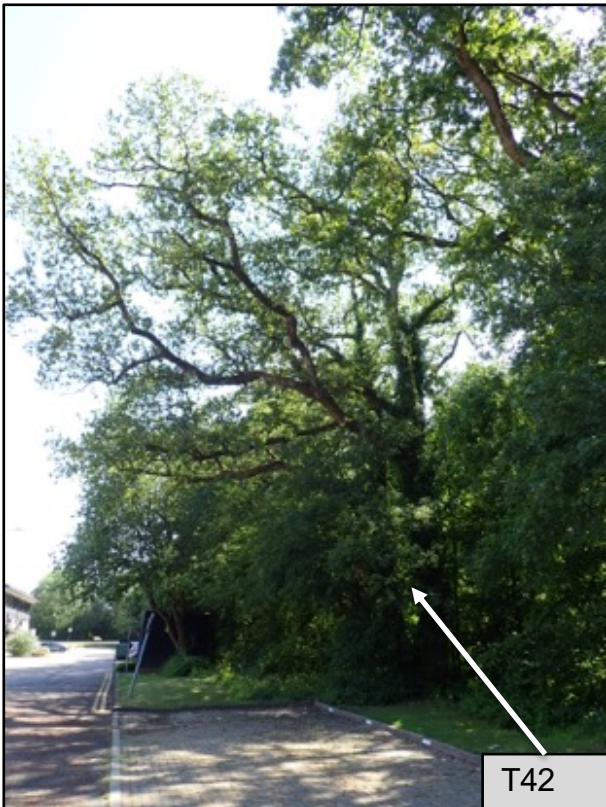
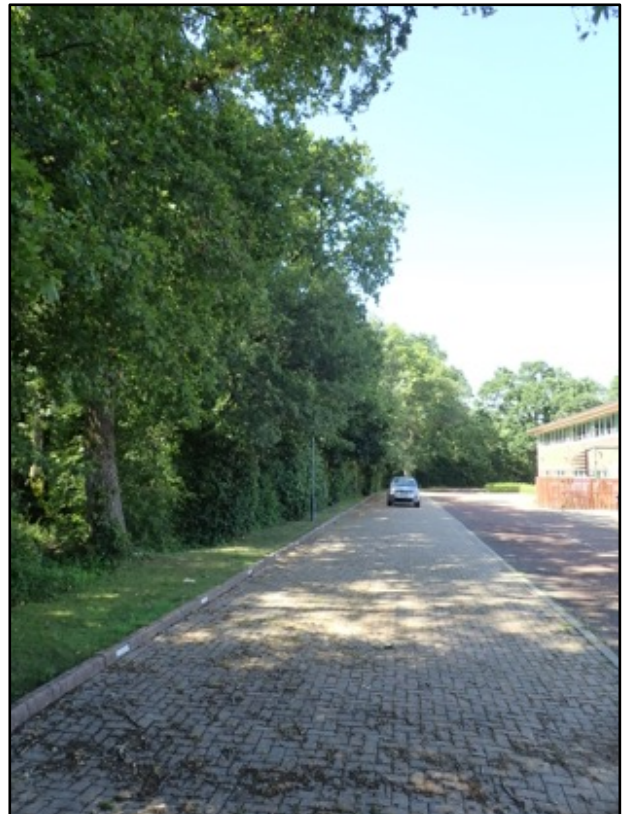
Above and below right: View to north, along western boundary. Below: Southwestern corner.
