**Badger Report on 36 Lower Church Road,**  
**Gurnard, Cowes, IOW, PO31 8JF**

**Carried out by Paul Creer**  
**The Badger Action Group**  
**16<sup>th</sup> July 2023**

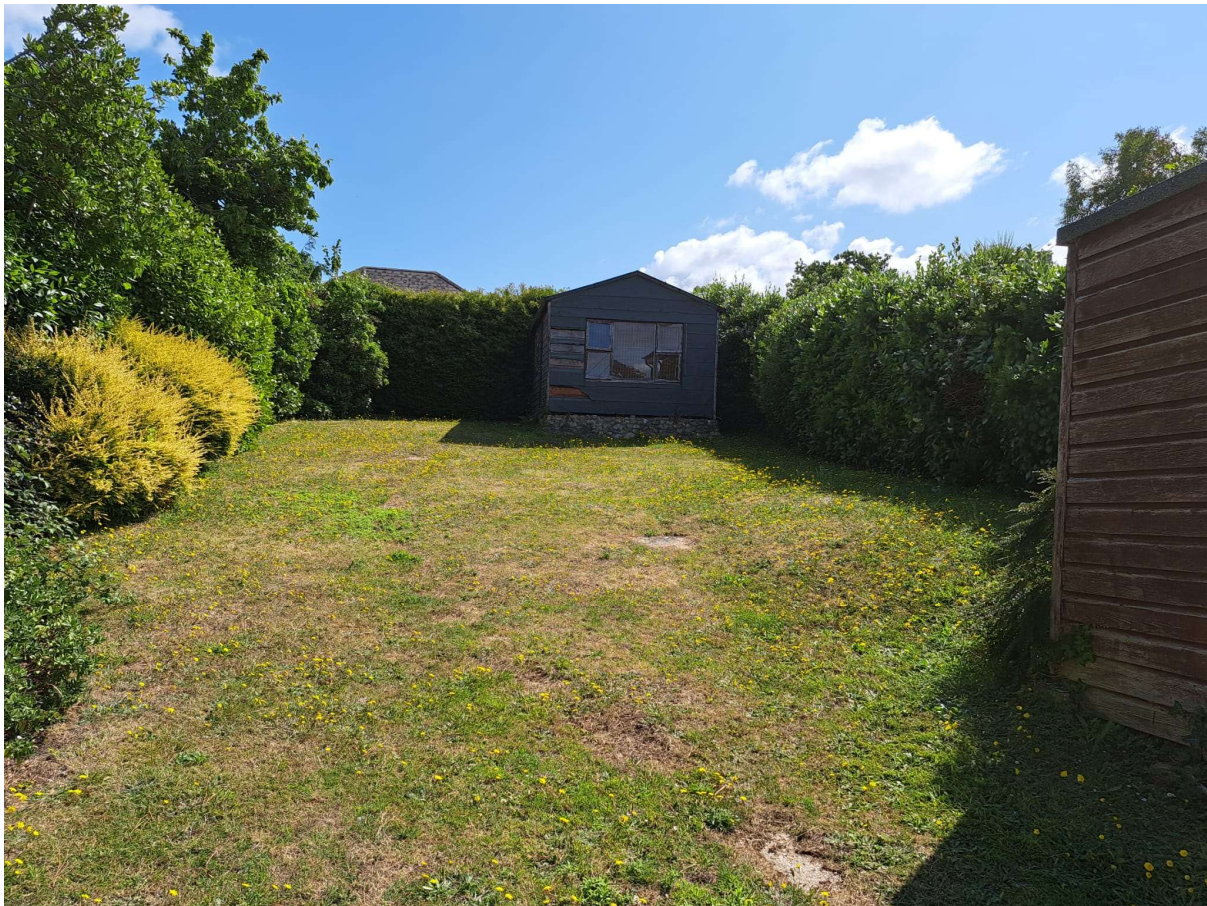
(The picture above shows the rear garden & it's boundaries)

There are no visible badger paths within the grass of either the front and rear gardens which also indicates there are no badgers on this site.

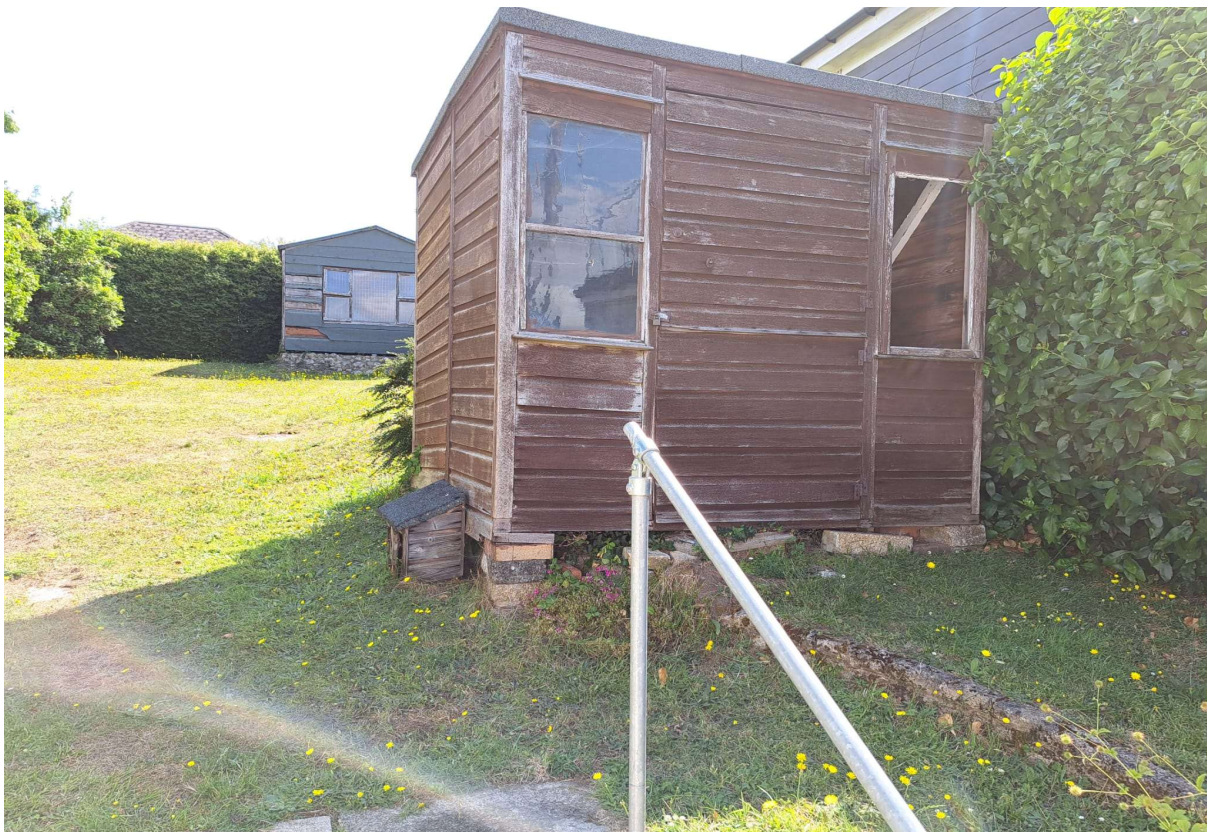
(Picture shows the two wooden sheds to the rear of the garden).

There is a small amount of historical evidence that badgers had been under the first wooden shed in the garden previously, but this was very old activity with no current badger paths within the lawn leading either to or from the shed, this finding supports that this is old activity within the garden.

There are no badgers on-site, the demolition of this building must be overseen by a badger consultant to ensure the badgers do not regain entry during the demolition process. If the sheds are to also be demolished a survey should be conducted to confirm there is no badger activity to either shed in the rear garden before they are also demolished.

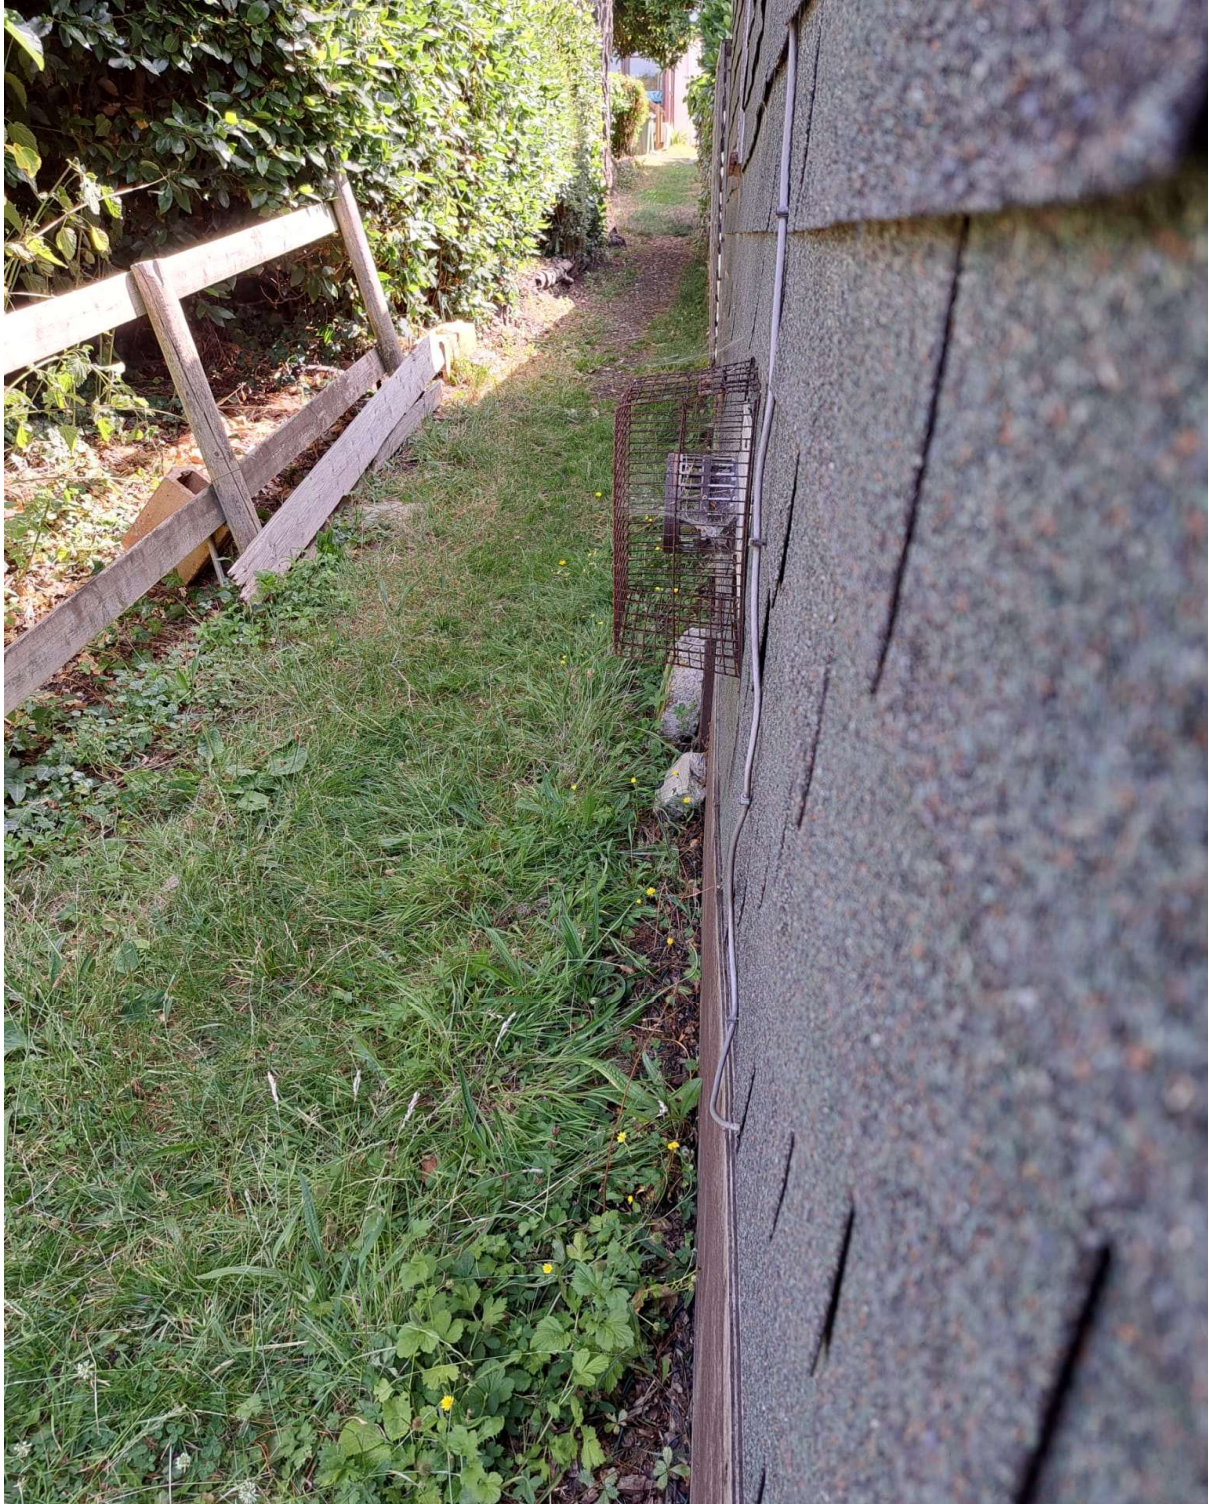
(The above picture shows a view down the left hand side of the property which is on the right-hand side of the picture – it also shows the grass path in the adjoining property’s garden – this path also contains chain-link fence on the ground, however, this is not visible in this picture).

There are no active badger setts on this site either to the house or to either of the wooden sheds. There were no badger setts to the adjoining properties that I could visually see, there was no evidence of badger activity/setts or signs within the gardens of the 3 properties which adjoin the boundaries of this property.

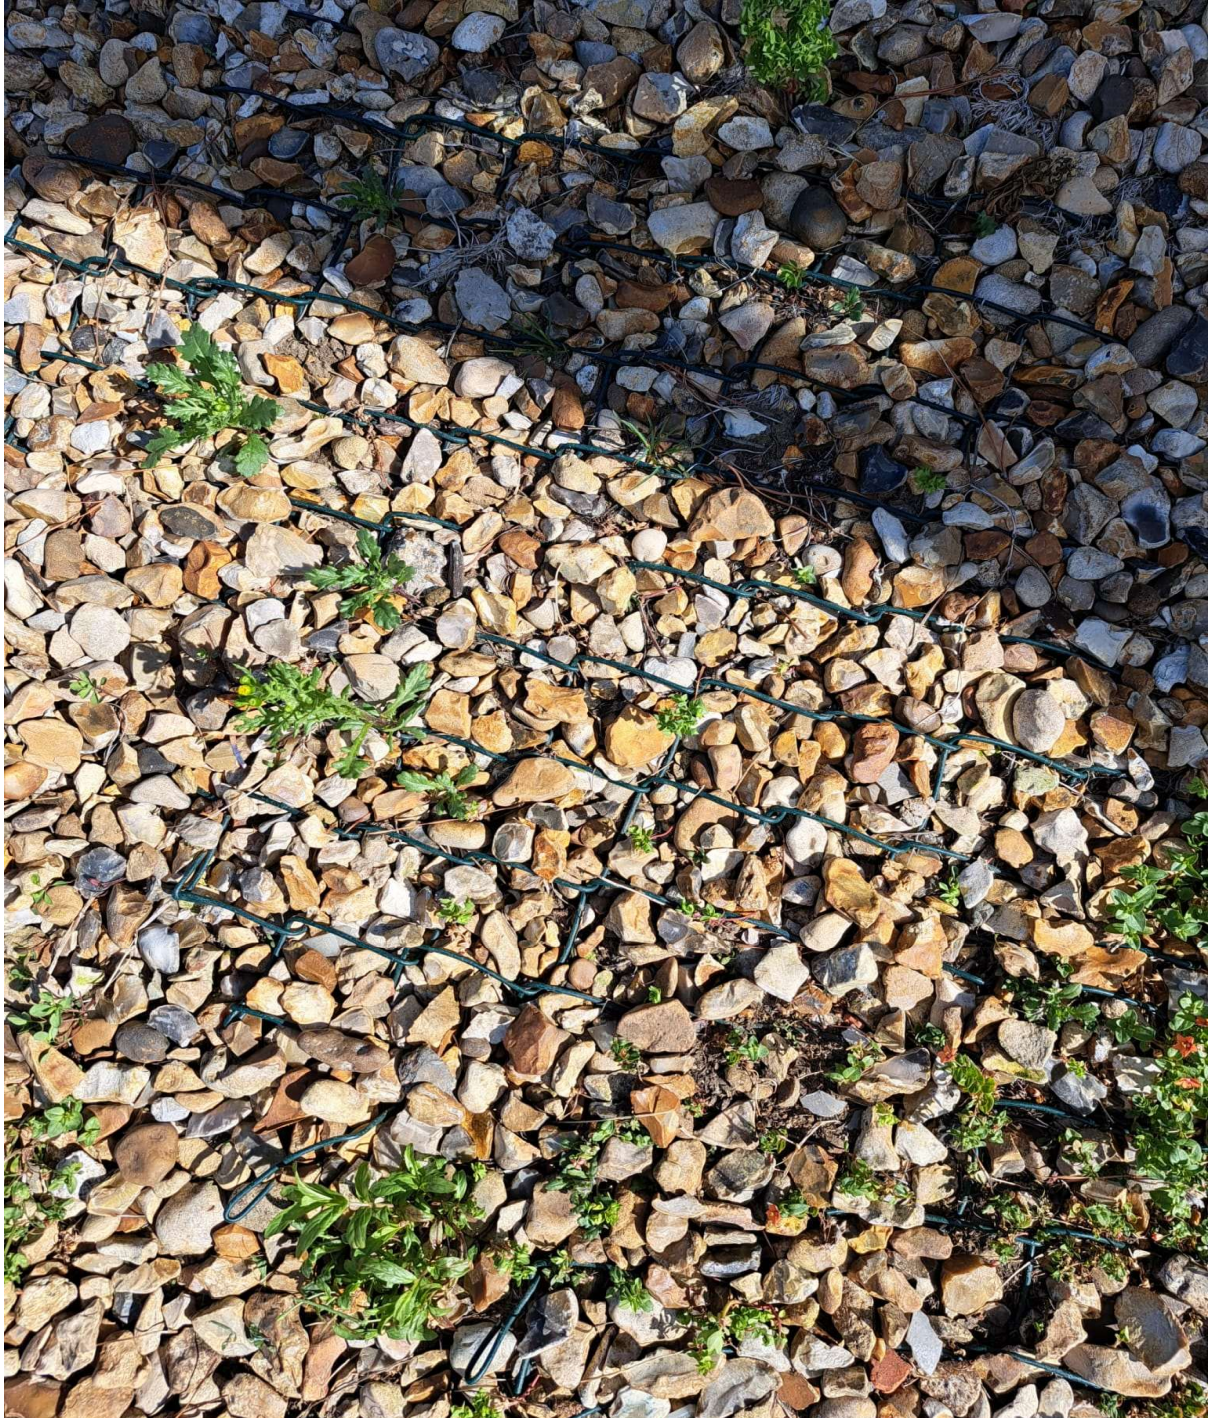
After carrying out some historical investigation of this site, I discovered that there used to be an active badger sett under the front wood construction of this property. A badger exclusion was undertaken with chain-link fence being installed across the front

of the property and down the left-hand side of the property, (as I face this construction from the front garden) to stop the badgers from digging back underneath this part of the property.

(Picture shows chain-link fencing on the ground to the front of the property amongst shingle).

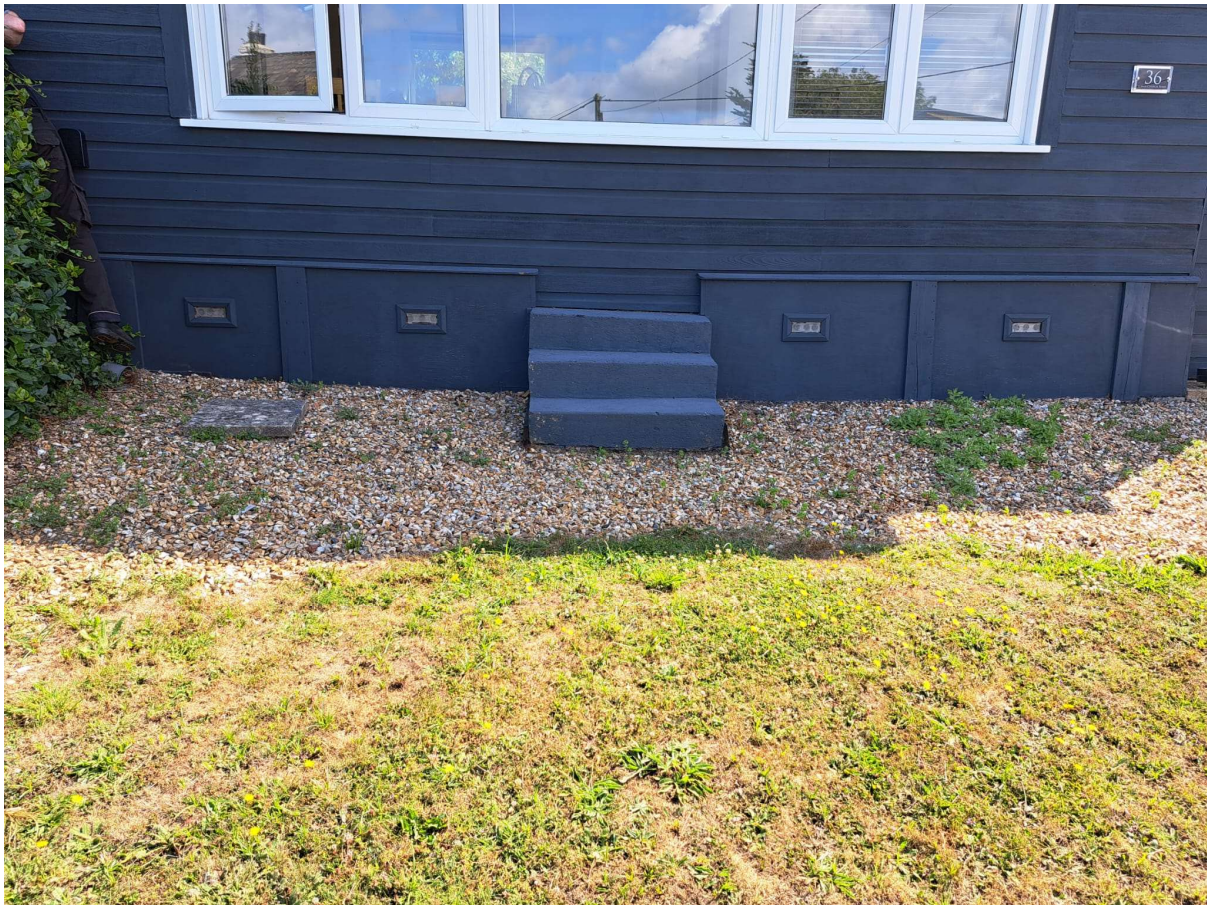
(Picture above shows the front of the property which has been boarded down to the ground – showing the shingle where the chain-link fencing has been located).

The chain link fence is also installed in the neighbouring property as well, during or after the badger exclusion all three sides of the wooden part of this property were closed off to prevent the badgers from getting back into this area. I understand this was undertaken some years ago and is still in very good condition when I surveyed this site, it's obviously has been very successful and therefore there are no badgers underneath the front part of this property or any where else on this site.

As this site has history of badgers being beneath the front of the wooden area of the property, demolition will have to be undertaken in a certain way to stop the badgers from regaining entry.

On-site discussions will need to be had with the owner & the demolition company, and works must be overseen by myself to ensure work is undertaken in a proper manner and the badgers do not regain entry.
