Carbis Bay Hotel St Ives, Cornwall

Ecological Appraisal For Habitat Restoration

Document Reference: 9747.001

February 2023

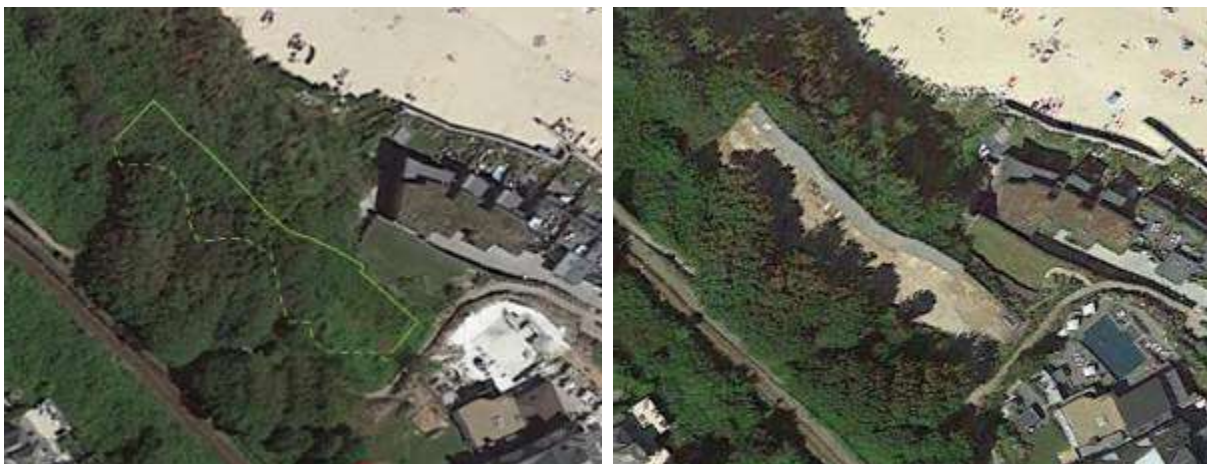
3.28 Aerial imagery reviewed prior to construction and post-construction (post-demolition of the constructed lodges) indicate that the majority of the tree canopy in the vicinity of the site is retained. Mature trees appear to be located only to the south of the site, on the cliff slopes above, with canopy overhanging the site. Dense scrub appears to surround the site to the west and north, except for a small overlap in the northeast corner with the existing hotel infrastructure.

Figure 2: Google Earth pictures from March 2021 (left, pre-construction) and July 2022 (right, post-construction) showing site location and the adjacent tree canopy

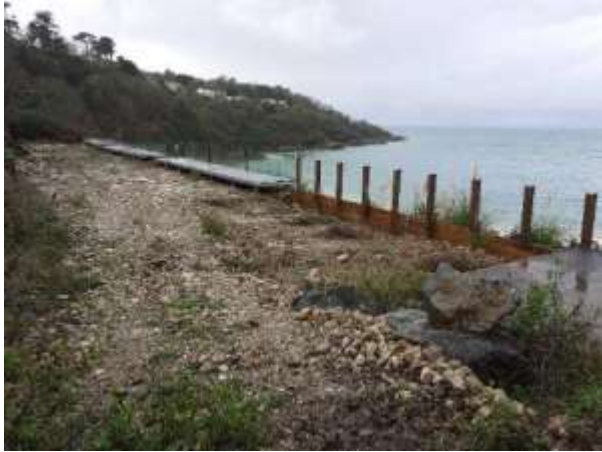
Figure 3: General view across site (glass balustrade and deck are understood to have since been removed)

- 4.1 ER1-ER3 will be complied with in full. The buildings, services, decking and glass balustrade have or will be completely removed from site. There are no further ecological measures required or recommended.

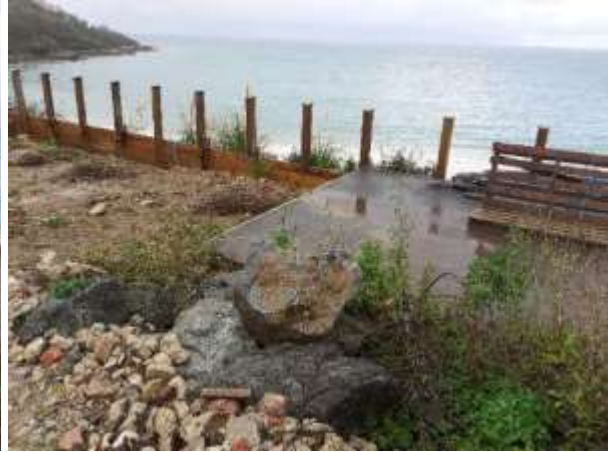
Figure 4: Remaining timber balustrade and tarmac platform in northeast of site (north boundary)

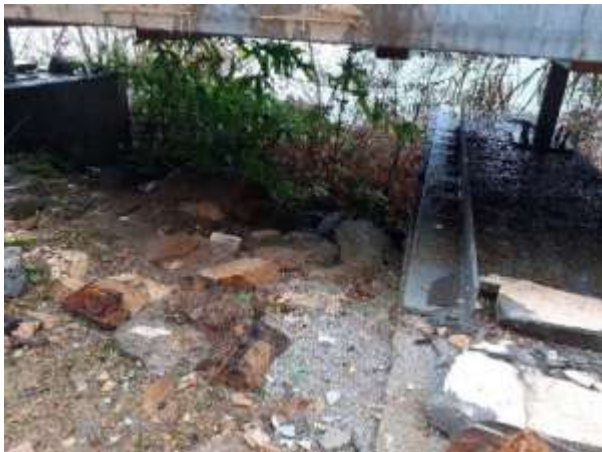
Figure 5: Concrete supports (north boundary)

- 4.2 ER4 requires the demolition and removal of the concrete slabs and pile foundations. No pile foundations were used. The concrete slab supports on the north boundary and the rubble fill between them would ideally be left in situ to avoid further disturbance of adjacent habitats. These structures also provide some wildlife opportunities e.g., for reptiles and invertebrates and, along with the boulders in the east of the site, create exposed surfaces that may become suitable for colonisation by lichens. They will quickly become visually obscured from the coastal path above and beach below by establishing and proposed new vegetation. Visual prominence would be further lessened if additional granite boulders were to be interspersed amongst them.

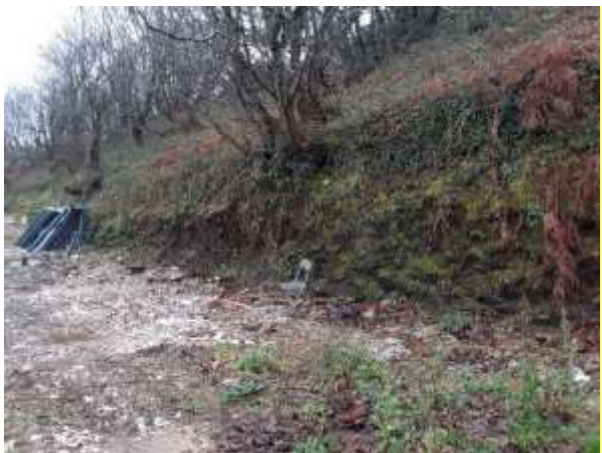
- 3.35 A retaining wall approximately central to the site on the south boundary is a concrete structure with wooden cladding. The wall (Figure 8) is in good condition, although the wooden cladding is partly removed towards the bottom of the wall, exposing the cavities between the cladding and the concrete wall. The rest of the south boundary of the site is formed of what appears to be pre-existing near vertical cliff profile, vegetated with low scrub and herb cover. A group of sycamore trees is situated on the slope above (Figure 7).

Figure 7: Vegetated cliff face (south boundary)

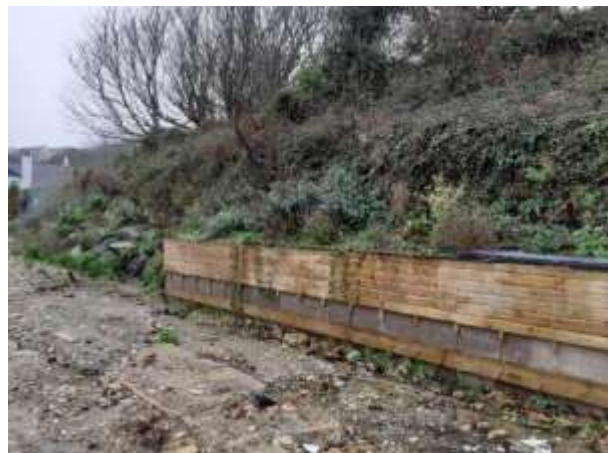
Figure 8: Retaining wall (south boundary)

- 4.3 ER5 requires the demolition of the retaining wall. Proper assessment of the bank stability should be undertaken by an engineer before any work is undertaken. However, based on the information available relating to the retaining wall and the previous AIA, it is considered that removal of the wall without provision of an alternative retaining structure is likely to increase the risk of bank instability, ultimately risking the failure of the trees on the slope to the south of the site. The location of the trees set-back from the slope face, and their rooting pattern (insofar as it can be determined from the photographs in the AIA) does not lend itself to natural ground stabilisation. Photograph 2 of the AIA shows the soil profile with tree roots occupying the upper 500mm, but with few visible roots below this depth. If the wall were to be removed, the lack of cohesion from tree roots at the face of the bank is likely to lead to soil erosion that will eventually undermine the trees. Future tree root growth and the addition of new ground vegetation is unlikely to be able to prevent erosion in the absence of the retaining wall; additional tree planting could help bind the top layer of soil but failure from underneath will be difficult to prevent and the bank would need to be retained in some alternative way.

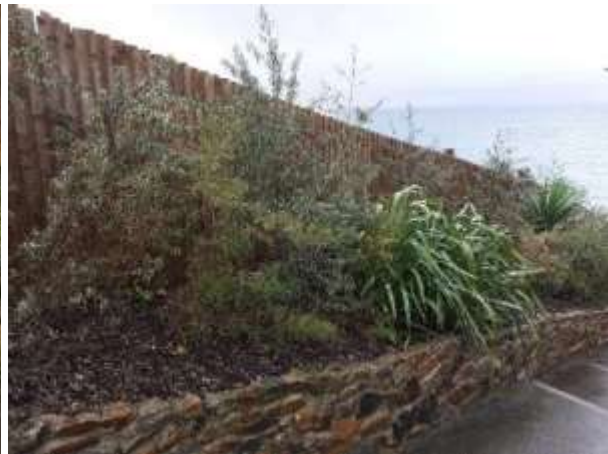
Figure 10: Stone faced wall topped with timber fence and landscape planting

therefore requires removal. The timber close board fence is therefore proposed for replacement with a lower post and wire fence in this location, which would not result in loss of views.

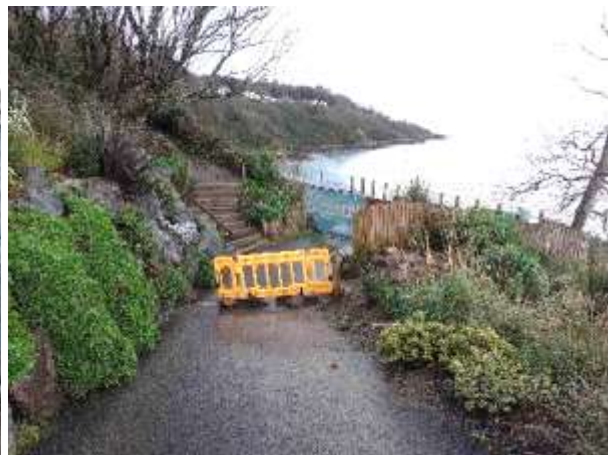
- 3.38 The final area covered by the enforcement notice comprises a tarmac track leading from the coast path opposite the site entrance (Figure 12) around the back of the hotel to the car park. At this point, the south side of the track comprises a steep bank faced with boulders which is establishing with low growing bushy flowers (asters/osteospermums) (Figure 13). Further along, behind the hotel, the track has been edged with a stone-faced wall to both sides (Figure 14), with the height varying according to the adjacent land profile. The stone facing is beginning to colonise with species such as ivy-leaved toadflax and spleenworts. Lawn areas and landscape planting (pre-existing established areas and recent planting) form the majority of land uses adjacent to the track to the south.

Figure 12: Tarmac track as it approaches the coastal path (view west, coastal path descending via steps)

- 4.7 ER7 and ER8 require the demolition and removal of the tarmac access road behind the hotel and the stone terrace walls associated with the access road. However, the access road behind the hotel between the car park and the coastal path is desired to be retained for fire safety reasons. The stone-faced terrace walls are establishing well with vegetation, which although is predominantly non-native includes flowering species that would likely contribute towards available forage for pollinating species. No further ecological measures are recommended for this area.

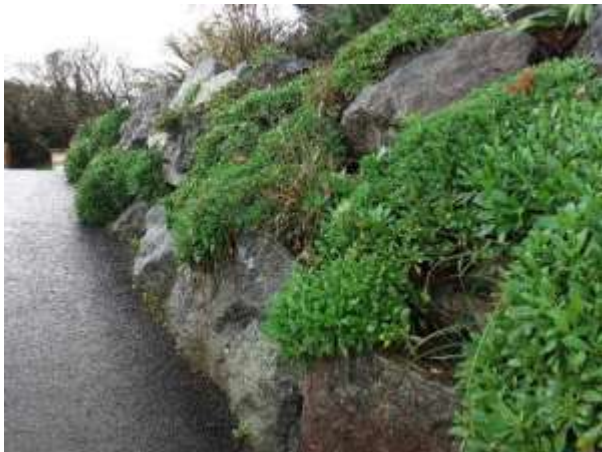
Figure 13: Boulder faced bank along tarmac track on approach to coastal path from the hotel

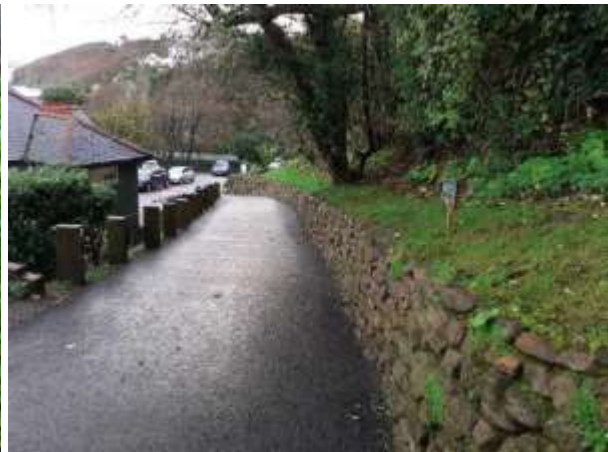
Figure 14: Tarmac track to rear of hotel leading to car park in the east

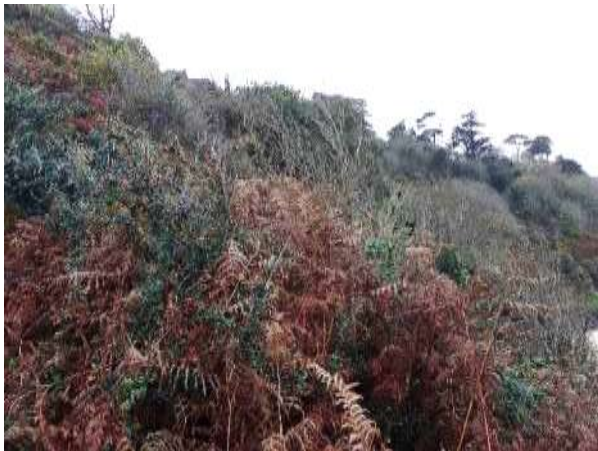
- 3.40 The habitat adjacent to the site in west (Figure 15) is considered to be most indicative of the original form of the site, pre-development. The adjacent cliff face (Figure 16) comprises mainly gorse and bracken with frequent bramble, occasional buddleia, willow and thorn species. Traveller's joy was frequent throughout the scrub layers. Cotoneaster was also noted adjacent to the site on the west edge.

Figure 15: Habitats immediately west of site, dominated by gorse and bracken

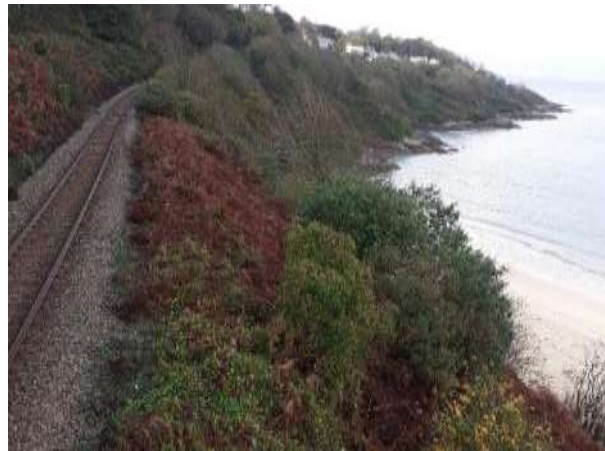
Figure 16: Slopes extending west of the site, viewed from the railway bridge
