**Arboricultural Impact Assessment and Method Statement**  
as per BS5837:2012 Trees in relation to design demolition and construction- Recommendations  
at

**135 Burbage Road,  
Dulwich,  
London,  
SE21 7AF**

File Ref: AIAMS159.1

Ross Fountain Dip. Arb L4 (ABC)  
21.11.23

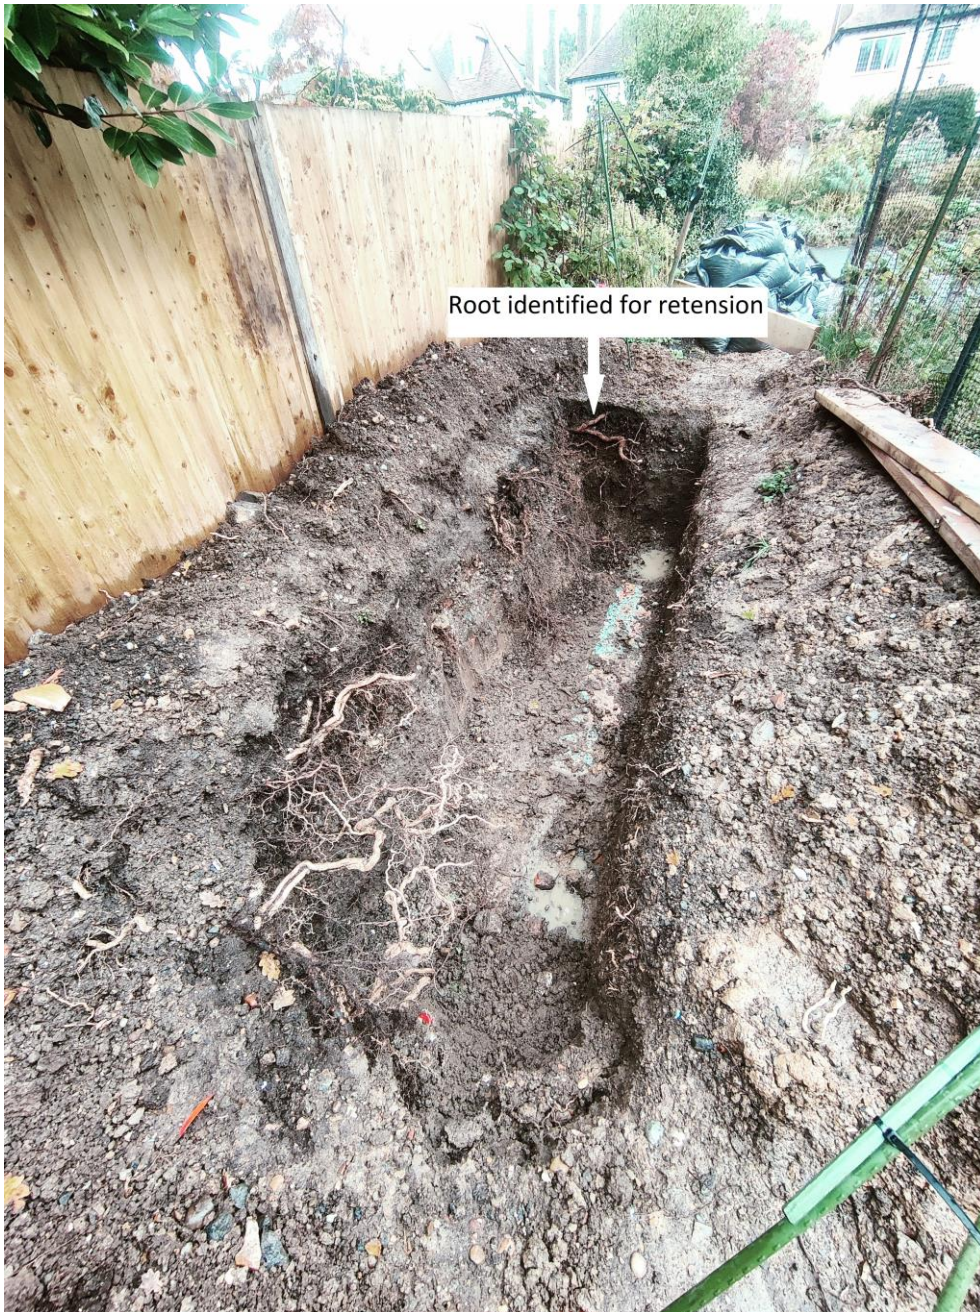
**4.4.2** There is some risk of root disturbance caused by demolition, excavation and construction. The main consideration is the construction of the proposed building and the potential root disturbance and damage to nearby N003 (cherry). As the proposals included some incursion to the RPA of N003, some careful excavation with hand tools has taken place to assess rooting activity. This trial excavation revealed limited rooting activity in general. One significant root was found at the north end of the trial excavation, that was assumed to be from N003 and had a diameter of around 30mm. Another smaller root was found at the south end of the excavated area. There was very little rooting activity found between these roots. Due to the findings, the design has been altered to ensure the root at the north end of the trial excavation can be retained without pruning. It is considered that the root at the south end of the excavation can be appropriately pruned. Therefore, it is considered that the proposals can be implemented without significant impact on N003. Furthermore, the construction methods, prohibitions and precautions within RPAs and tree protection measures as set out in the AMS means the risks of impact through the construction of the proposed building, installation of services and driveway alteration will be suitably controlled. The trial excavation is shown in pictures 1-4 in the appendix.

*Picture 1 (top left)- showing the trial excavation trench and the root identified for retention at the North end. Very little other rooting activity, with lighter coloured roots not from tree N003.*

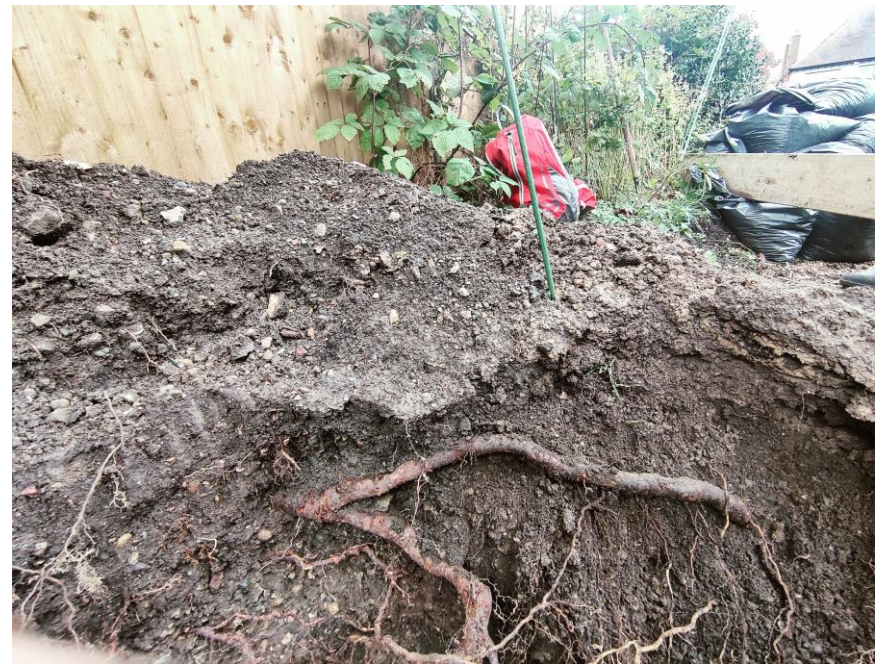
**4.5.4** A minor alteration has been made to the design to minimise impact on N003. Following the pre-planning submission trial excavations, the proposed building was redesigned to ensure the root uncovered at the north corner of the building could be retained without pruning. No additional alterations or additional mitigation has been recommended as it has been considered a low impact scheme. Protection measures have been provided in the AMS.

*Picture 2 (top right)- Root identified for retention, initially growing perpendicular to the fence, and then heading northwards.*

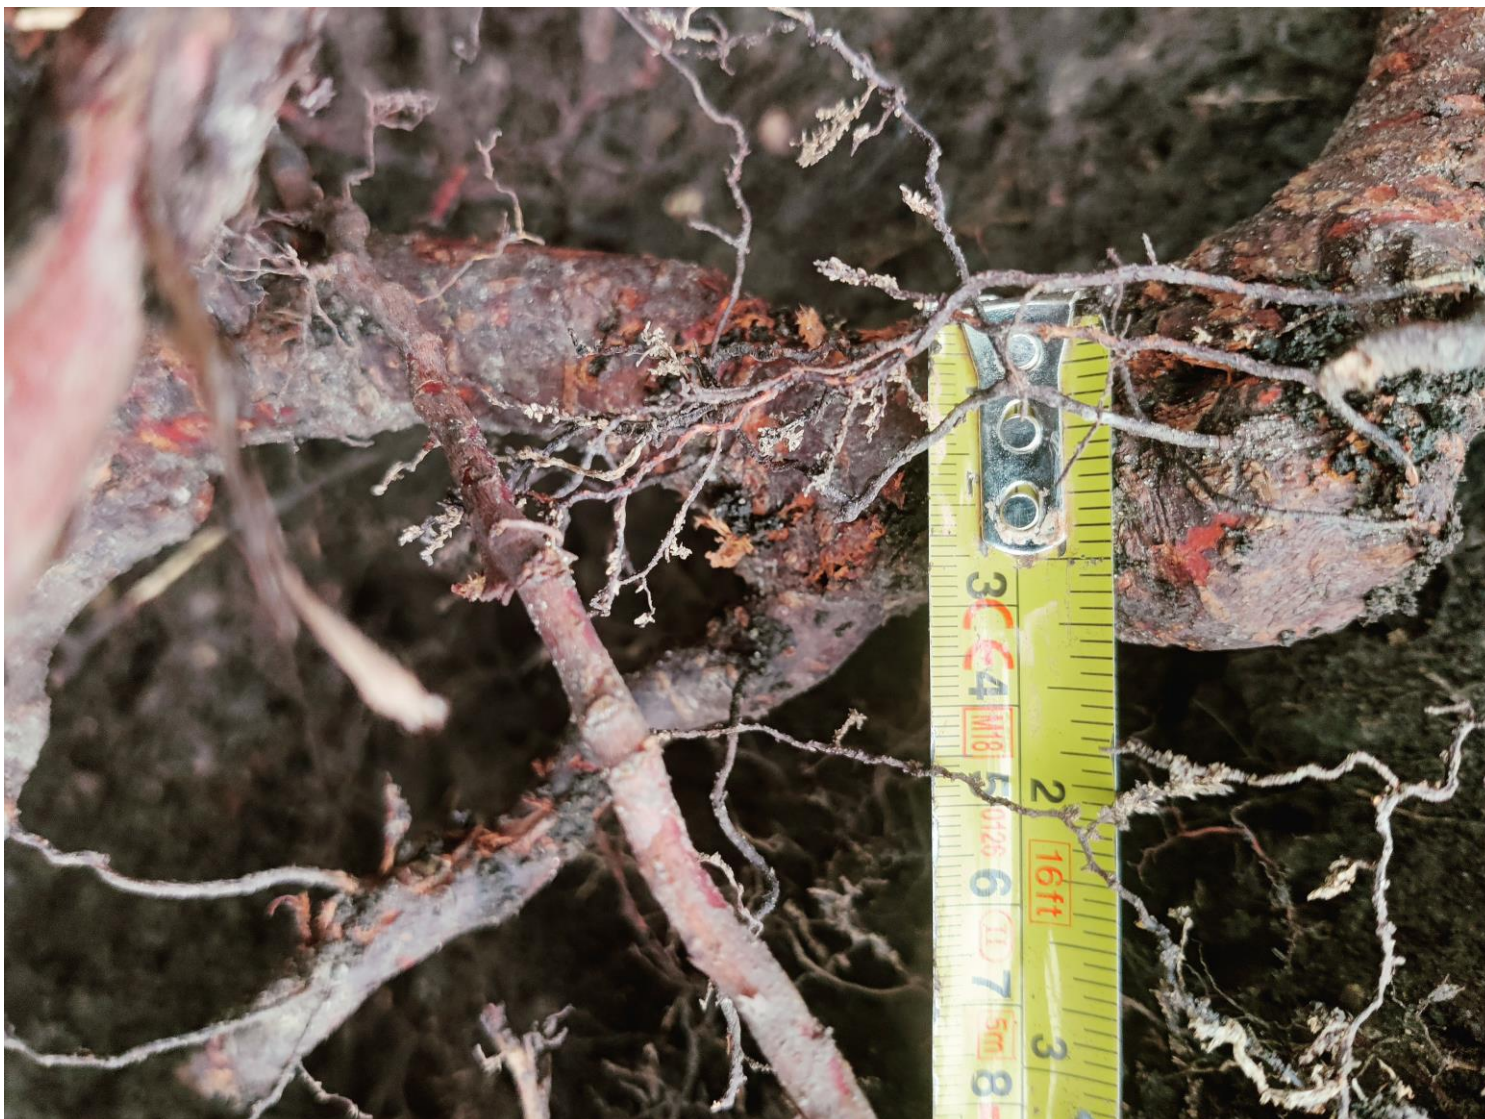
*Picture 3 (bottom left)- Root diameter approximately 3cm in trial excavation area.*

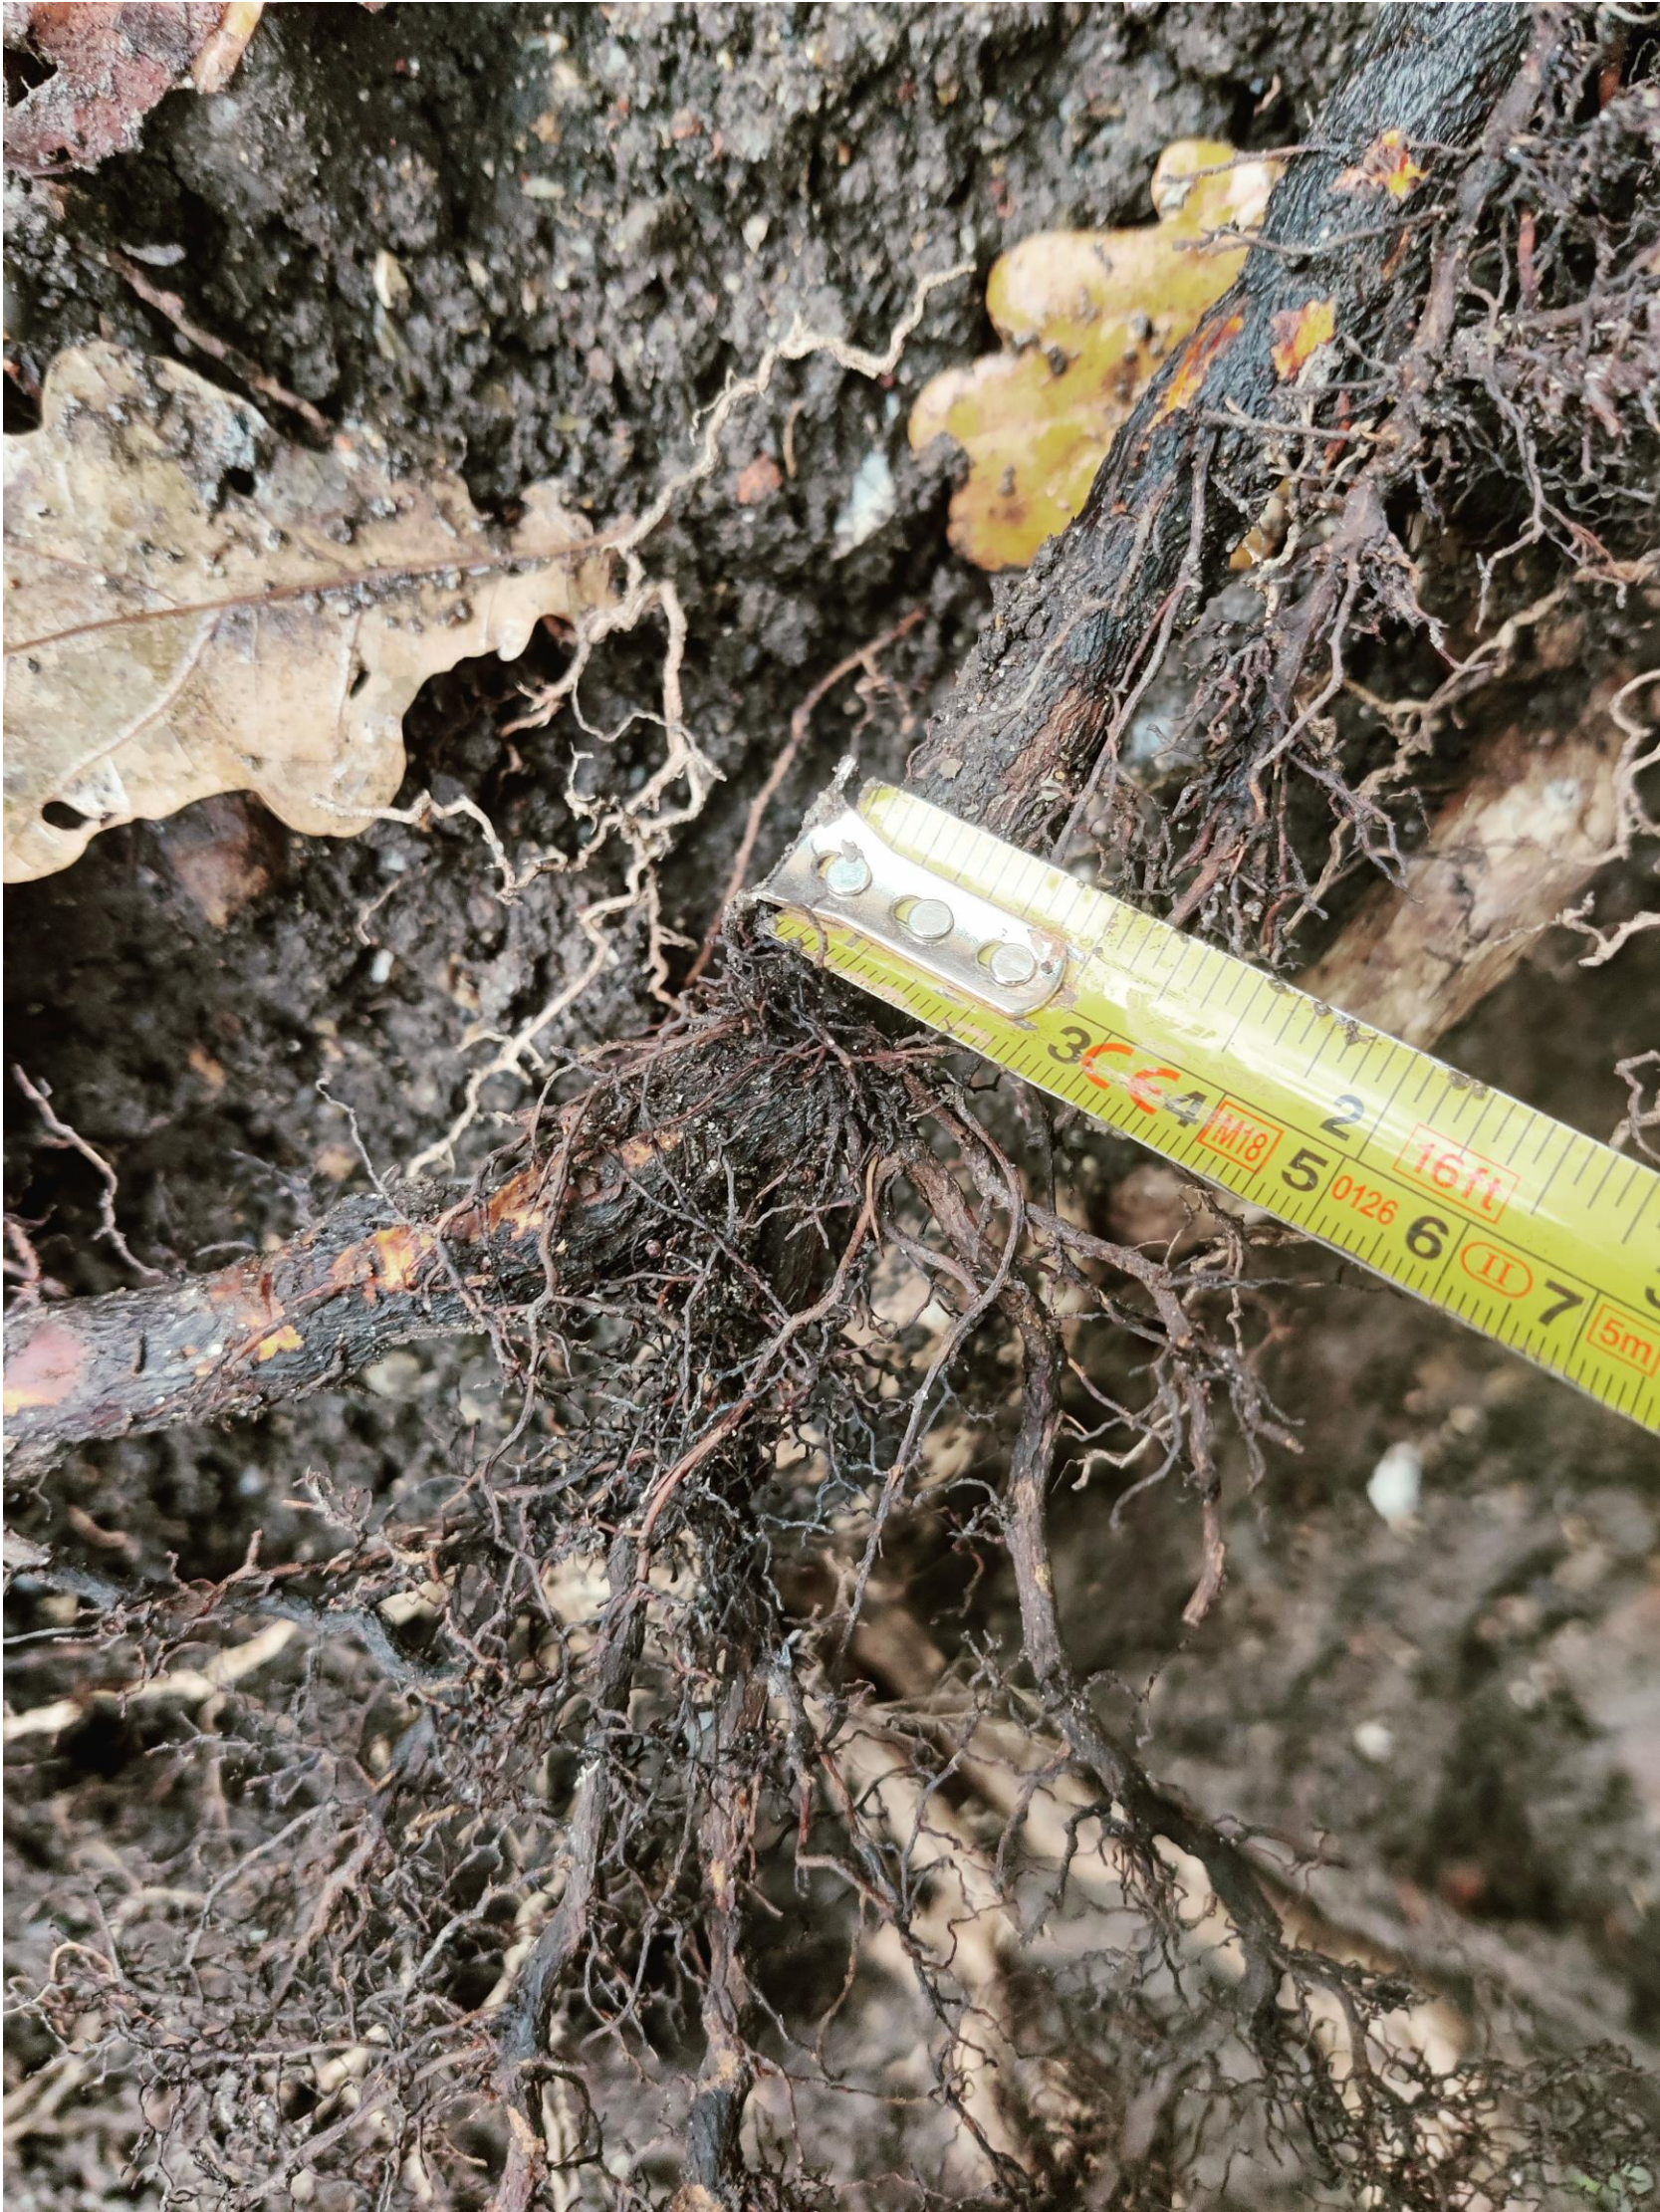
*Picture 4 (left)- showing smaller root of 15mm diameter at southern end of trench which can be pruned.*
