**BS5837 Arboricultural Report and
Arboricultural Impact Assessment**

OUR REFERENCE	AC.2023.590
CLIENT	K and S Construction
SITE	Canterburys, Darby Green Road, Blackwater, Surrey, GU17 ODT
REPORT BY	I S Thompson (known as Tom) M. Arbor. A., BSc. (Hons) Arb, MSc. eFor
DATE	18th November 2023
DATE OF SITE VISIT	30th October 2023

Application Ref No Unknown **Construction of four semi-detached properties and three terraced properties on land that was previously a pub and car park.**

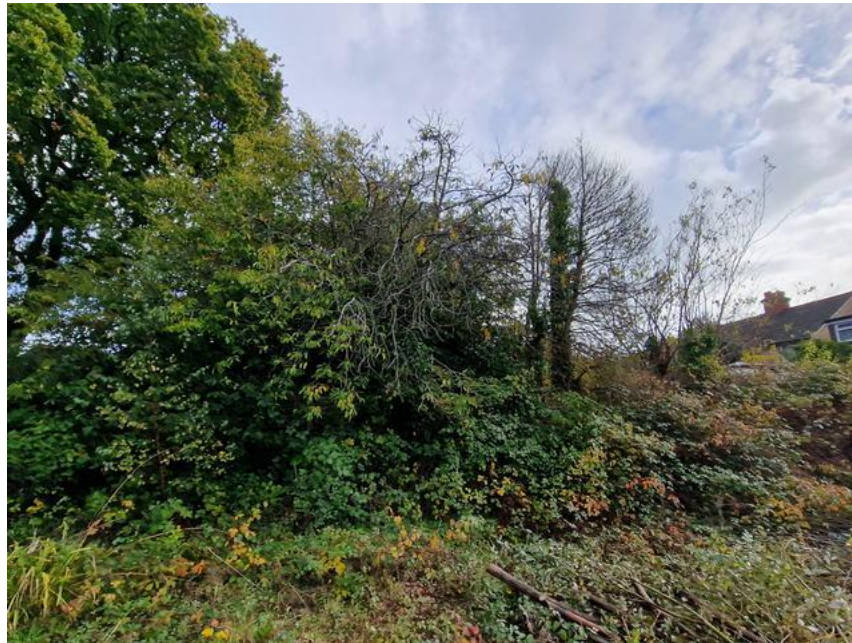
- 2.2.4** G01 is a small group of mixed species trees and shrubs along the eastern boundary. They were categorised as a C2 group, see Image 1 in Appendix III.

Image 1 G01 a group of mixed species trees in the adjacent property along the boundary.

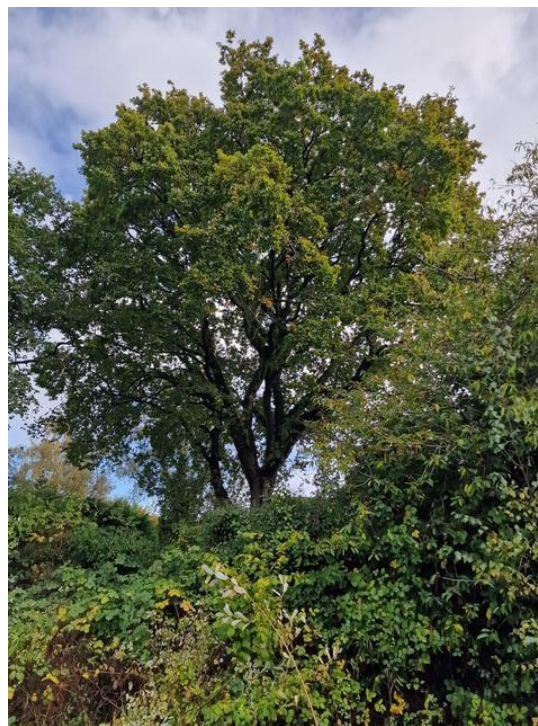
- 2.2.5** T02 and T03 were both mature oak trees T02 was on the adjacent property and was categorised as an A1 tree, and T03 as a B1 tree, see Images 2 and 3.

Image 2 T02 a very large mature oak tree in the adjacent property.

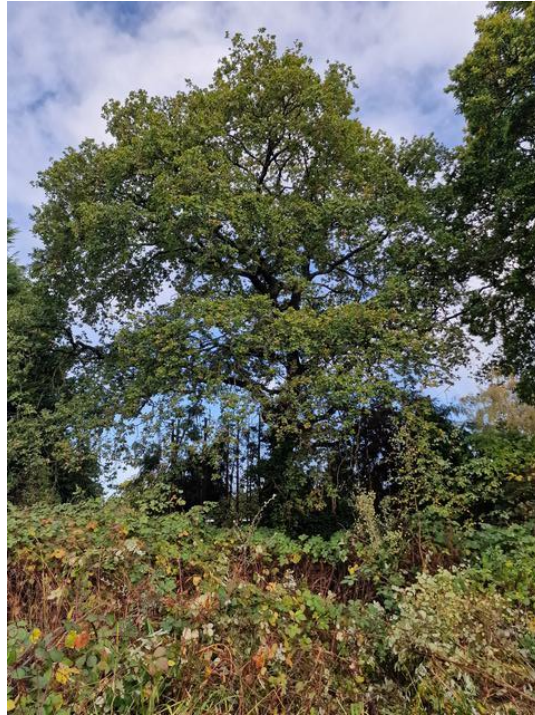
Image 3 T02 a large mature oak tree at the far end of the property in the centre.

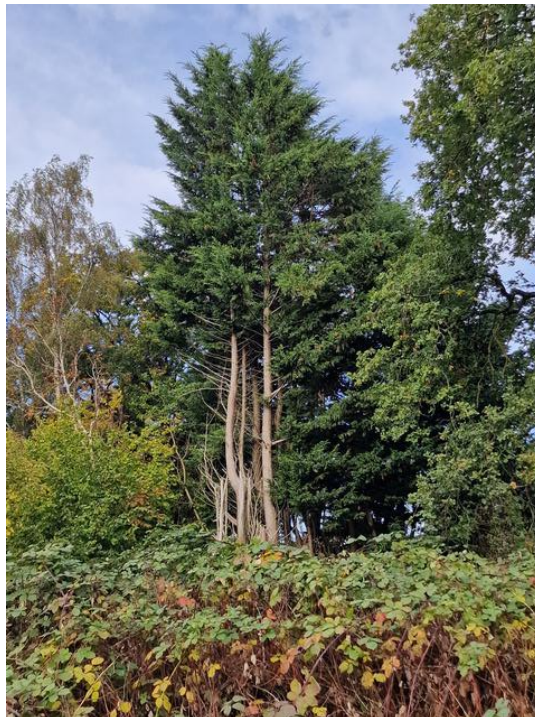
- 2.2.6** H04 is a group of eight Leyland cypress trees in the adjacent property to the west. They have a low crown on the western side, but it is around 6 m on the eastern side facing the plot, where the lower branches have been cut back over time, see Images 4 and 5.

Image 4 H04 a row of cypress trees along the side boundary, crown lifted to around 6m.

3.3.3 There will be one low small diameter branch pruned on T03 to provide ground clearance, but this tree has been crown lifted in the past. The lower branches of H04 will be crown lifted to 6m taking any recent regrowth back to the site boundary. The crowns of H06, G07, and H08 will also be taken back to the site boundaries. All tree surgery works will be undertaken prior to construction activity and in accordance with the Arboricultural Method Statement Section 12 Remedial Tree Works.

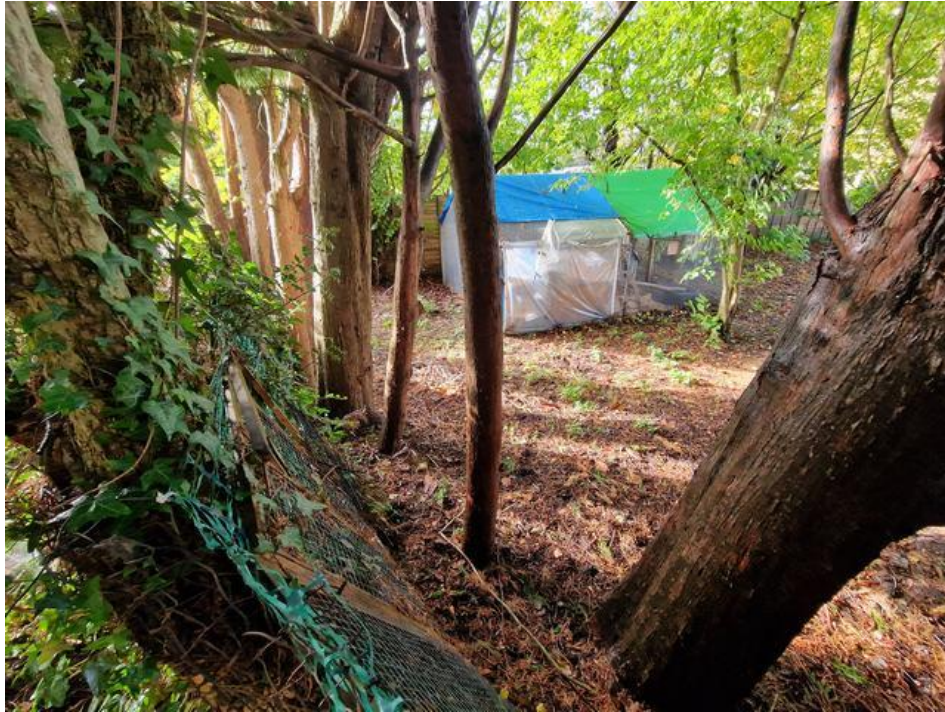
Image 5 Lower trunks of H04 in the adjacent property.

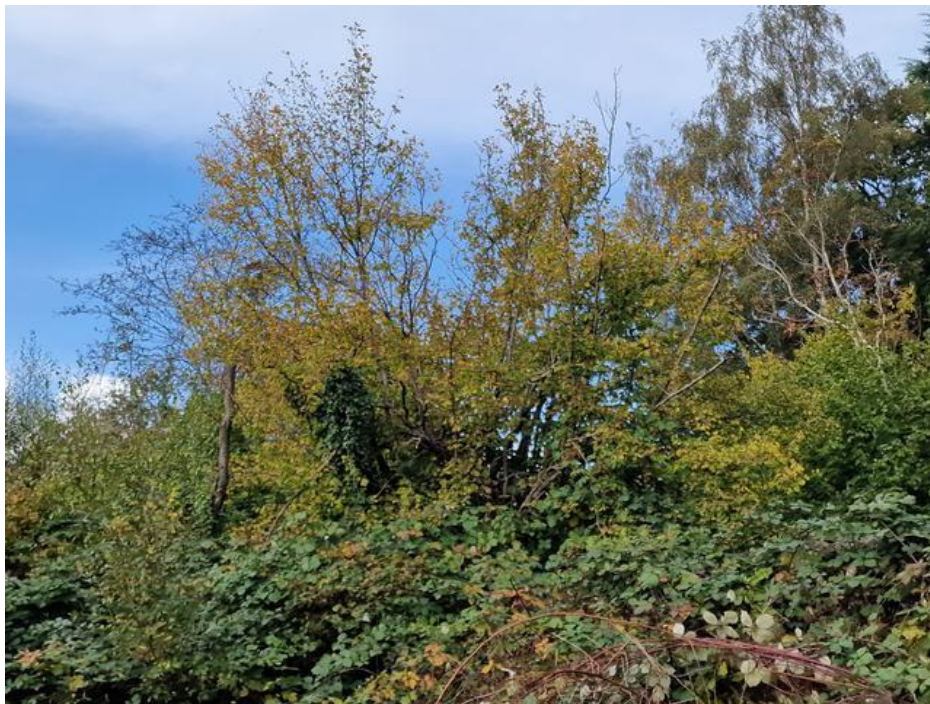
- 2.2.7** T05 is a multi-stemmed hazel tree that is coppice regrowth. This was categorised as a C1 tree and is identified for removal due to its conflict with the proposed design, see Image 6.

Image 6 T05 as multi stemmed hazel tree that is to be removed.

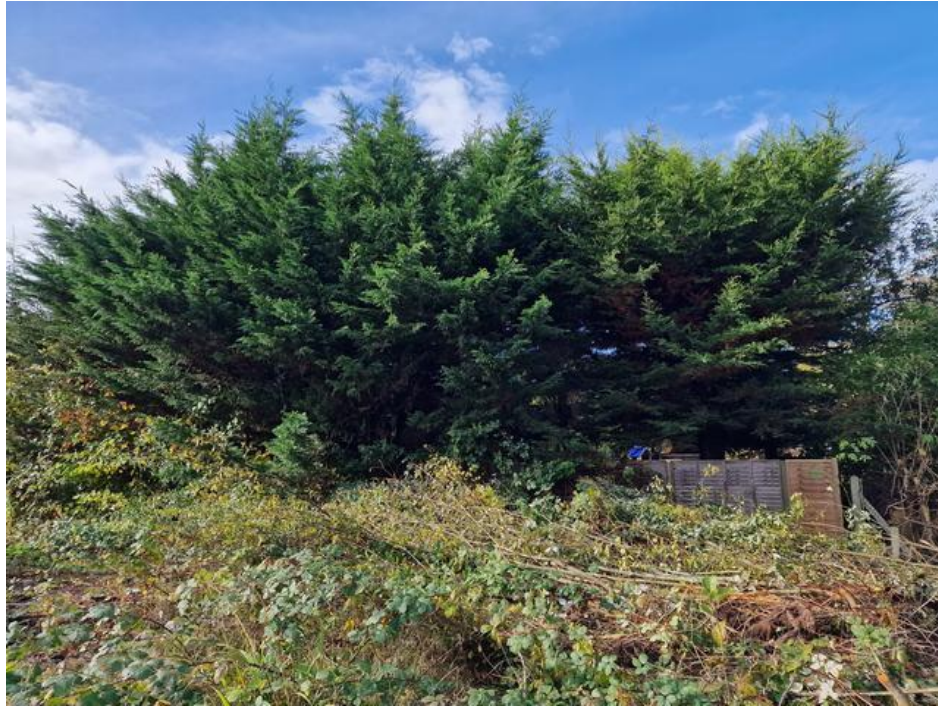
Image 7 H06 a row of cypress trees along the site boundary to be cut back.

3.2.1 There is only one tree, T05 a C1 multi-stemmed hazel tree that is being removed. Additionally hedges H04, H06, and H08 and G07 are all being cut back to the site boundary. Consequently, there will be a minimal effect to the amenity value of the area.

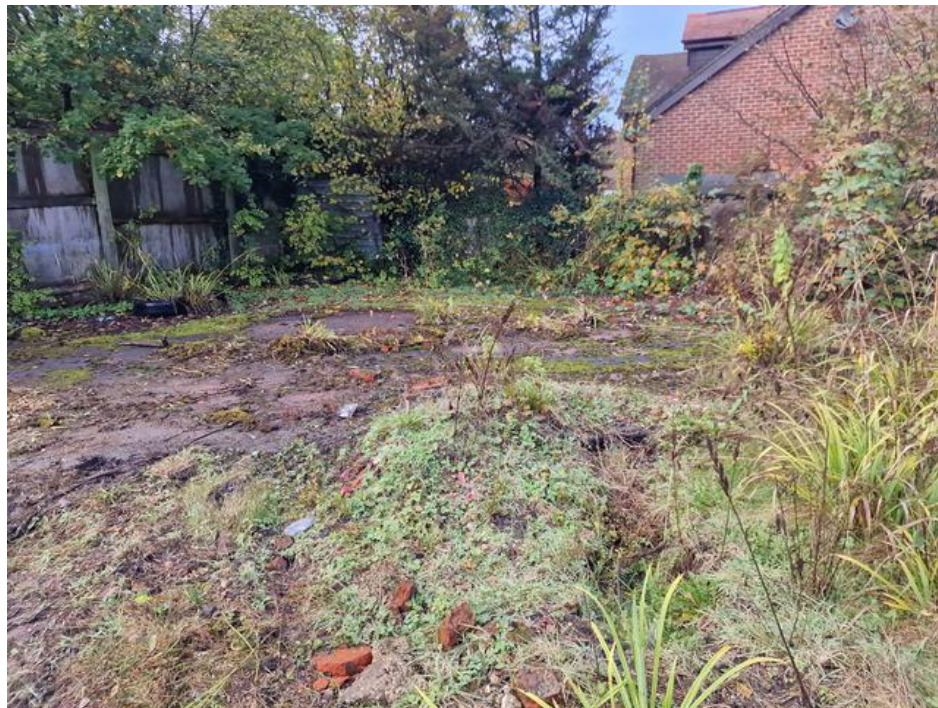
- 2.2.8** H06 is a C2 Leyland cypress hedge, see Image 7.
- 2.2.9** G07 is a C2 group of young hazel trees, see Image 8.
- 2.2.10** H08 is a C2 Monterey cypress hedge, see Image 8.

- 2.2.11** G09 is a C2 mixed species group, see Image 8.
- 2.2.12** T10 is a very young oak tree that is categorised as C1 due to its size, see Image 8.

Image 8 H08, G09, and T10 in the top left, with site entrance just to the right of them.

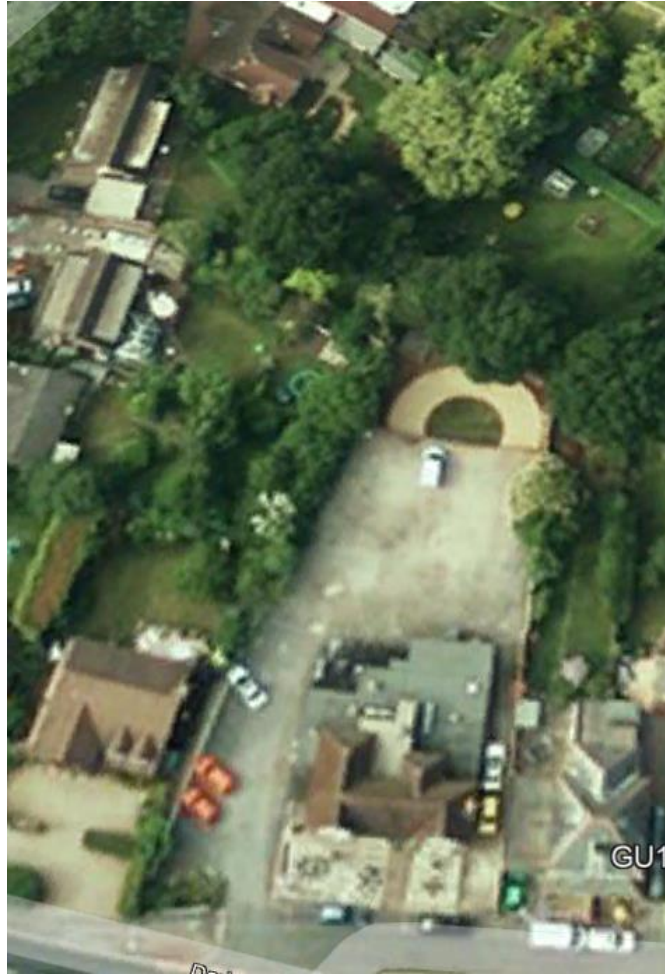
- 2.2.13** Most of the southern end of the plot extending up to the dashed line on AC.2023.590 tpp-1 Rev A, and then circling around under the oak tree was previously converted to hard standing for car parking, see Image 9.

Image 9 Historic image of the site showing the pub and the extent of the car parking area.
