Roof repairs to:

Moor Hall Farm, Moor Green SG2 7AT

HERITAGE STATEMENT & DESIGN AND ACCESS STATEMENT

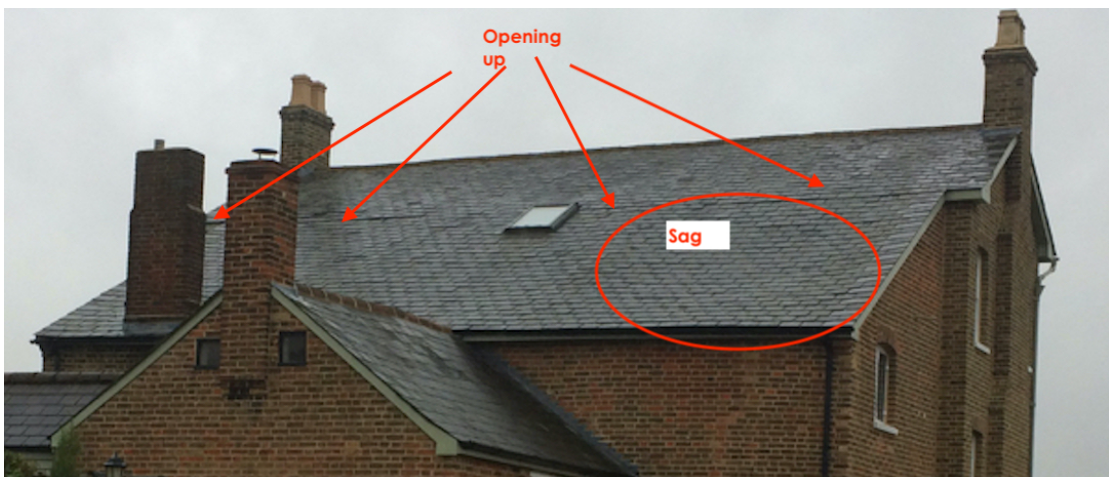
Main roof at rear – Pitch 2

- 3.1** There is concern about the condition of the main slate roof. Slates have been lost in bad weather – including the verge slates which were incorrectly sized. The roof was re-slatted some decades ago.
- 3.2** There is concern about the condition of the reduced historic frame in the lean-to section at the rear, There is a noticeable opening up at the junction of the main roof and the lean-to and the roof sags in parts.

Reslating it would allow for the existing timbers to be inspected and repaired or replaced. It would also allow insertion of Sheeps' wool insulation between the joists in the lean-to in addition to the lath & plaster repairs for which consent has been granted.

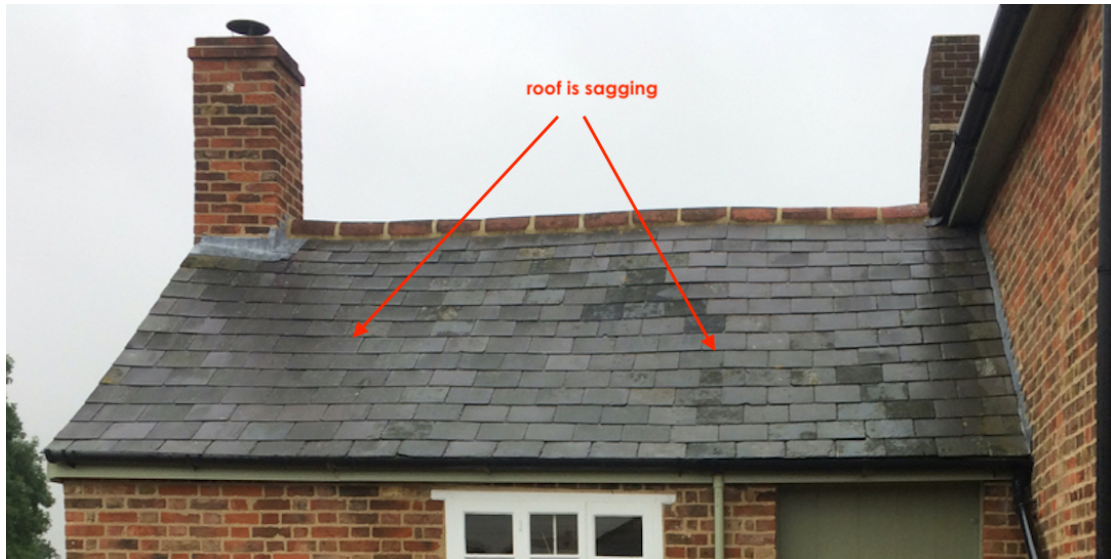
Brewhouse roof Pitch 3

- 3.3** There is also concern about the condition of the timbers in the brewhouse roof. There is a noticeable sag in the timbers over the entrance.

There is already consent for alterations on the other side of this roof to form the junction to the lead roof (which will need slate removal up the pitch to form an adequate junction) and for inserting a new rooflight. Reslating it would allow for the existing timbers to be inspected and repaired or replaced.

It would also allow insertion of Sheeps' wool insulation between the joists in addition to the woodfibre, lime-finished underboards which already have consent.

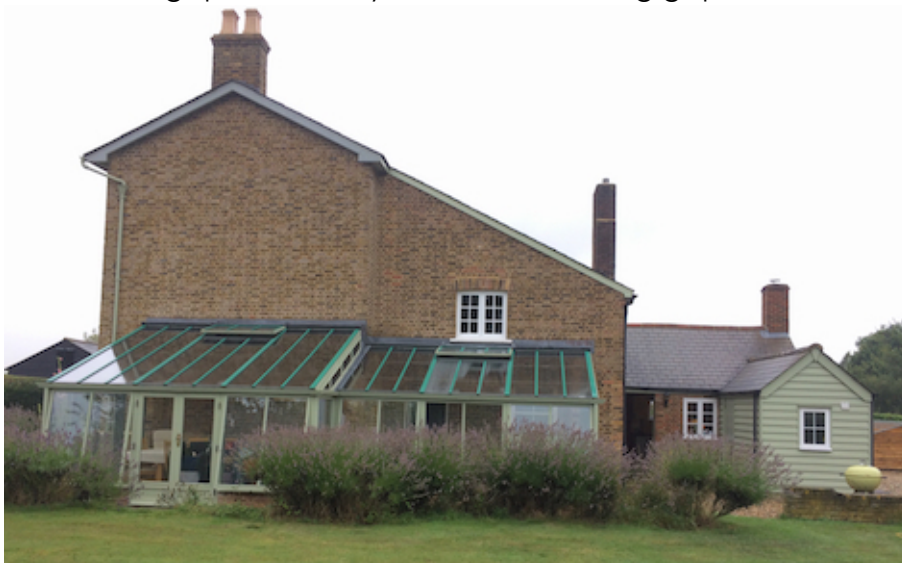
- 4.8 The fascia and soffits do not appear to be historic and have no special detailing. They have a neutral impact on the setting of the heritage asset.
- 4.9 The ecologist has identified some areas that have gaps used for ingress by the bats into the roof space. This has significance.
- 4.10 It is proposed that the condition of the fascias and soffits are given a closer inspection to assess their condition. If found to be defective, they are to be replaced in a profile to match existing but in treated SW.
- 4.11 Current openings for the bats are to be maintained – either by retaining the relevant board or if defective, replacing with a new board with gaps to exactly match the existing gaps.

Bats have been noticed exiting from the roof on this elevation
