ARBORICULTURAL IMPACT ASSESSMENT & TREE PROTECTION STRATEGY

Ashley Pines, Barnet Gate Lane, Barnet, EN5 2AA

Reference: MDJAC-22.158-AIA-02

Date: May 2023

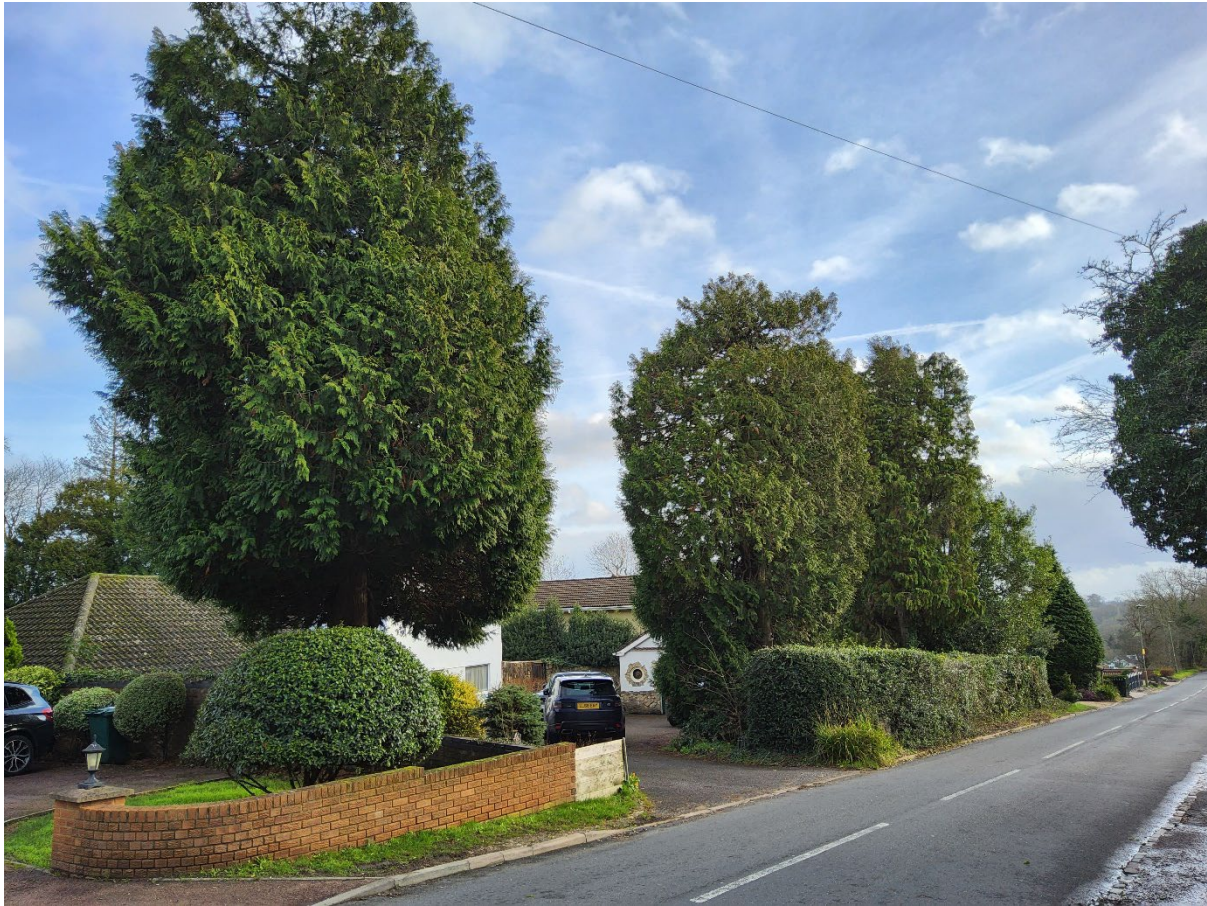
Photograph 1: showing the presence of coniferous trees along the site's frontage, readily visible and which make a significant contribution to public amenity in views from Barnet Gate Lane.

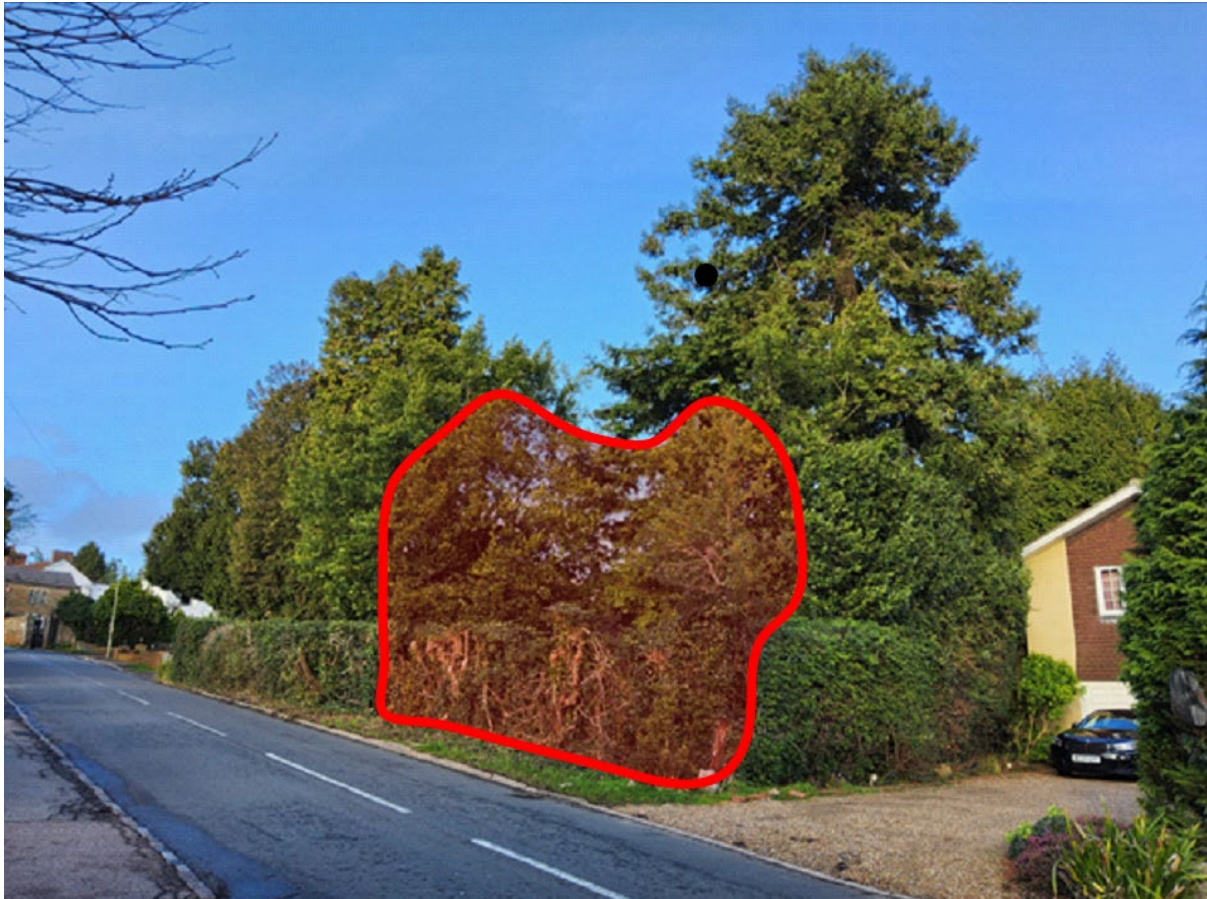
5.1.1 The proposed development will require the entire removal of one group of trees (G11) and the partial removal of a roadside group of trees (G13) to facilitate the proposed crossover. The removal of a section of G13 was approved under planning application ref. 23/0373/HSE.

Photograph 2: showing the approximate location of the proposed vehicular crossover with the canopies of those to be removed highlighted in red.

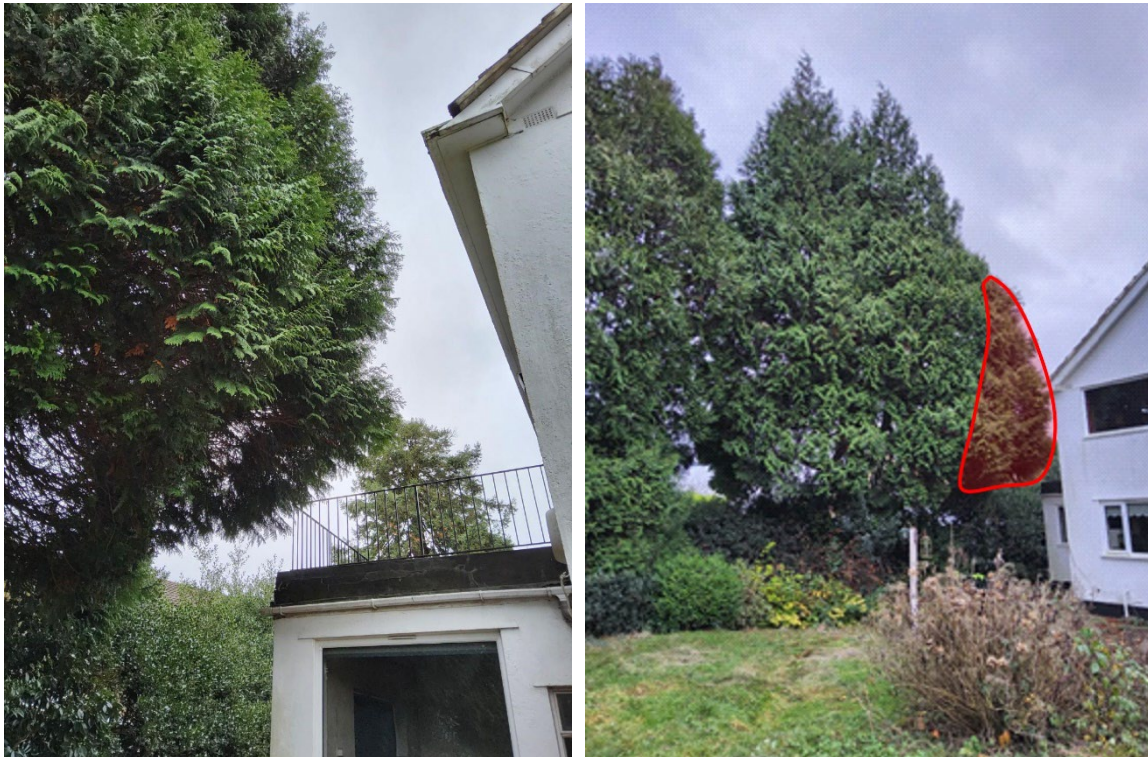
5.2.5 In any event, the western aspect of the canopy encroaches on to the existing property and routine arboricultural management works are required to maintain a harmonious relationship irrespective of the development proposals.

Photograph 3: showing a close up of the relationship between the T5's canopy and the existing property; and Photograph 4: showing the wider relationship between T5 and the existing property, and the extent of canopy lost through the proposed pruning.

5.2.6 Unlike many other coniferous species, Western red cedar is able to tolerate moderate pruning as it is able to regenerate new growth from pruning wounds. Consequently, the proposed pruning is unlikely to have any significant detrimental impact on the tree's physiological or structural conditions.

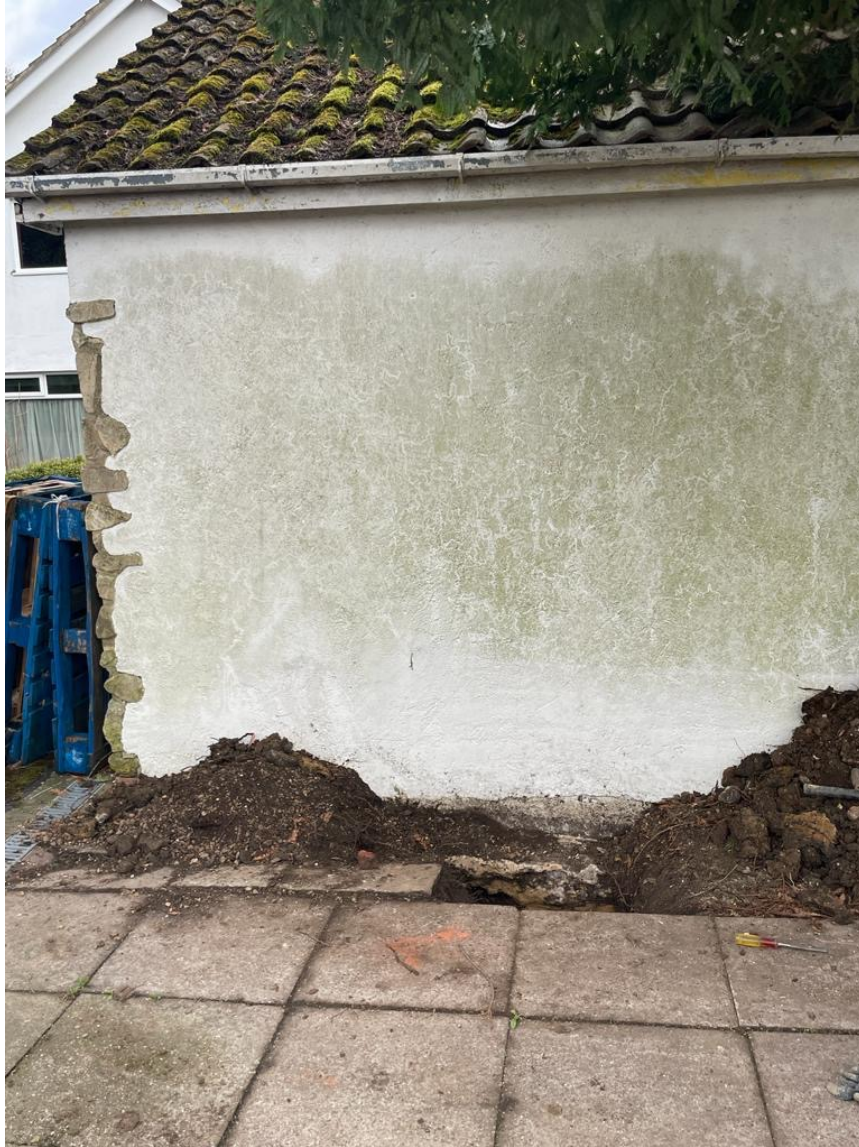
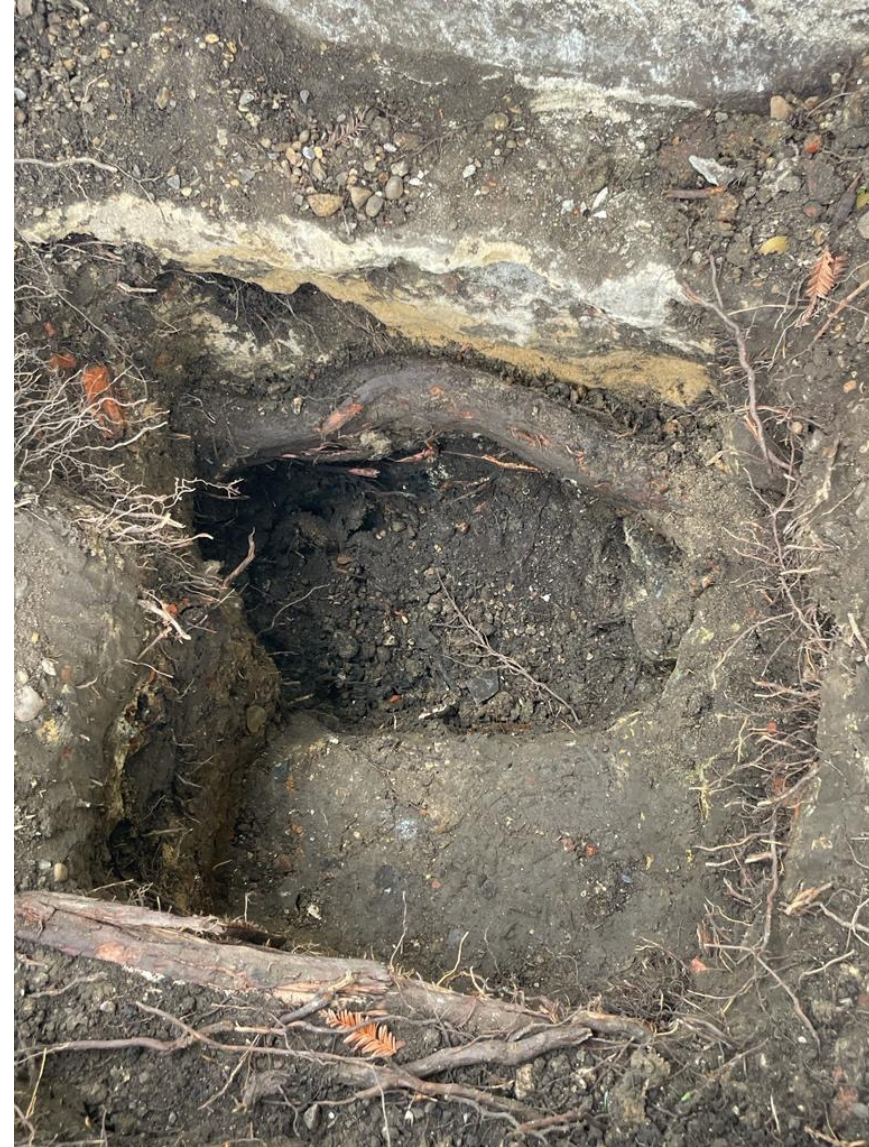
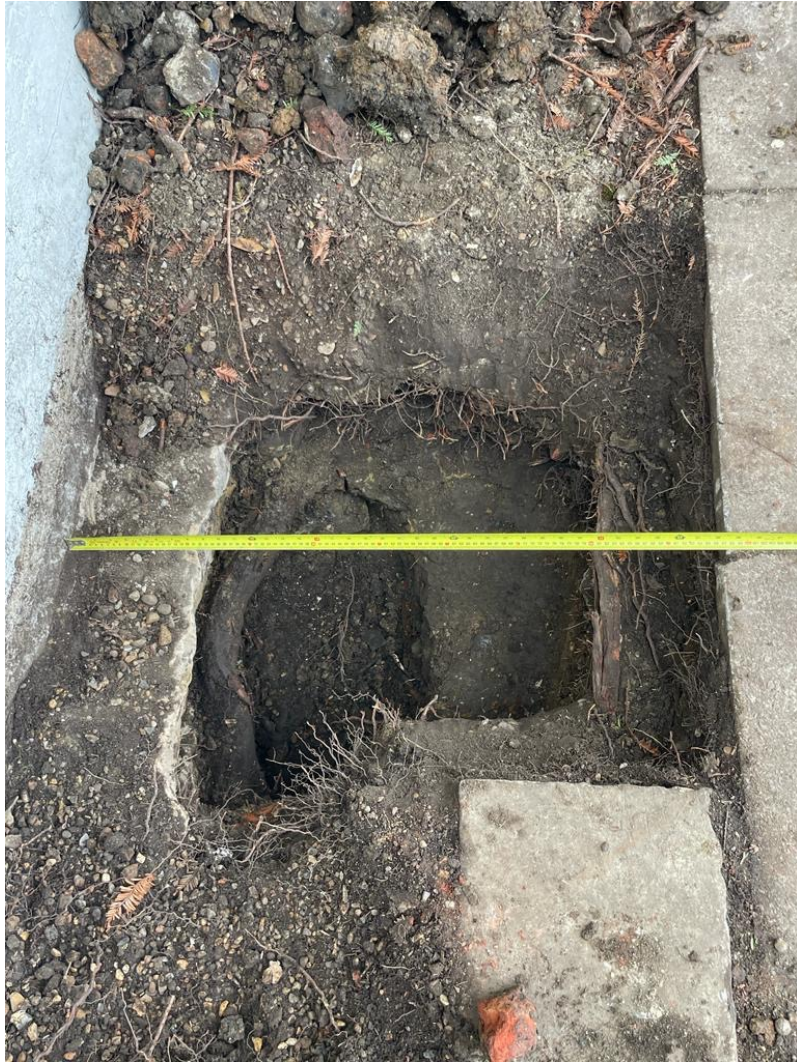
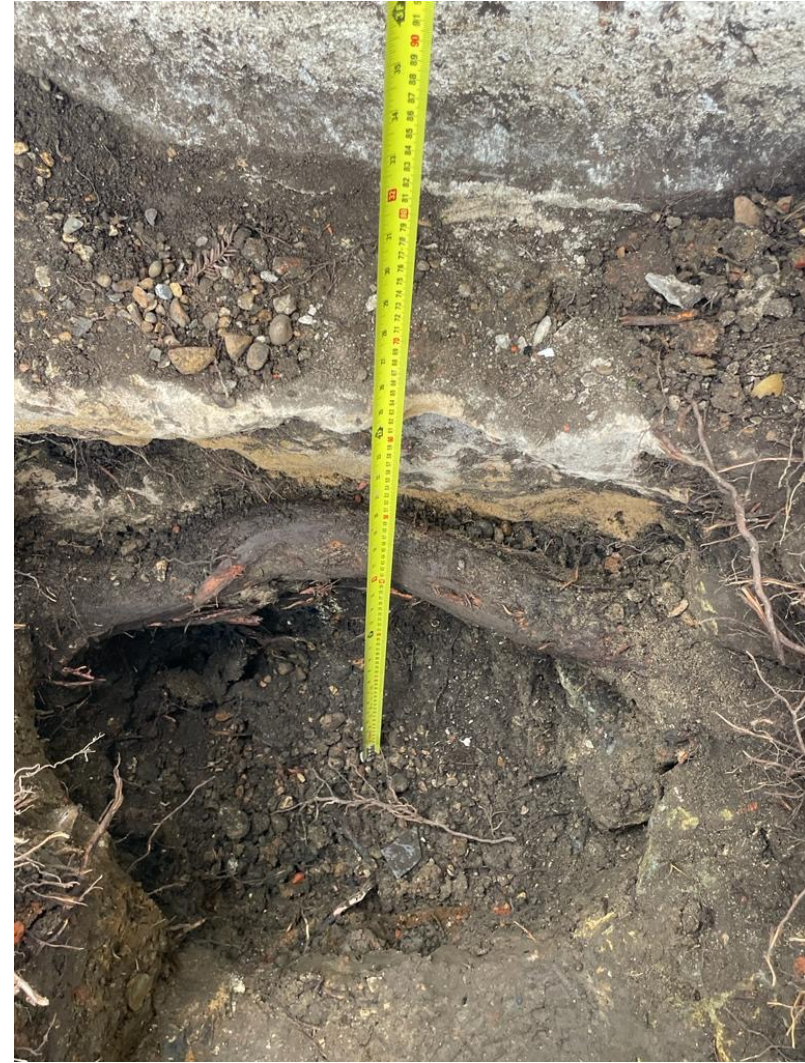
Test hole 1 – To the front of garage (roadside)

5.3.10 'Test hole 1' was located on the southern flank of the existing detached garage, to a depth of circa. 800mm below ground level. This revealed the presence of a large root of circa 80mm diameter extending from south-east to north-west, along the existing foundation. This is suggestive of the significant foundation of the garage causing a physical barrier to root growth to the north, and so it is likely that the majority of the roots of the coast redwood (T4) follow a similar disposition.

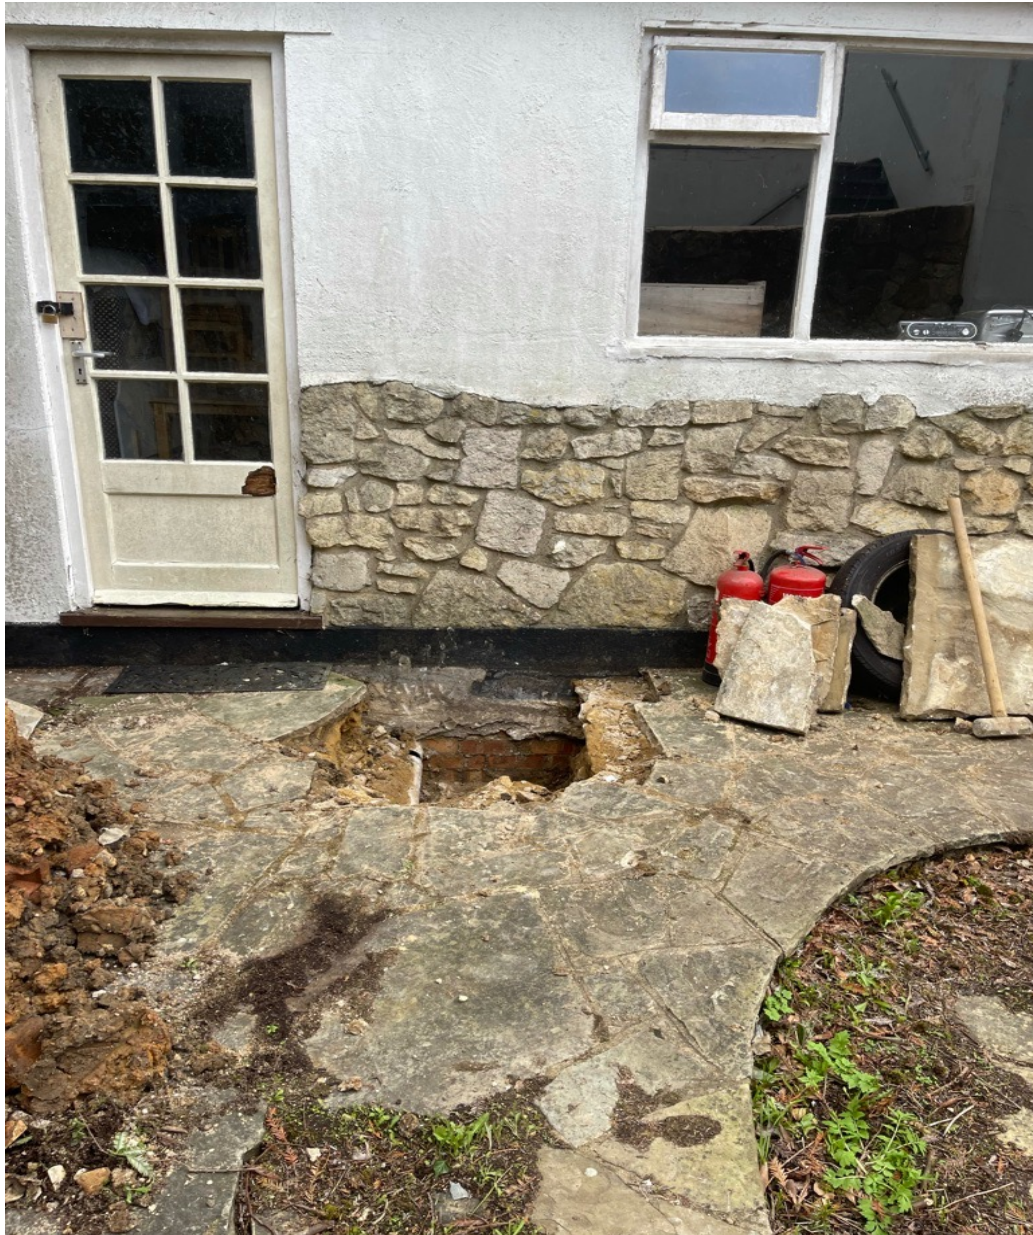
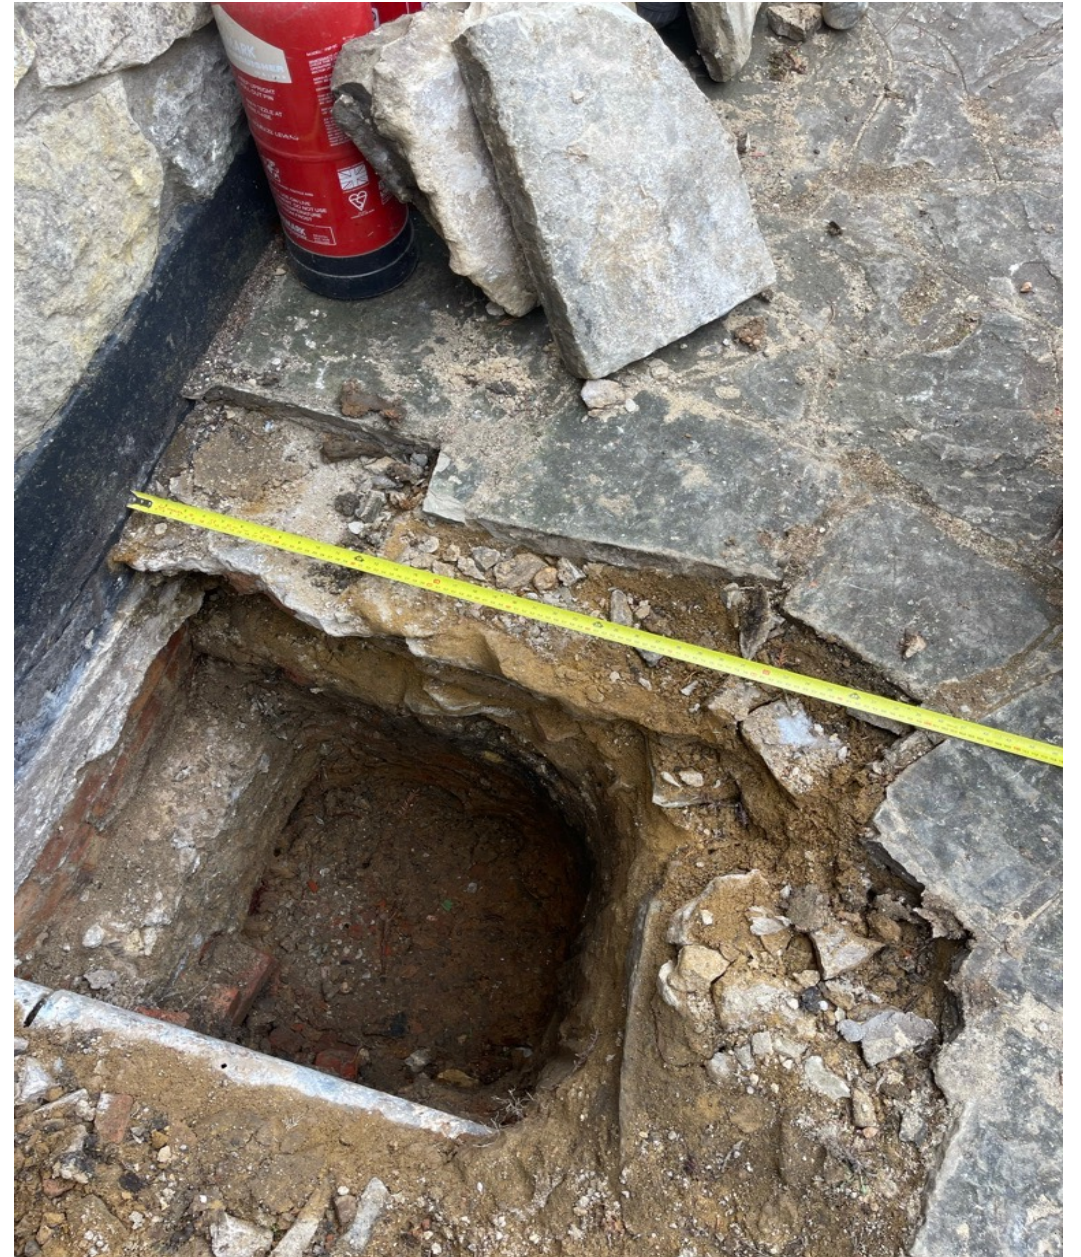
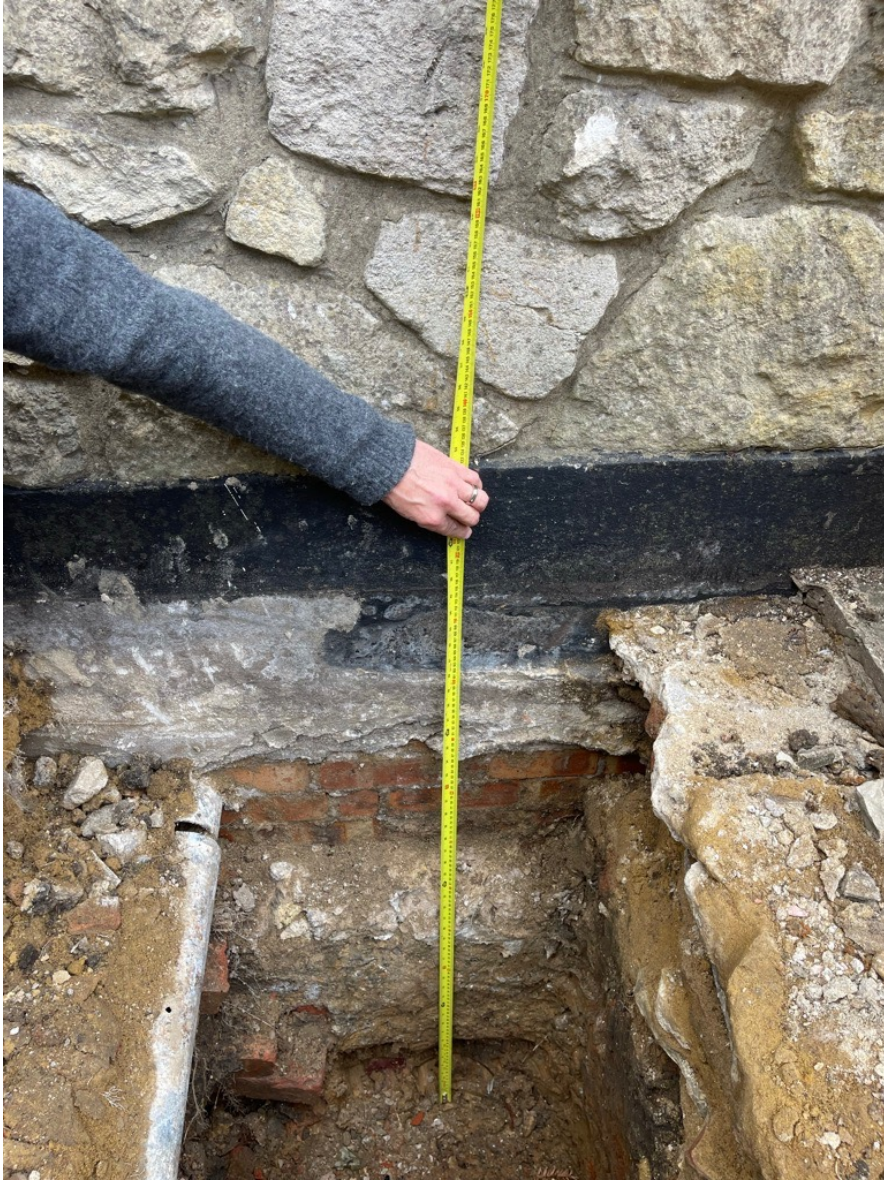
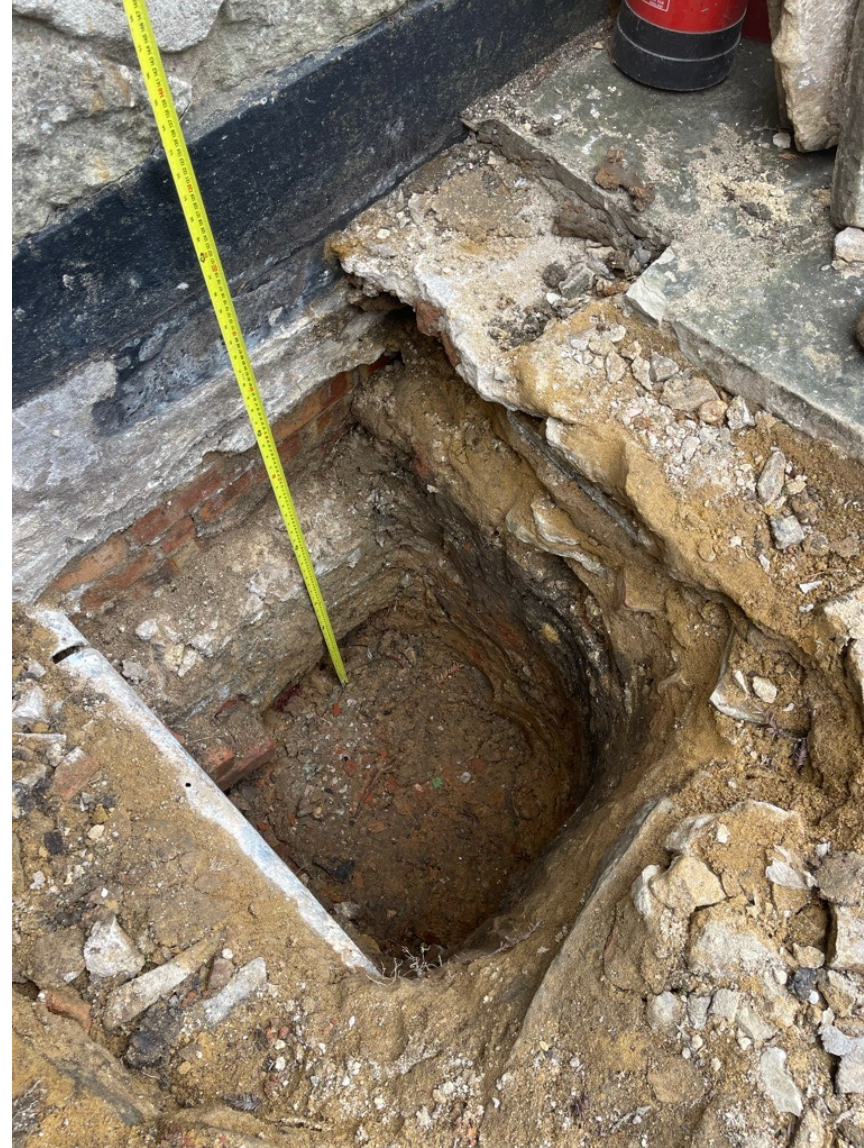
Test hole 2 – To the rear of garage

5.3.11 To quantify this, a second hole ('test hole 2') was carried out on the north side of the garage, to a depth of approximately 900mm below existing ground levels. No significant rooting was observed within this hole, which adds weight to the above notion that root growth has been inhibited beneath the garage by its foundation.

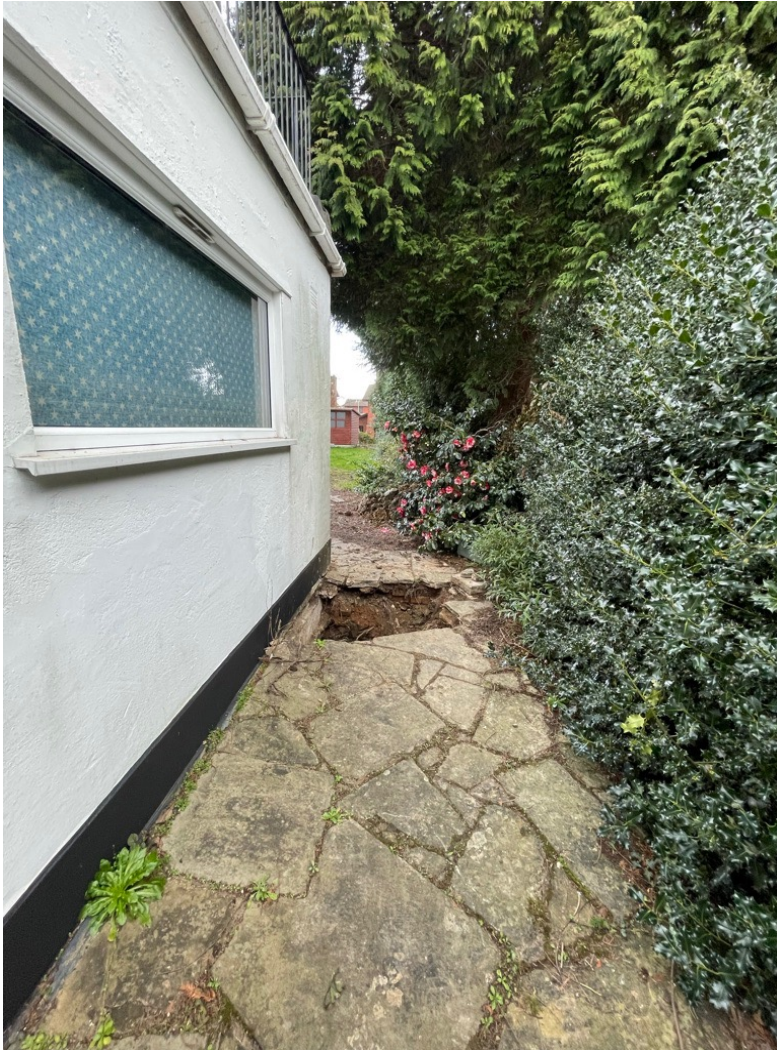
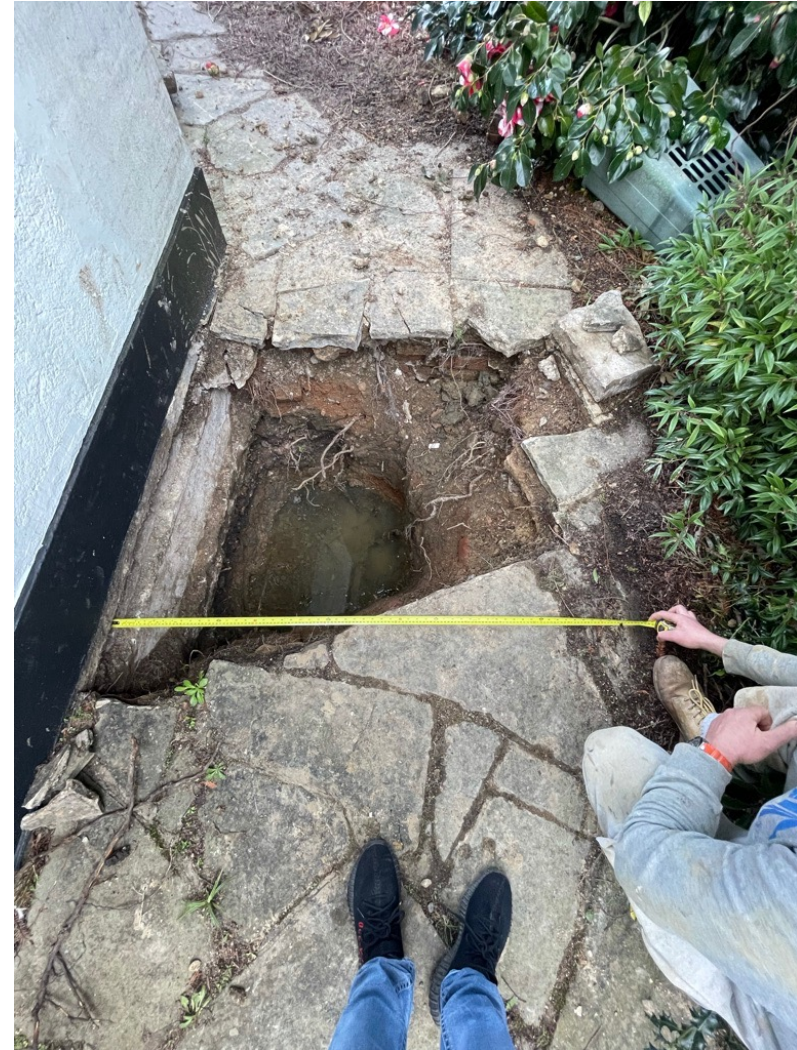
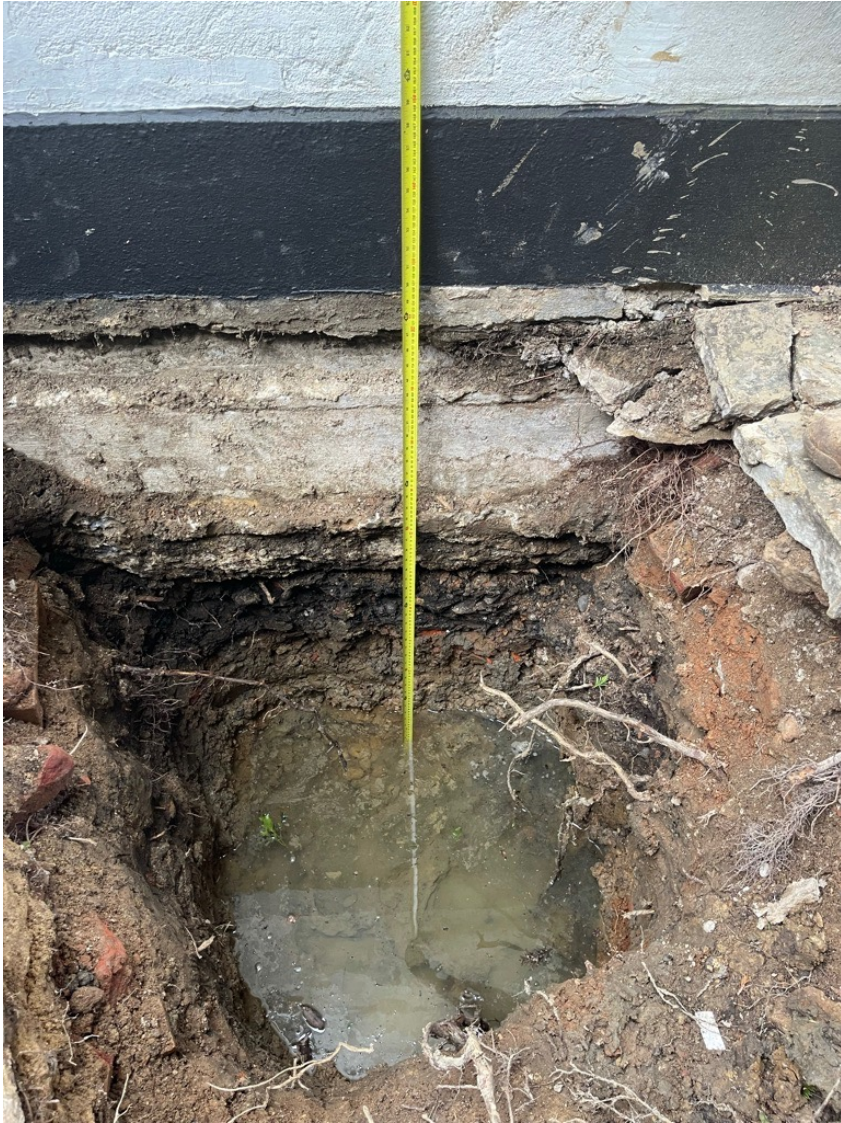
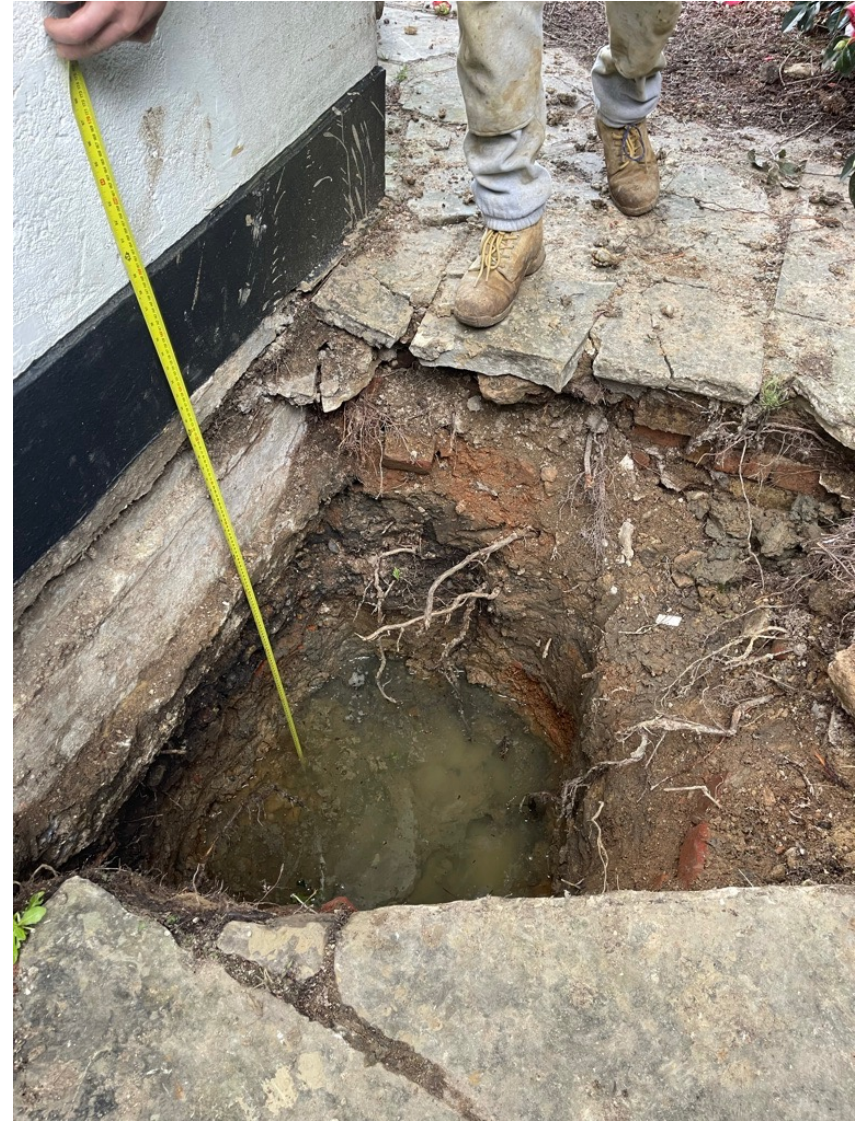
Test hole 3 – To the rear right of house

5.3.12 The final hole ('test hole 3') was located on the south-eastern corner of the existing property, within the RPA of the western red cedar (T5). This revealed a significant foundation of reasonable quality, and the presence of fibrous rooting, as would be expected. However, no significant roots (those being defined as having a diameter of 25mm or more) were encountered.
