The Jam Factory
4 Hollybush Row
Oxford
OX1 1HU
Design and Access Statement

November 2023

Energy Strategy Report

Ref: The Jam Factory, No 4 Hollybush Row, Oxford, OX1 1HU.

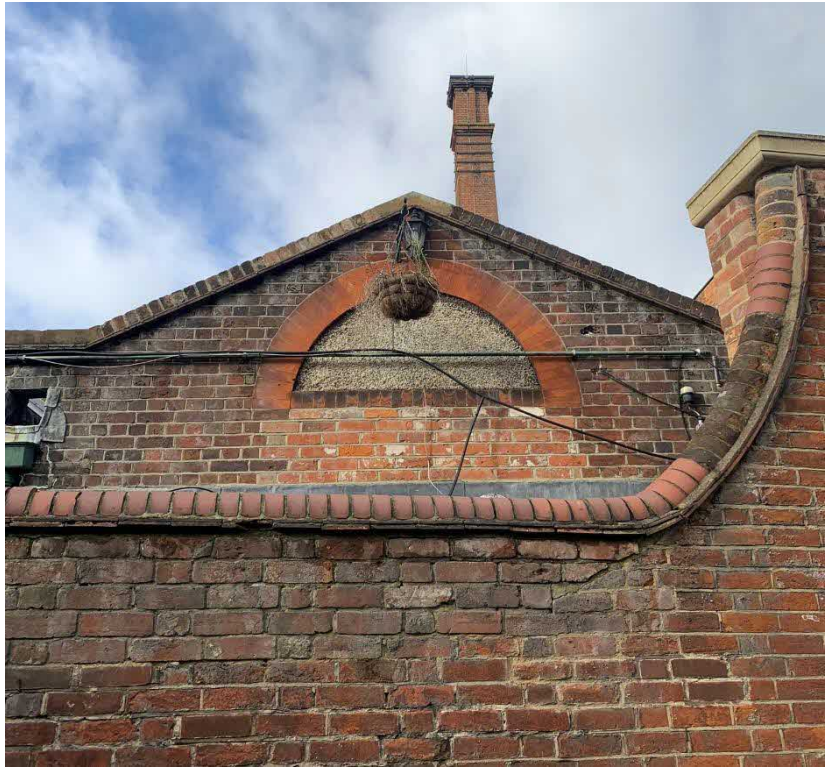
Figure 3 - External brickwork showing later alterations. (Survey Photo)

The visible brickwork is in reasonable condition and has had some changes/ additions made over time, including a small infill extension, expected to have been built in the 70/80s.

The proposed replacement of the roof membrane with slates restores the originality of the building and ensures that all the pitched roof areas match in materiality. Where later openings have been be cut into external brickwork, a brick of similar colour or size will be used to repair these areas.

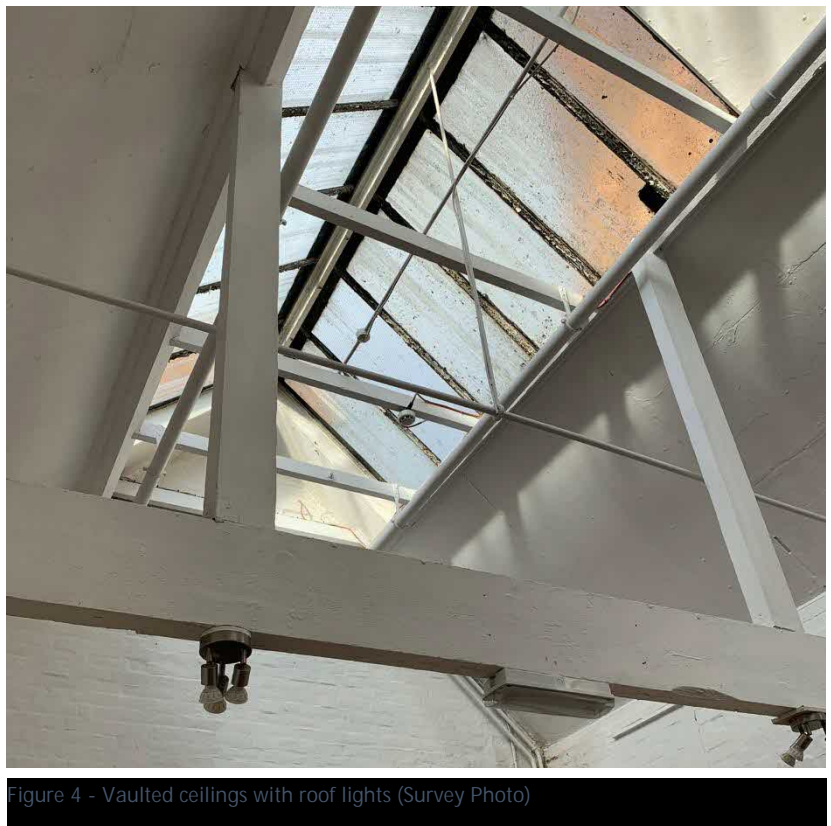
Figure 4 - Vaulted ceilings with roof lights (Survey Photo)

The majority of the roof is vaulted with exposed roof supports, bar the extension which has a flat roof.

The roof has significant areas of skylights, with the majority being single glazed.

The existing rooflights will be replaced or refurbished. This will enhance the buildings appearance by replacing unsympathetic modern rooflights with units to match the originals. Where replaced this will be with double glazing.

New flues for the coffee roasters will be installed. These will be routed through a roof light to avoid cutting to the timber clad vaulted ceiling.

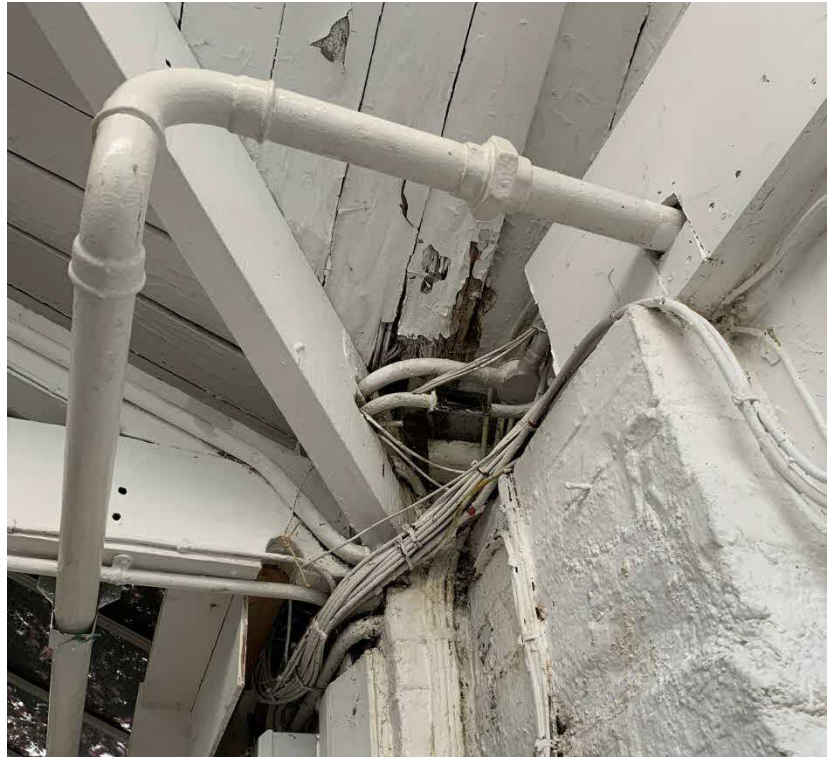
The existing buildings are mostly single storey and predominantly built of brick, with a mixture of pitched and flat roofs. Owing to the growth of the site over several decades, there is little coherence to either the interior or exterior of the building, with many later changes eroding its historical significance. Prominent features within the existing building include the vaulted ceilings with exposed structure and extensive roof lights. Although the condition of the building is generally good, a lack of maintenance has resulted in deterioration, most notably as a result of water ingress.

Figure 5 - Evidence of water ingress (Survey Photo)

There is evidence of leaks from the roof in three areas to the front of the building, and two areas to the rear. One area appears to have had leaking for some time as the boarding is quite rotten.

The existing roof membrane will be replaced with slates to match the rest of the existing roof. This will prevent further water ingress and improve the roofscape of the conservation area by utilising traditional materials and methods. When renovating the roof, the opportunity will be used to insulate the building and improve its energy efficiency. These works will also prevent further water ingress and reduce the need for costly maintenance in the future.
