Arboricultural Method Statement to BS5837:2012

M&D Properties Investment Ltd

**Marian Court,
Robin Hood Lane,
Sutton,
SM1 2SB**

08 December 2023

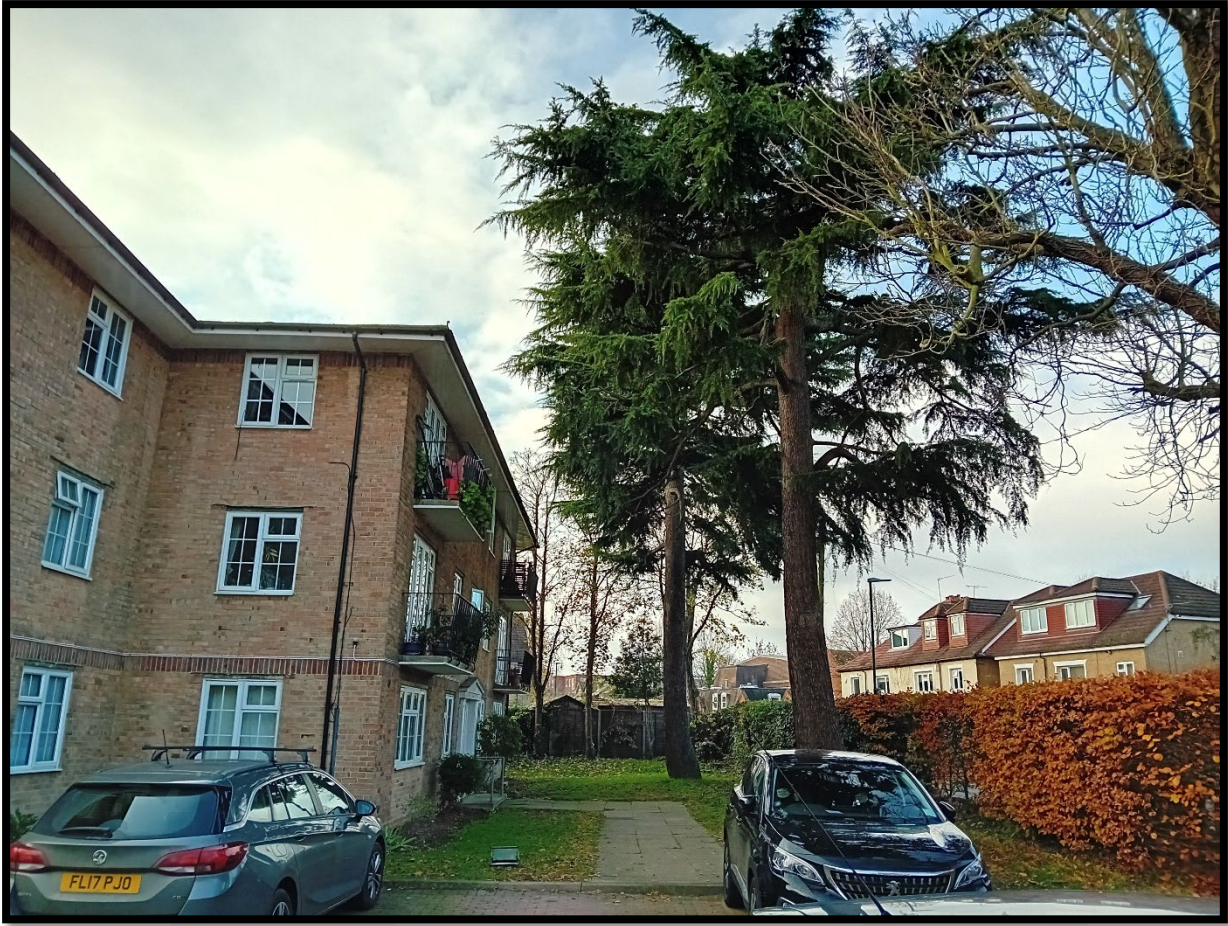
The aerial imagery in Figures 5 and 6 demonstrate the rate of growth between 2017 and 2021 to be minor, with Figure 2 taken during the Arbtech site visit in 2023 to demonstrate that the canopy is still not in contact with the building. Therefore, a prescribed pruning cycle of 5 years would be considered appropriate to maintain a suitable crown clearance of the building. As such, there is no obvious reason why the growth rate and resulting pruning requirements would significantly change as a result of the extension and thereby not introduce any new impact to the character of the area or introduce impacts to the long-term vitality of the trees.

Figure 2: Photograph of the crowns in relation to the existing building (Photograph - Arbtech 2023).

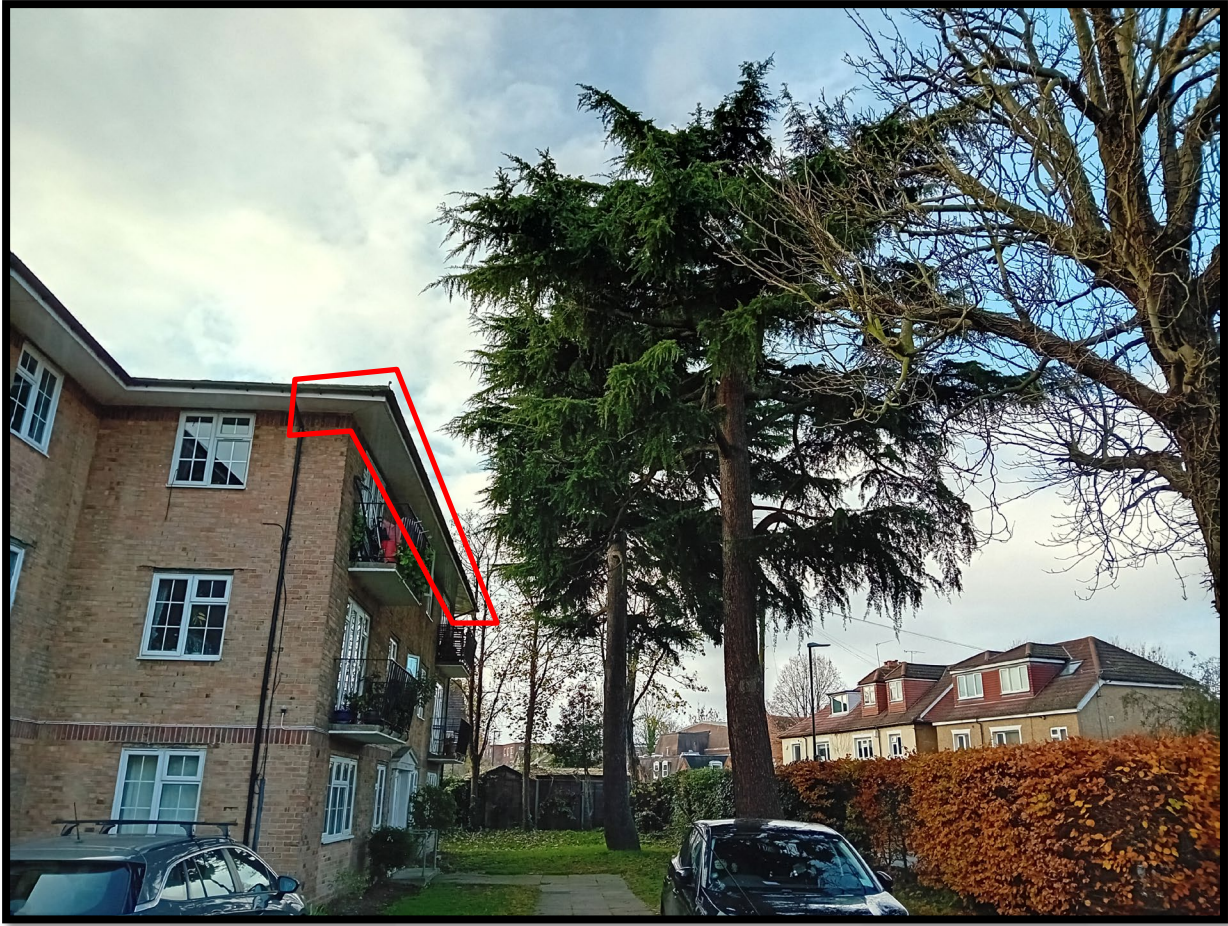
The existing building is three-storeys tall with a pitched roof and overhanging eaves. The proposal seeks to remove the eaves, which will pull the envelope of the building further away from the trees by 0.5 – 0.75m (Figure 3 and AIA plan). The pitched roof is to be removed and replaced with a mansard style roof, increasing the ridge height by 1.5m in total.

Figure 3: Photograph of the crowns in relation to the existing building, with the eaves to be removed highlighted in red (Photograph - Arbtech 2023).

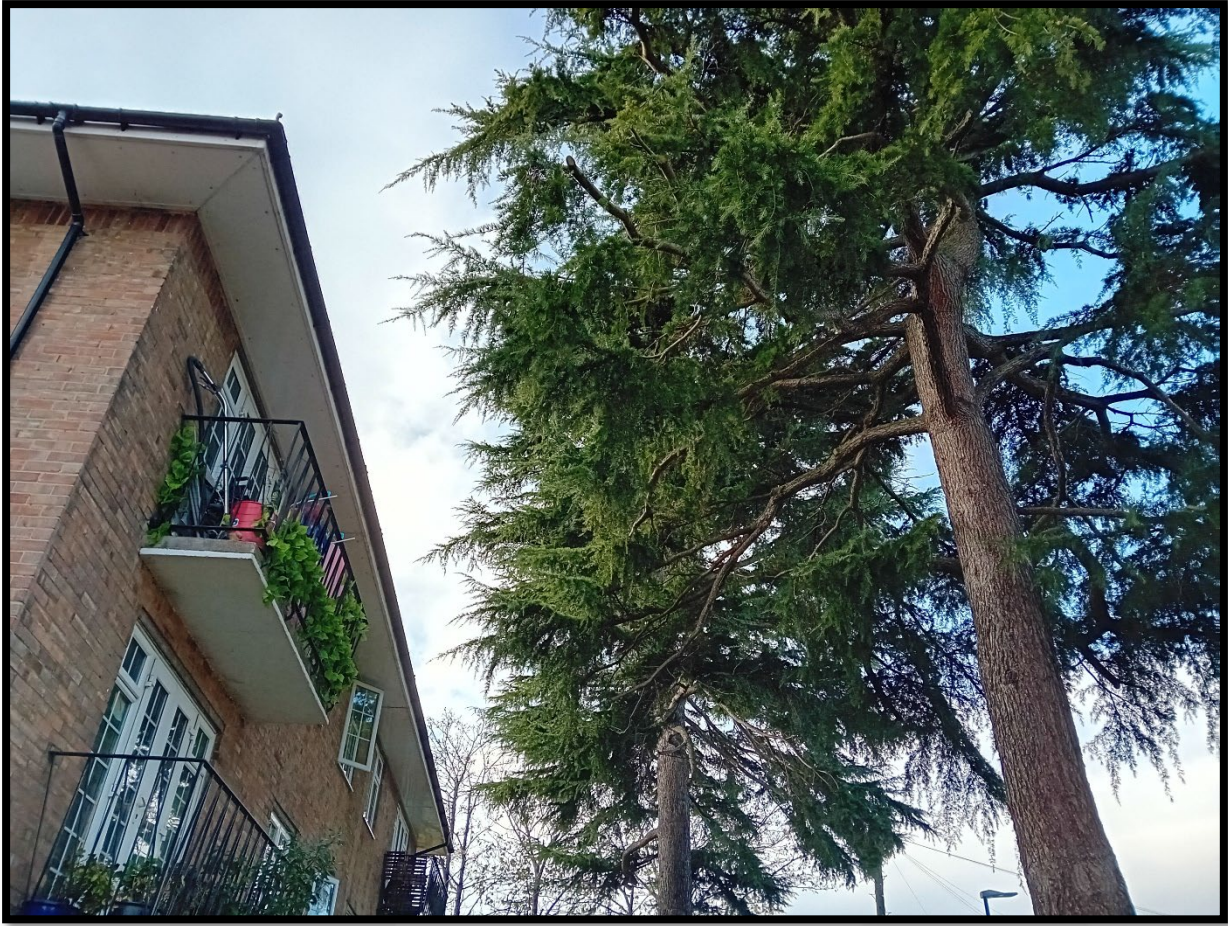
Figure 4 demonstrates that the next pruning regime would only require the pruning of tertiary branches to achieve the required clearance. No pruning above 13m above ground level will be required, allowing the upper canopy to remain untouched.

Figure 4: Photograph of the regrowth following the previous pruning cycle. The pruning cuts are clearly visible, with only minor regrowth beyond.

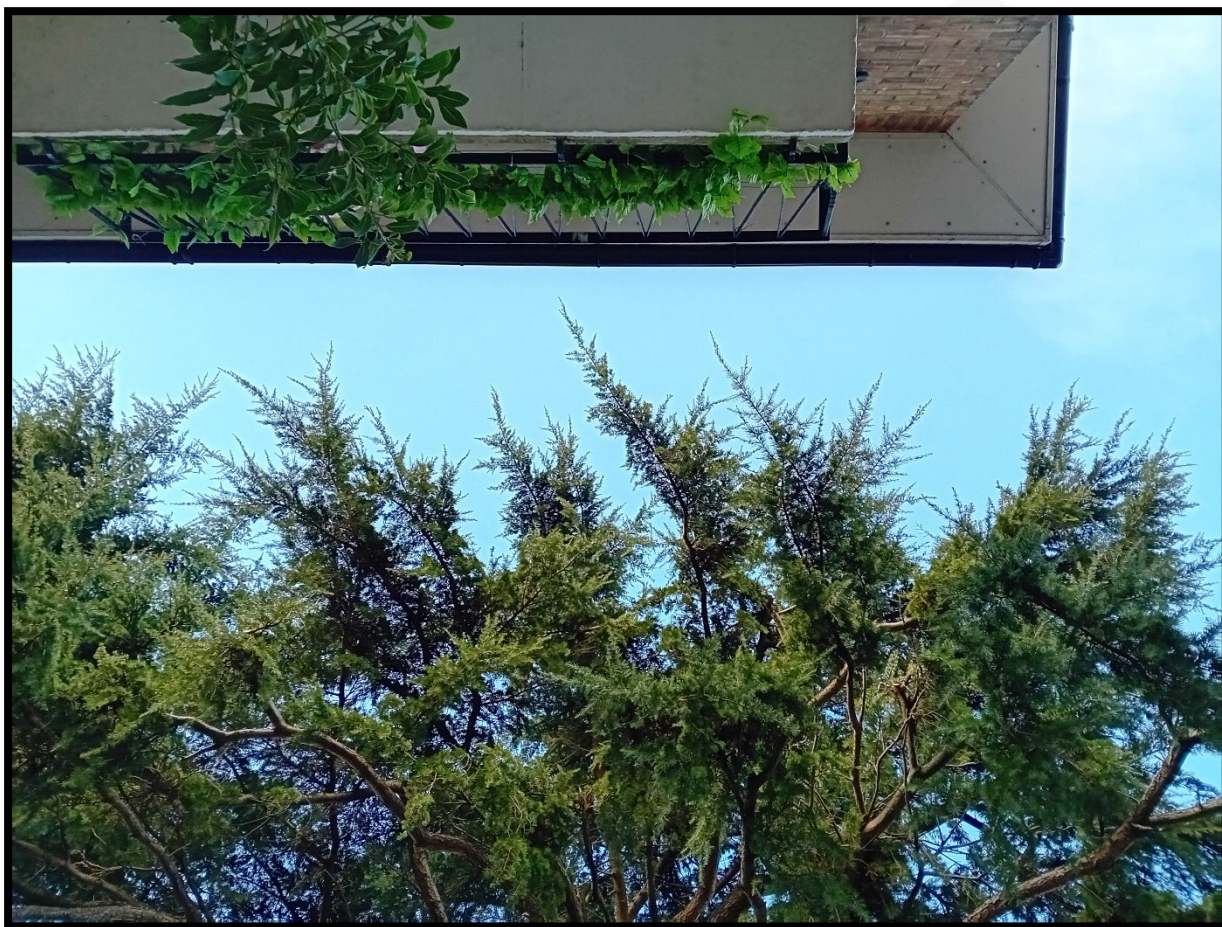
In order to carry out the works, scaffolding will be required around the perimeter of the existing building. Whilst the crowns are not currently in contact with the building, some minor access facilitation pruning may be required. As the branches that fall within the scaffolding area are minor, it is likely that most (particularly the lower branches) can be retained as they will not interfere with the works to the roof area. Any pruning that is deemed necessary will be limited to the tertiary order branches as visible in Figures 4, 7 and 8.

Figure 7: Photograph to demonstrate the current clearance of tree T06 (December 2023)

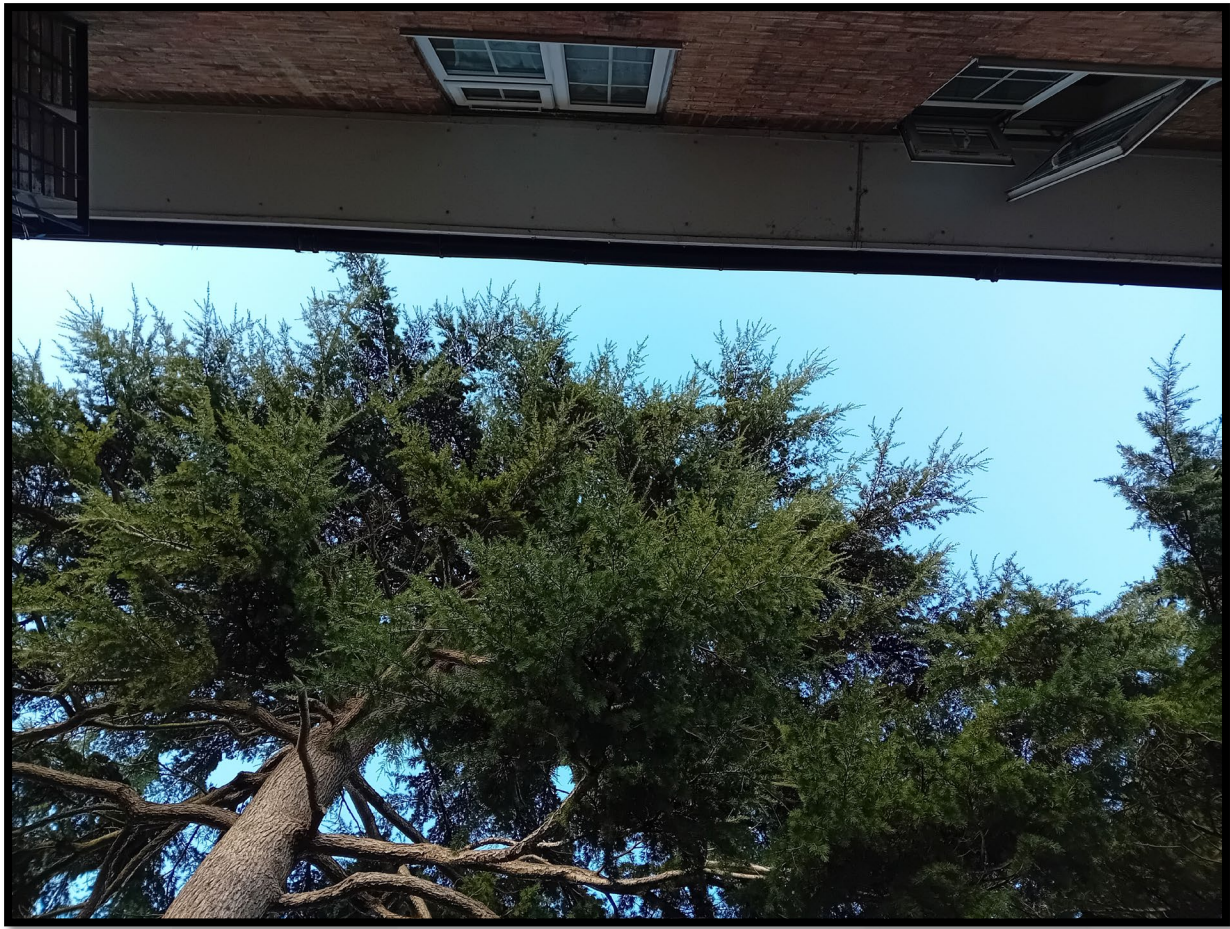
Figure 8: Photograph to demonstrate the current clearance of tree T05 (December 2023), with only 1 minor branch overhanging the roof.
