NOCTUA
ECOLOGY

Bat and Bird Assessment

Ruslin Farm, Butcombe

12th December 2023

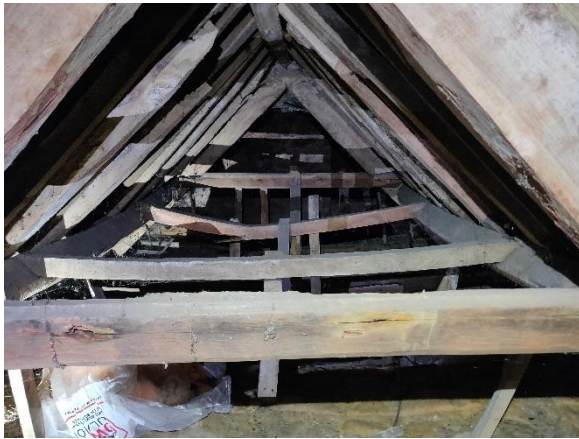
Photo 3. The south-western roof void of the Farmhouse.

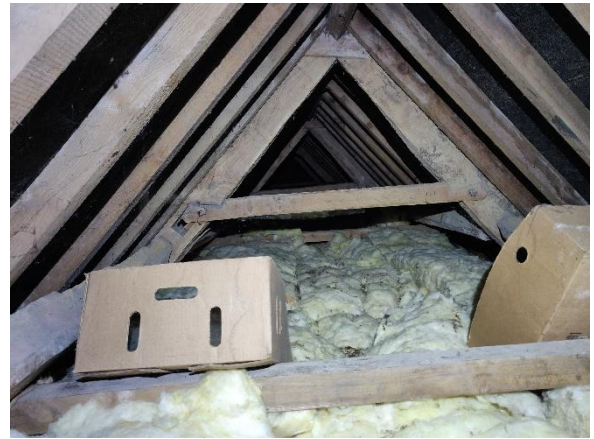
- 3.4.3 The south-eastern roof void of the Farmhouse was inaccessible owing to a very small access hatch in an awkward location which was sealed shut by paint. In addition, the northern roof void was only accessed from the access hatch, the combination of small height and thick layers of insulation made it unsafe to access fully. This was not considered to be a major constraint given the extensive survey effort over recent years, and that access was possible into the other roof void within the Farmhouse.

Photo 4. The northern roof void of the Farmhouse.

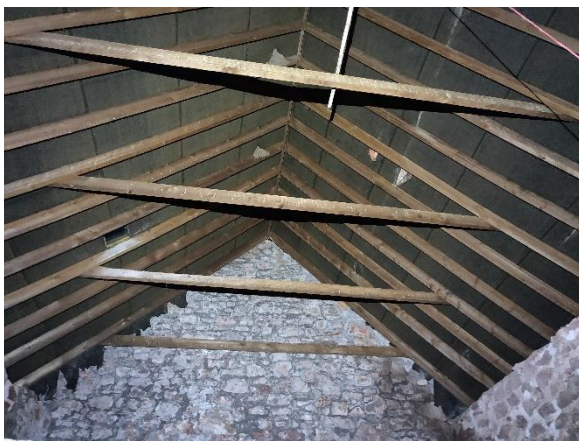
Photo 9. An internal view of the Main Barn.

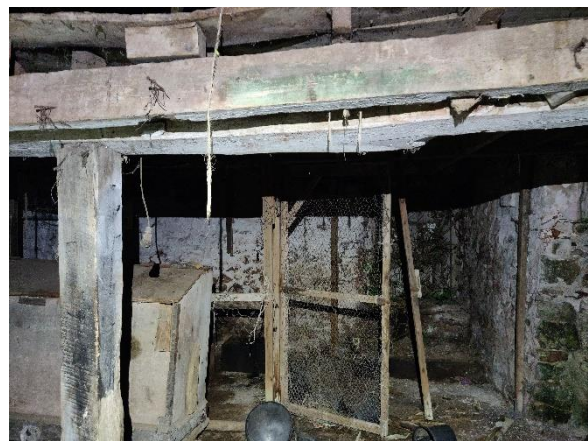
- 3.4.4 The first-floor areas of the Main Barn were constructed with deteriorating timbers which were considered unsafe to access. As such, these areas were assessed from the edge of the floors by ladder and using binoculars only. This was not considered to be a major constraint given that bat evidence could clearly be seen using this method.

Photo 10. An internal view of the Main Barn showing the floor and northern platform area.

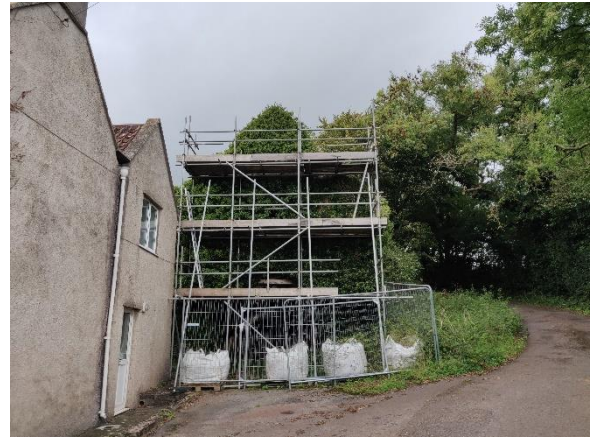
- 3.4.5 The Wagon House was in a state of disrepair and considered unsafe to access. As such, an assessment was undertaken externally, and from the open southern elevation only. This was not considered to be a major constraint given the extensive survey effort over recent years.

Photo 16. The southern elevation of the Wagon House.

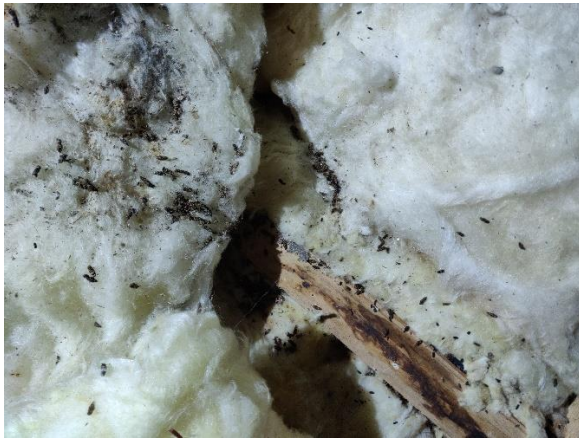
Photo 19. The cluster of brown long-eared bat droppings within the south-western roof void of the Farmhouse.

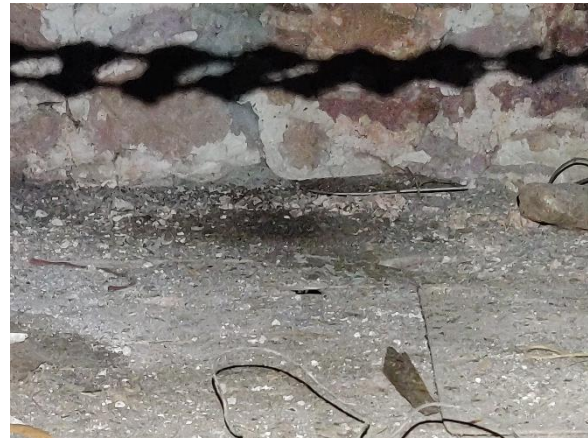
Photo 20. The large cluster of lesser horseshoe bat droppings within the northern portion of the Main Barn.

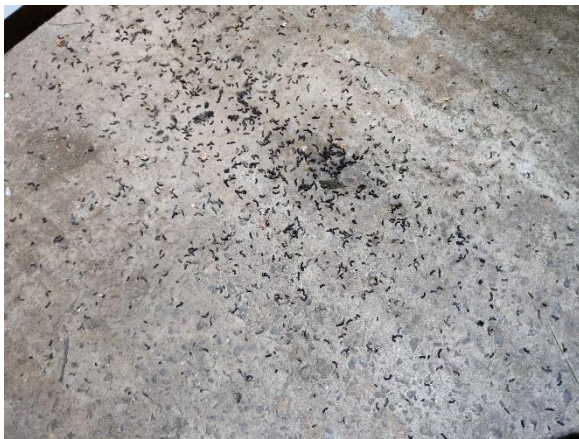
Photo 21. The cluster of lesser horseshoe bat droppings and insect feeding remains within the ground floor southern room.

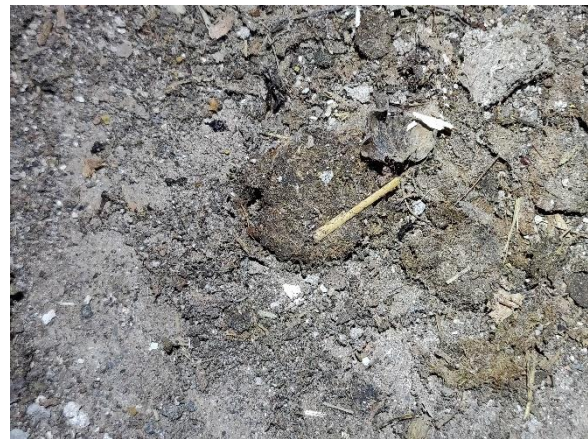
Photo 22. The scattering of lesser horseshoe bat and brown long-eared bat droppings within the Single Storey Barns.

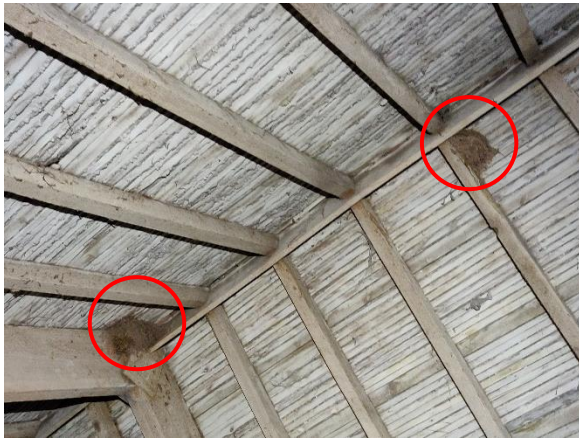
4.6.1 The preliminary bird assessment survey identified many inactive barn swallow (*Hirundo rustica*) nests within the Main Barn and Single Storey Barns (Photo 23, Figure 2). It was considered likely that the Wagon House also supported nesting barn swallow. In addition, all of the buildings within the site contained crevices, cavities, and ledges which could support nests of other bird species capable of nesting within buildings.

Photo 23. Two inactive barn swallow nests located within the Single Storey Barns.

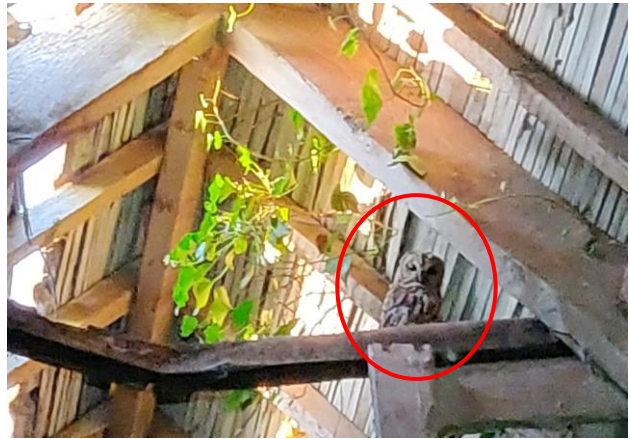
4.6.2 The surveys on the 24th August 2023 and 25th September 2023 also identified a roosting tawny owl (*Strix aluco*) within the Wagon House (Photo 24, Figure 2).

Photo 24. The tawny owl roosting within the Wagon House on the 24th August 2023.
