## Supporting document

Planning Application

Online Application Number: 100657196

Old West Manse, 2 Henderson Place, Dollar, FK14 7EZ

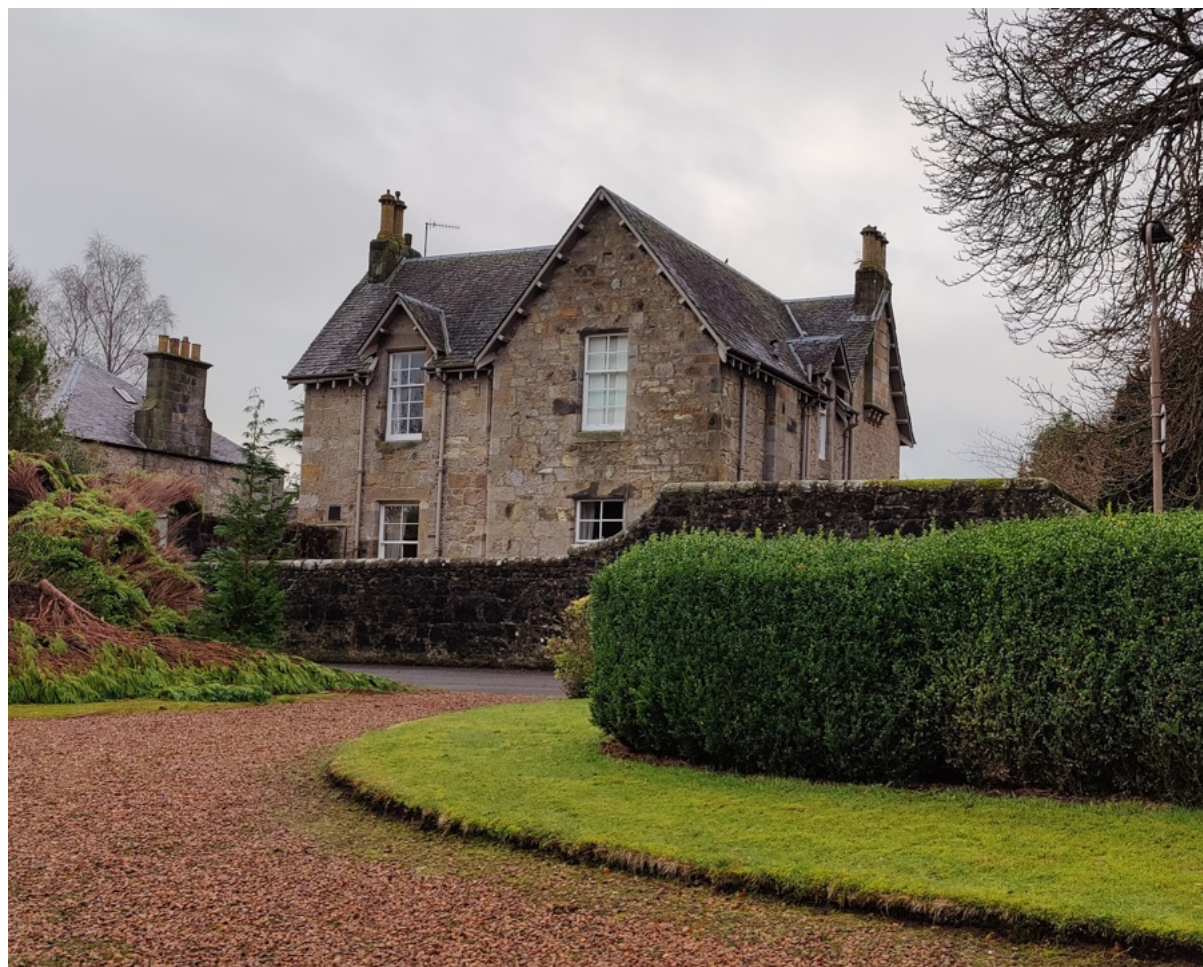
View of the property from Dollar Memorial Gardens.

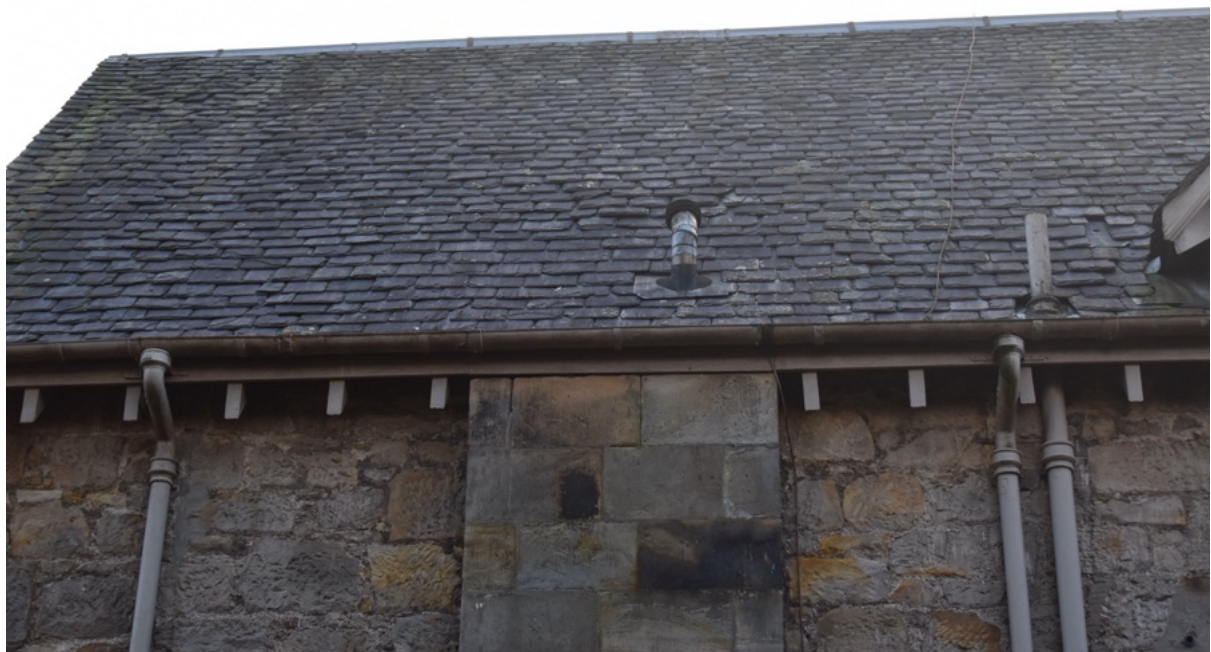
**1. North facing elevation.**

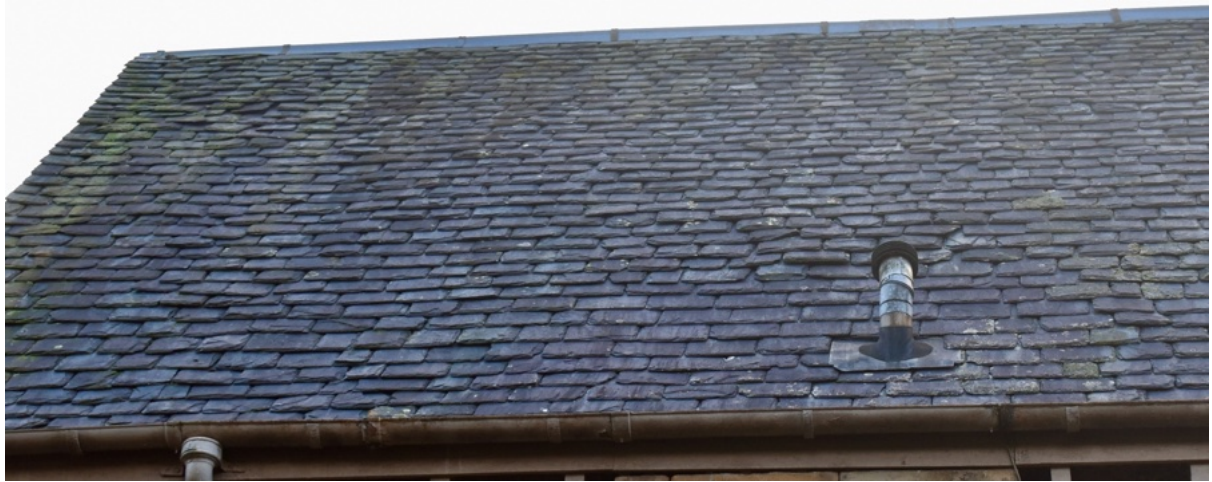
**2. Close-up. North facing elevation.**

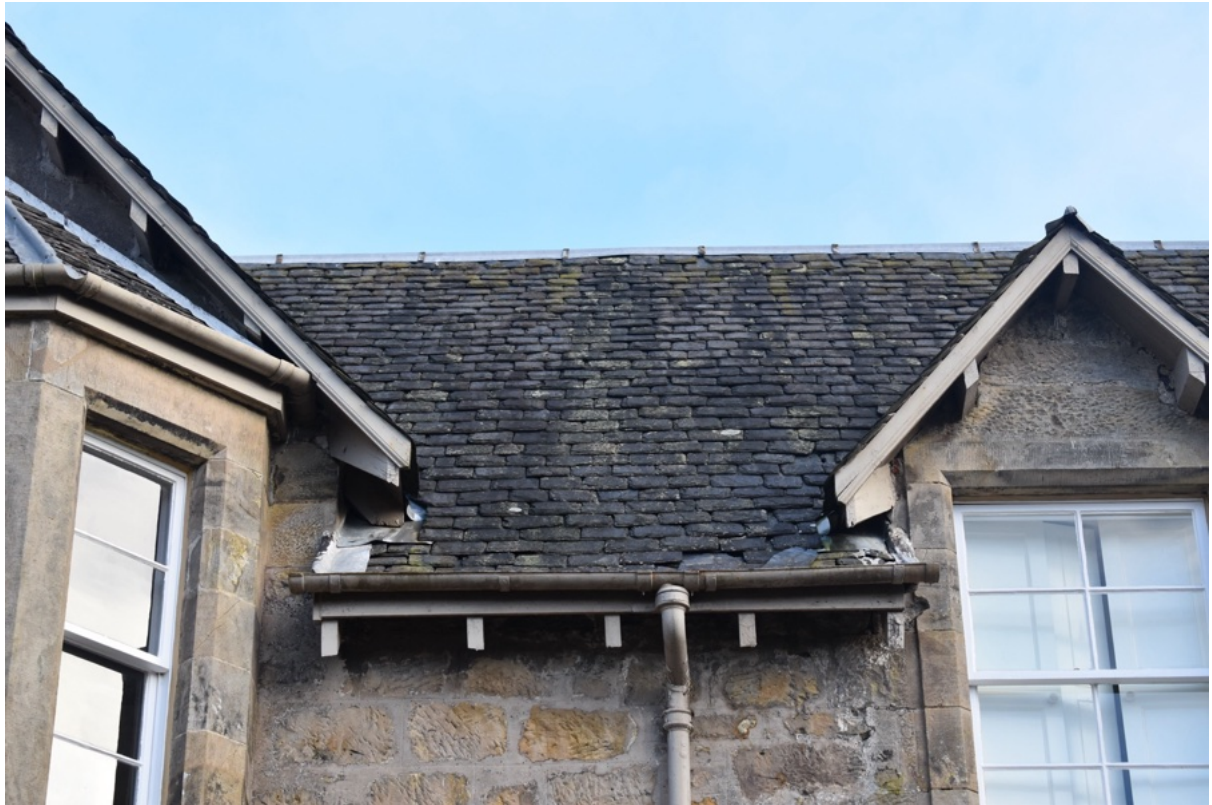
**3. West facing elevation.**

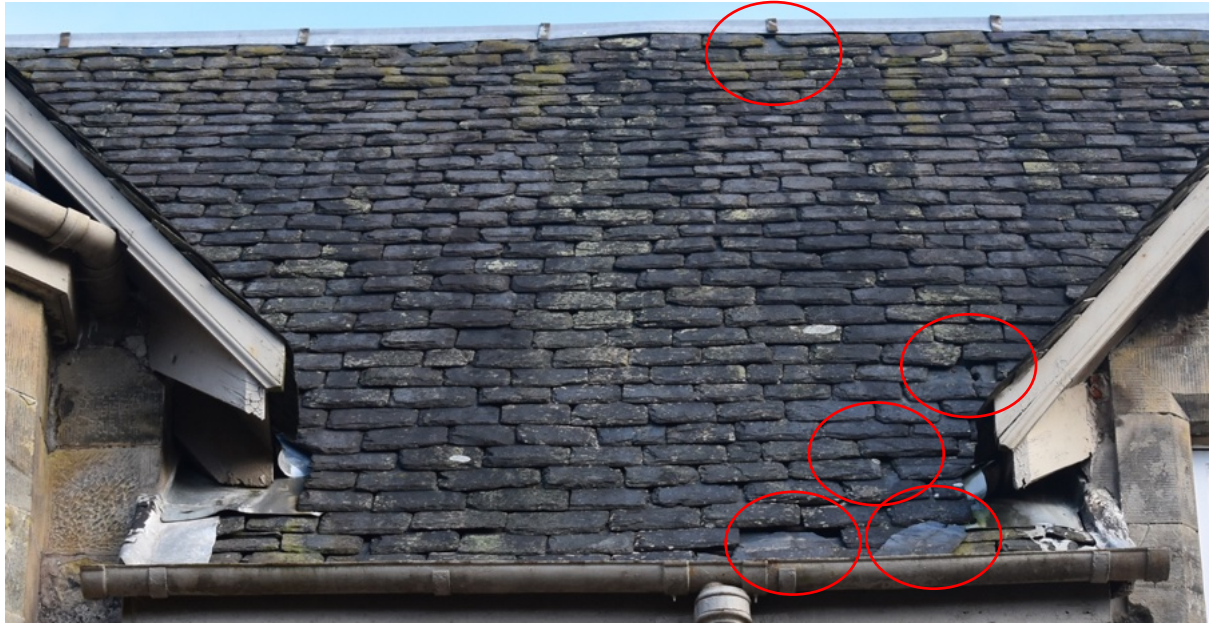
**4. West facing elevation. Close-up view**

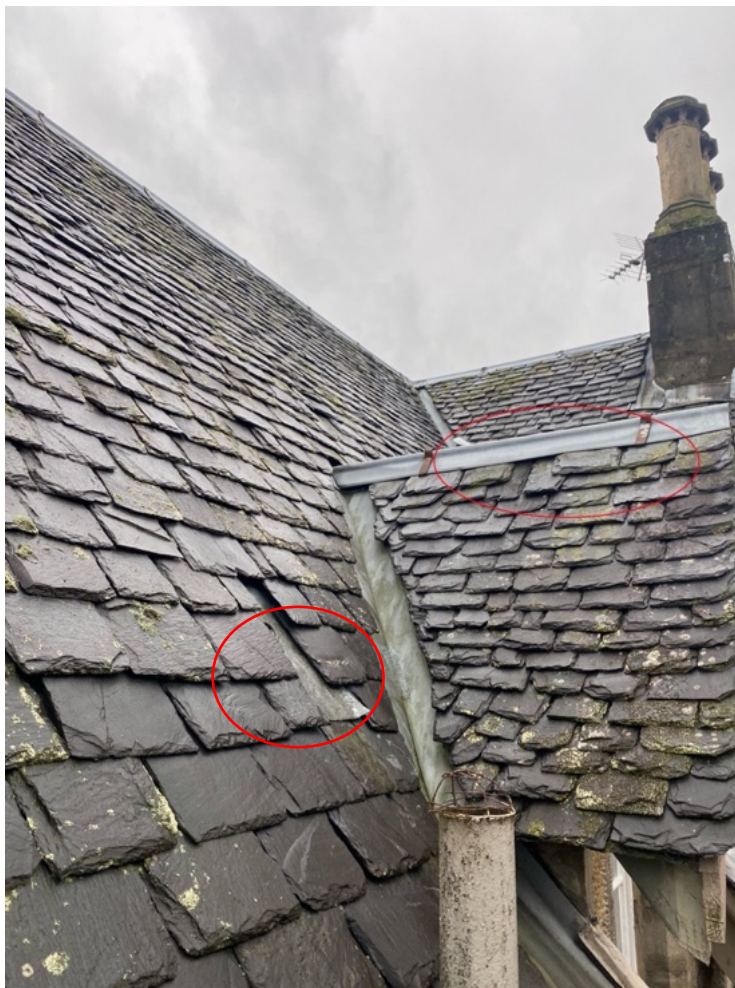
**5. Rear. West facing elevation.**

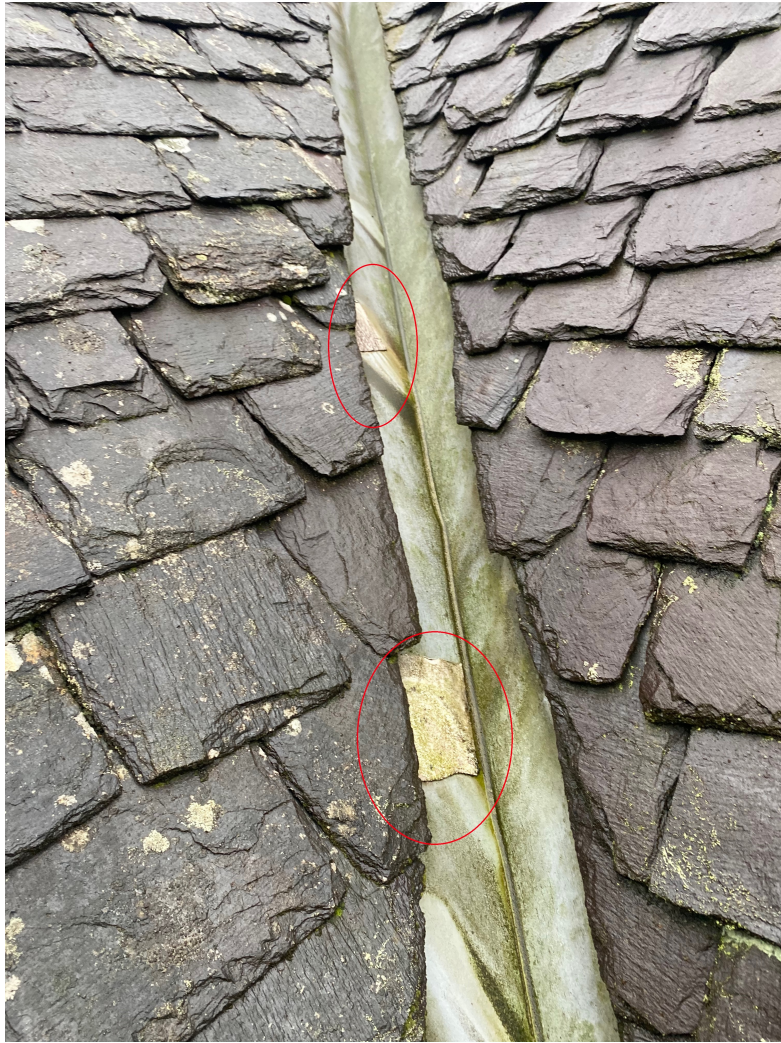
**6. Rear. West facing elevation. Damaged lead work**

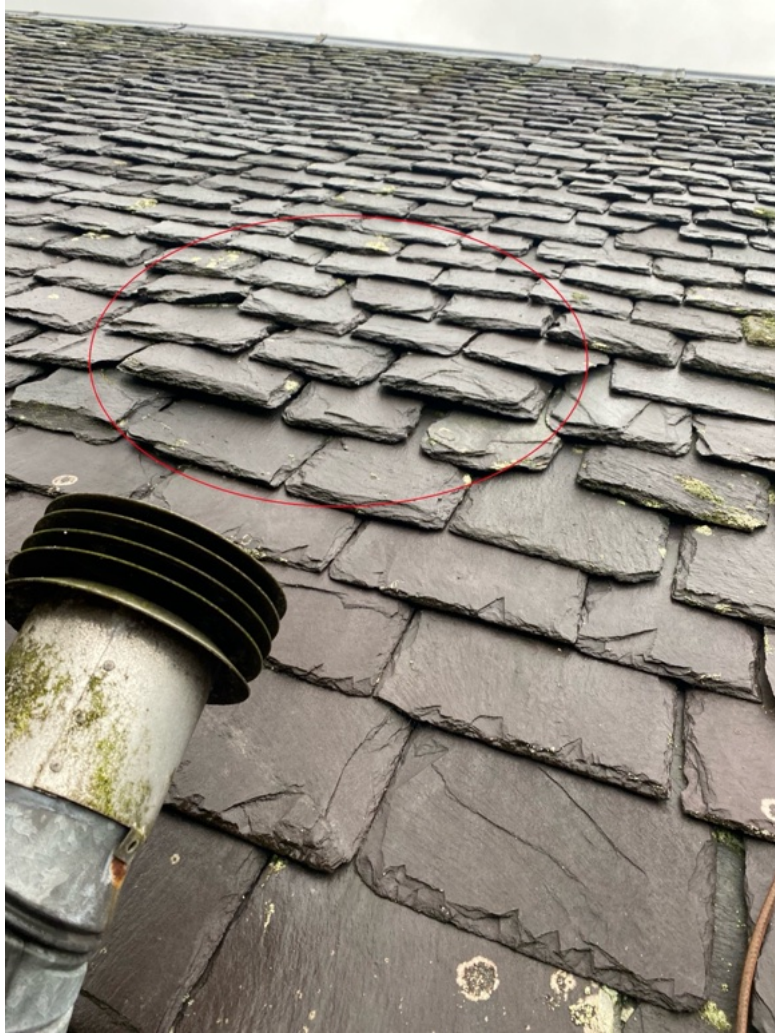
**7. North facing elevation. Illustrative roof state.**

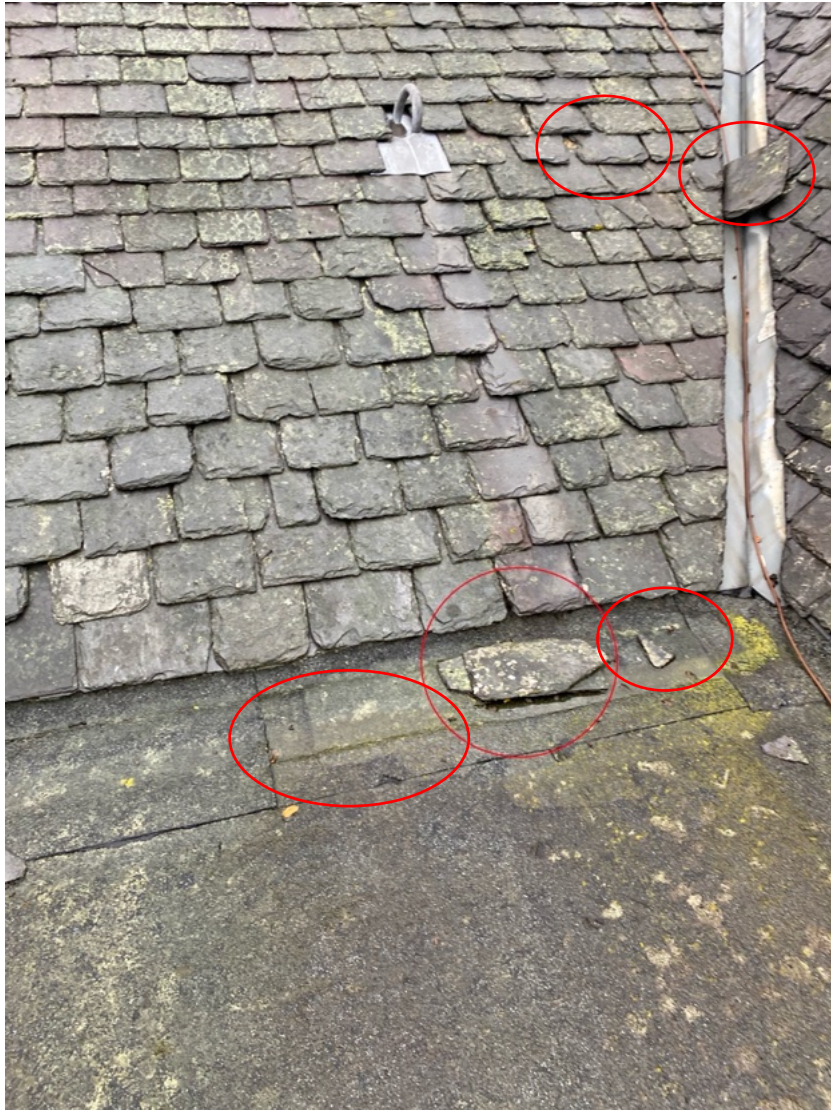
**8. Roof valley. Damage at former repair site.**
