Arboricultural Impact Assessment:

Lark House
Cornsay
Durham
DH7 9EP

Report Ref: Wakefields_LarkHouse_AIA1.1

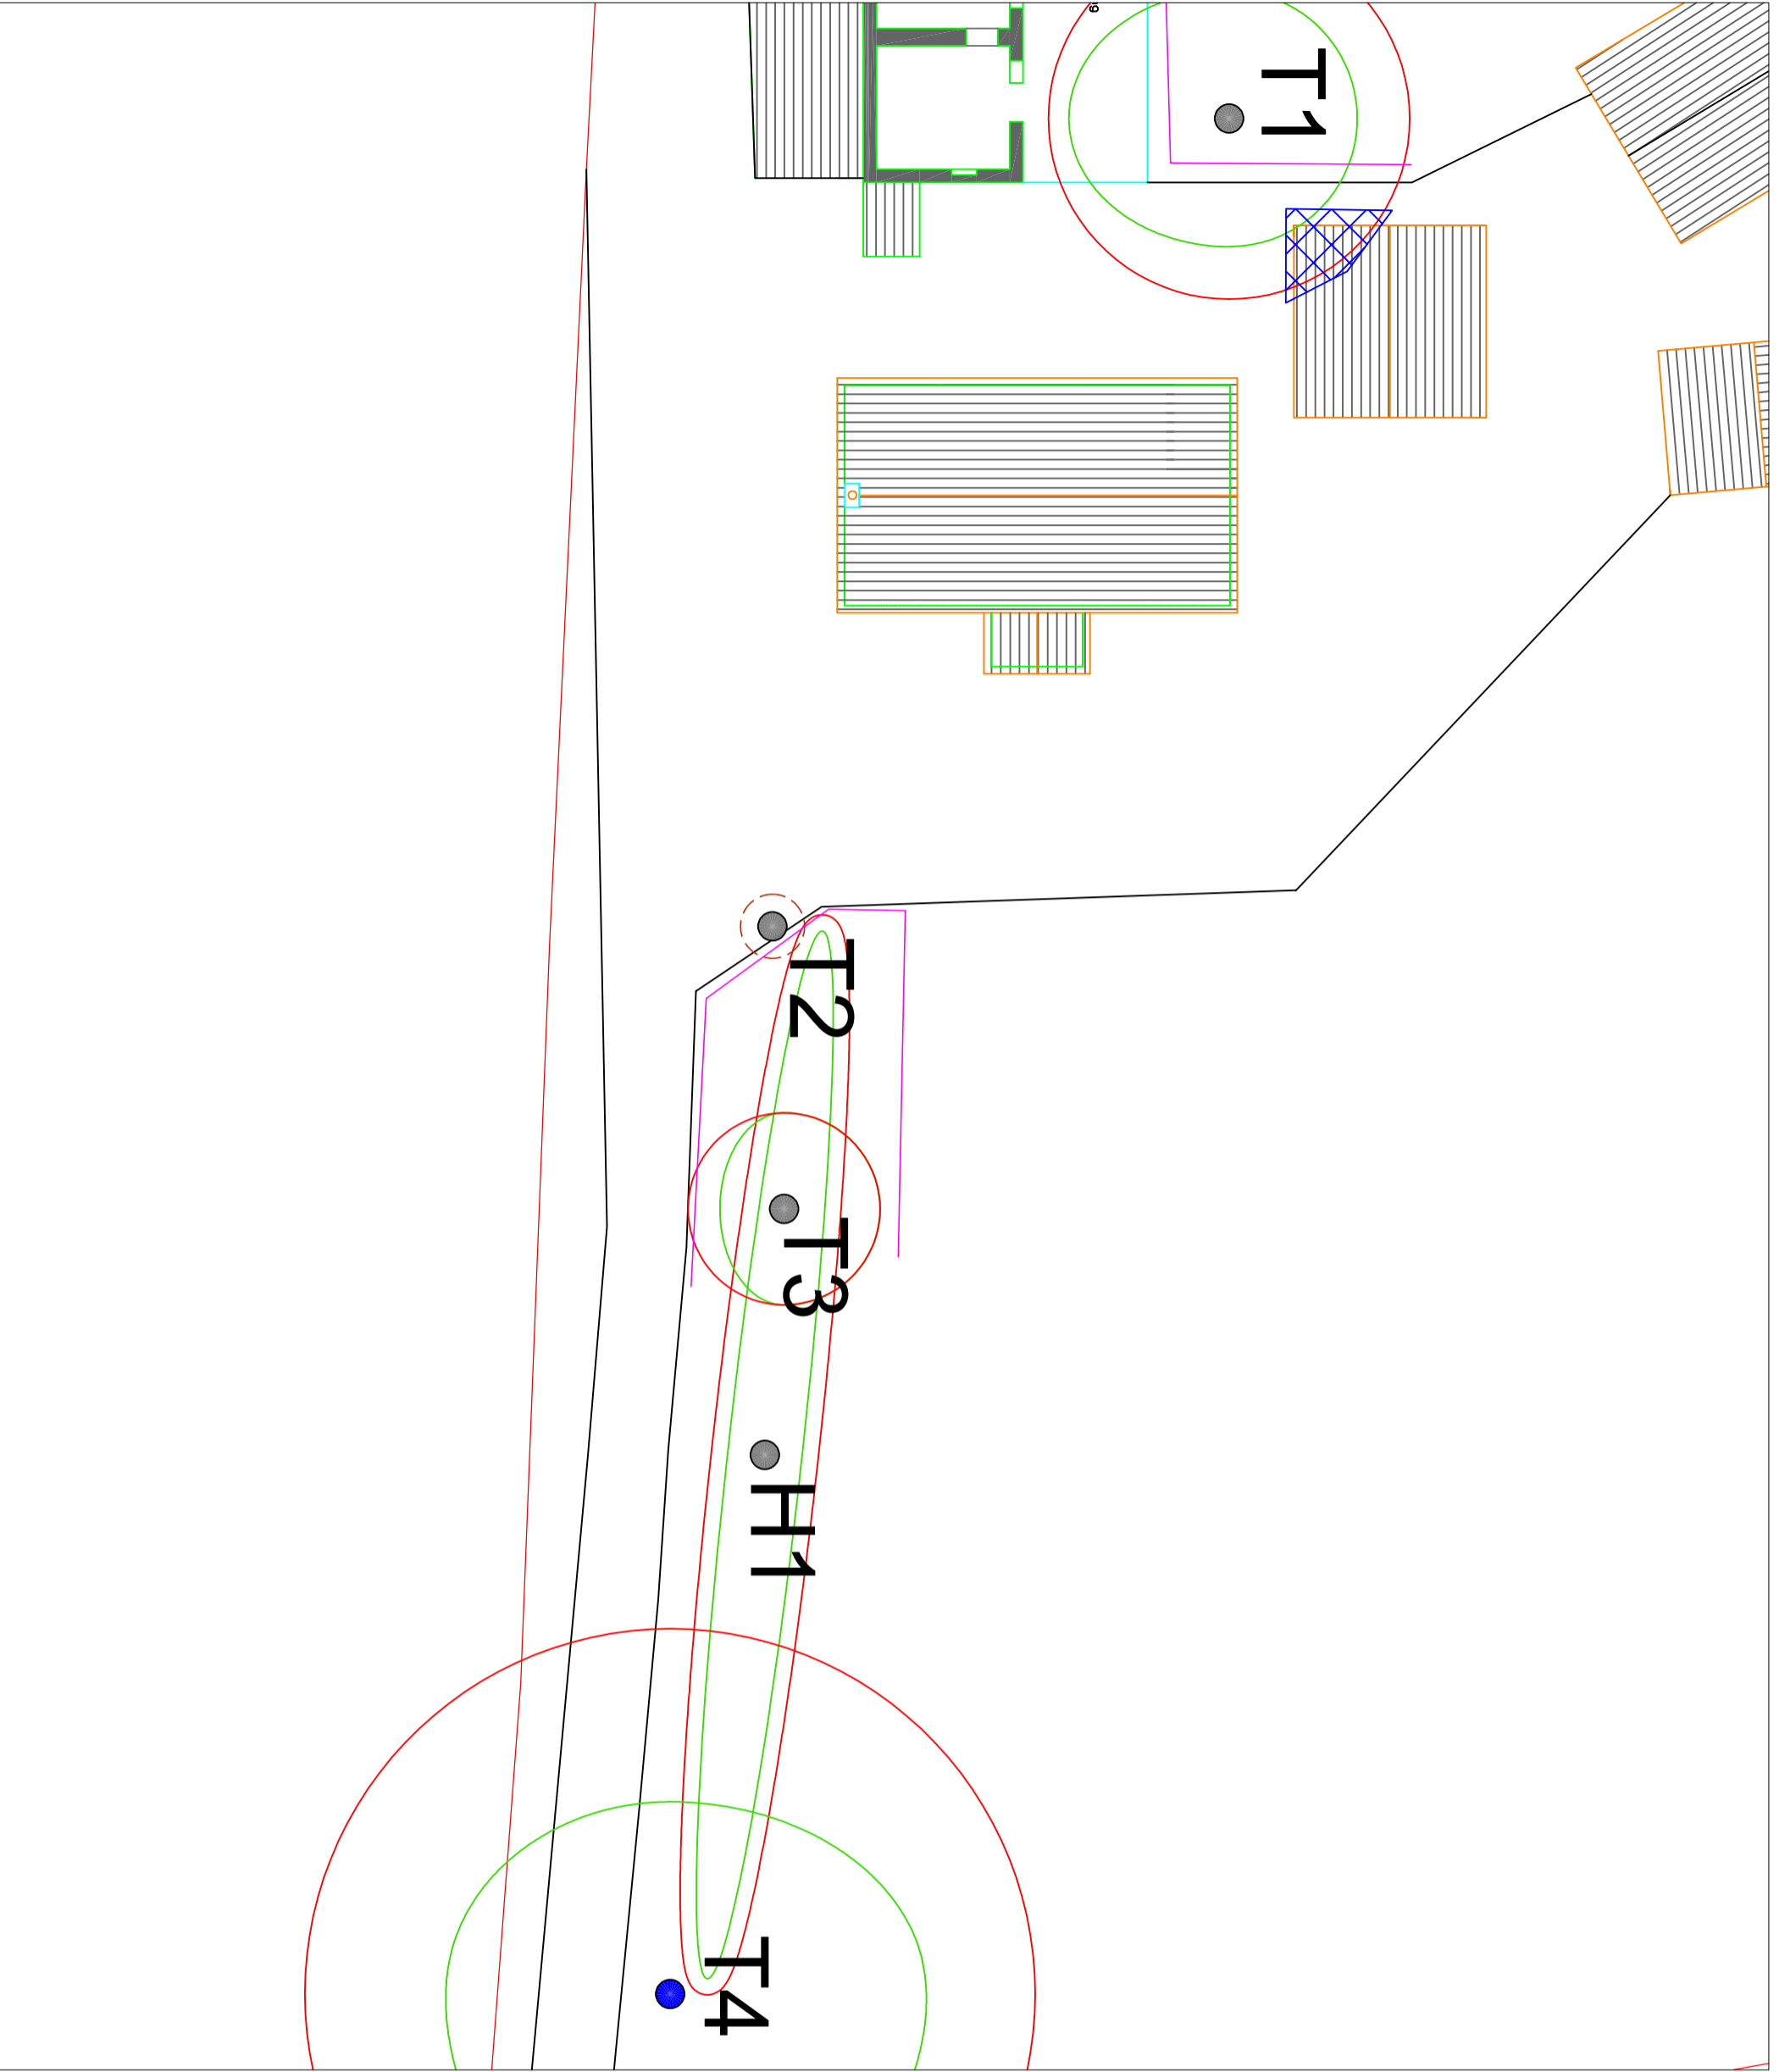
Appendix 1 – Tree protection plan

4.4.2 The proposed new garage narrowly breaches the RPA of T1. Standard construction methods could result in significant root damage.

5.3.2 The breach of RPA of T1 is considered to be minor and in this case acceptable. However excavation using a machine can result in roots being torn back toward the main stem, increasing the damage beyond the working area. Therefore in area hatched on the tree protection plan the excavations for the foundations will be dug by hand. Roots will be severed using a hand saw or bypass secateurs.

5.2.1 During the demolition stage protective fencing of the types shown in figures 3 and 4 below will be erected once the tree pruning/felling works have been completed. Signs will be attached to the fencing stated that it must not be moved. The location of the fencing is shown on appendix 1.
