**Gardeners Cottage. Tullimaar. Perranaworthal. Truro. TR3 7NT**

**Tree Survey and Arboricultural Method Statement. January 2024**

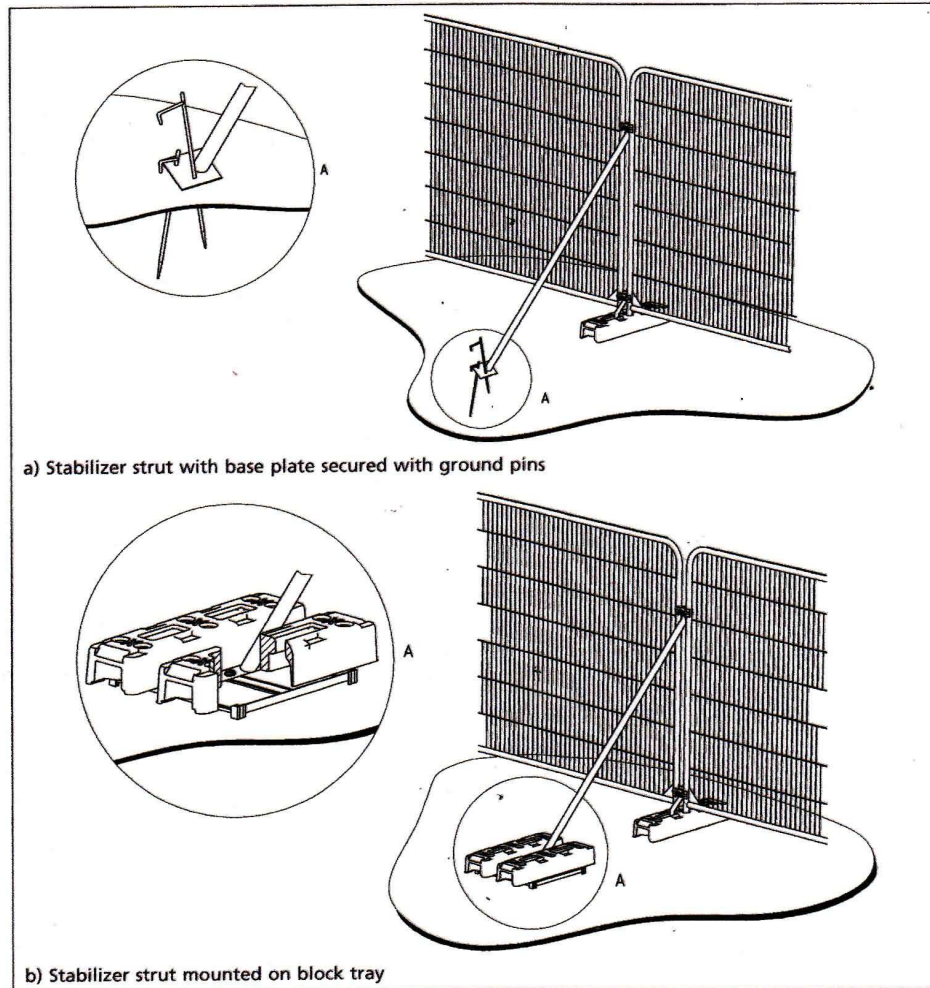
Figure 3 Examples of above-ground stabilizing systems

The tree protection fence as per figure 3 of the BS.

1. Assemble tree protection fences in the positions shown on the TPP.
2. Construction phase. Cement mixing will be on existing or new floor plates.
3. Dismantle tree protection fences when the last wet trade works (usually internal plastering) are completed.

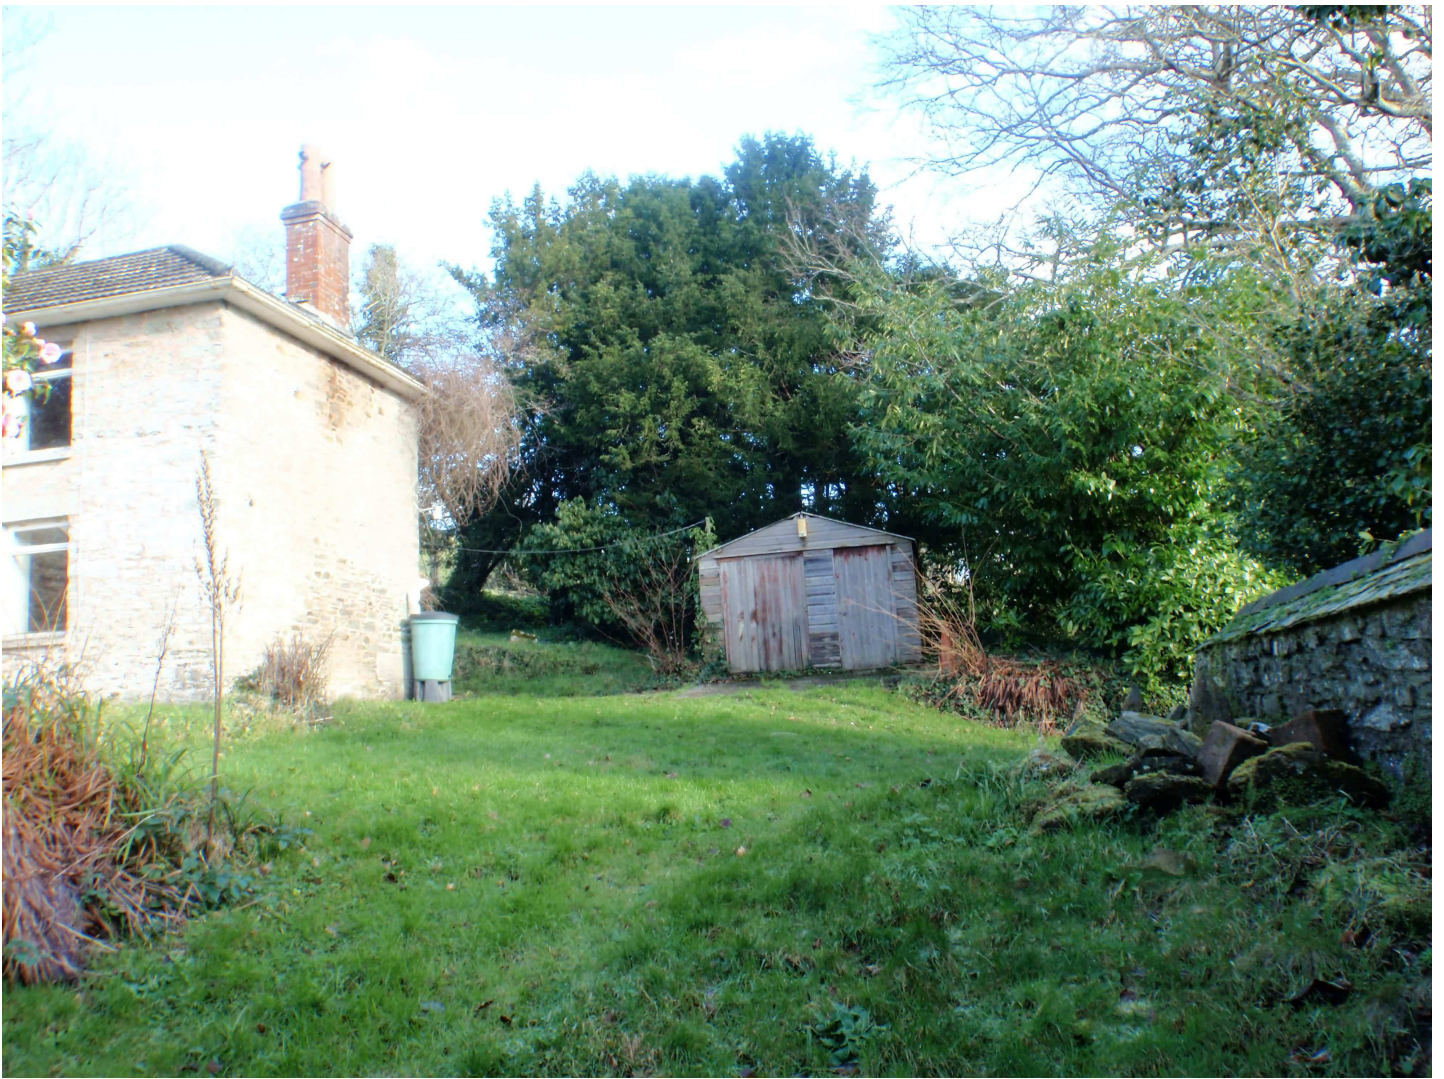
The Yew hedge Ts 8 could be pruned back into a real asset. Cherry Laurel could be cleared & Camellias released. The existing garage is the reference point for protective fencing.

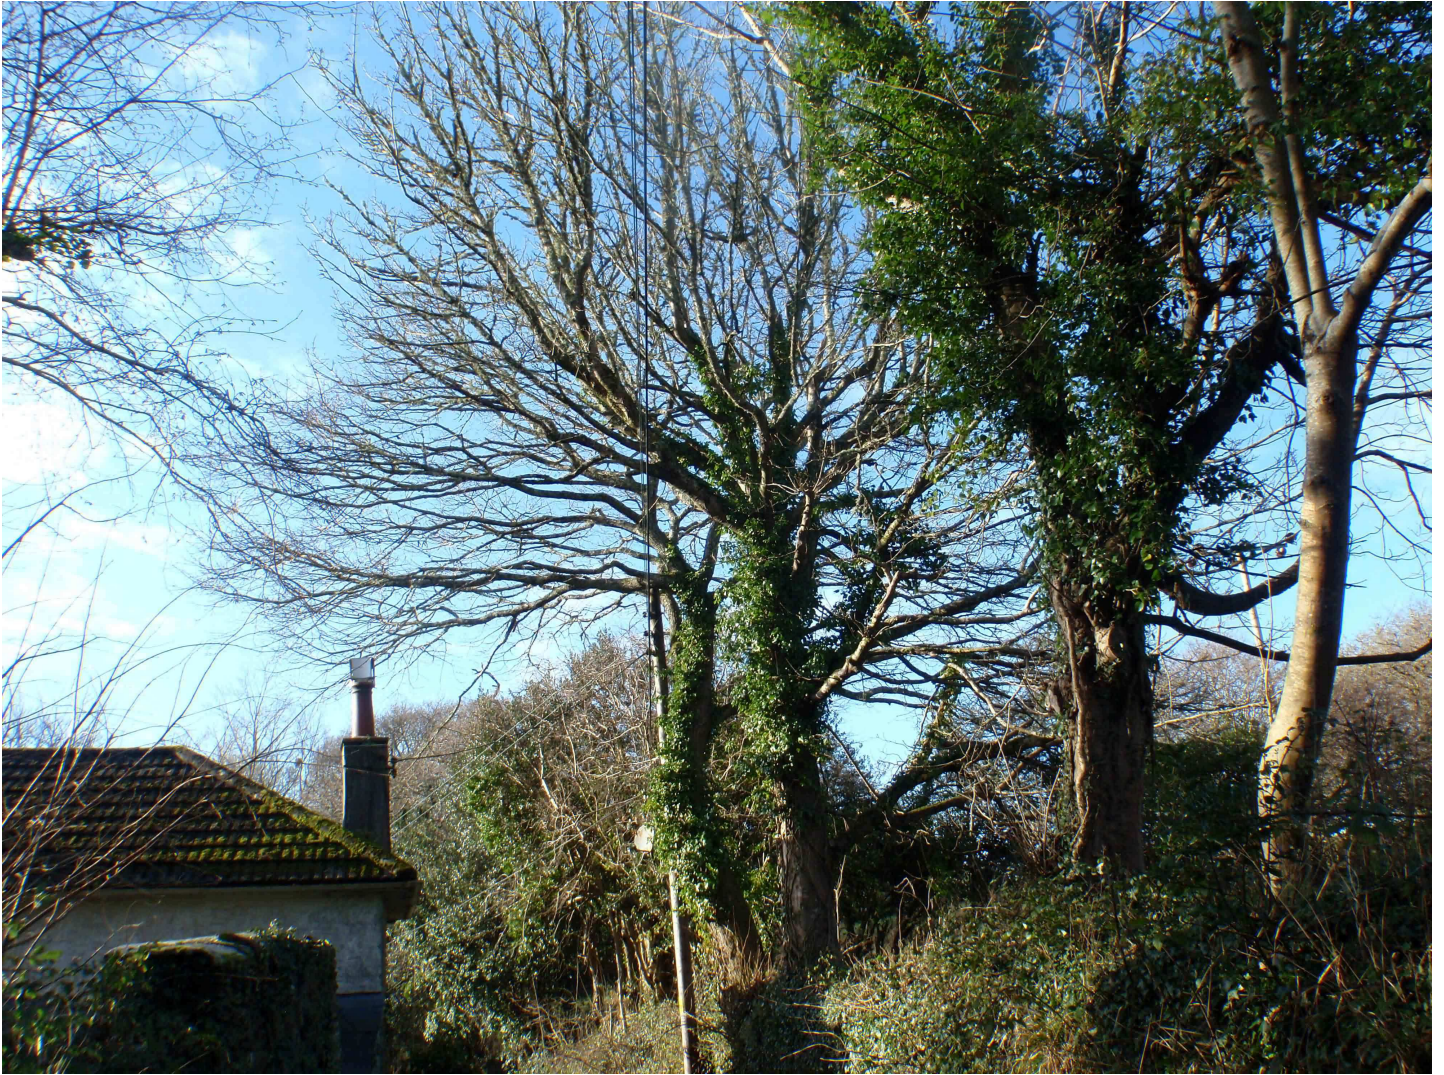
Ts 10 & require crown lifting off the existing roof of the gardeners cottage. This would be carried out by the electricity company who owns the poles and overhead conductors. (This is householder maintenance, not building tree work)
