## **BENNETTS FARMHOUSE, PADBURY**

### **TREE SURVEY REPORT and ARBORICULTURAL IMPACT ASSESSMENT**

**HDA ref: 1099.1**

**April 2023**

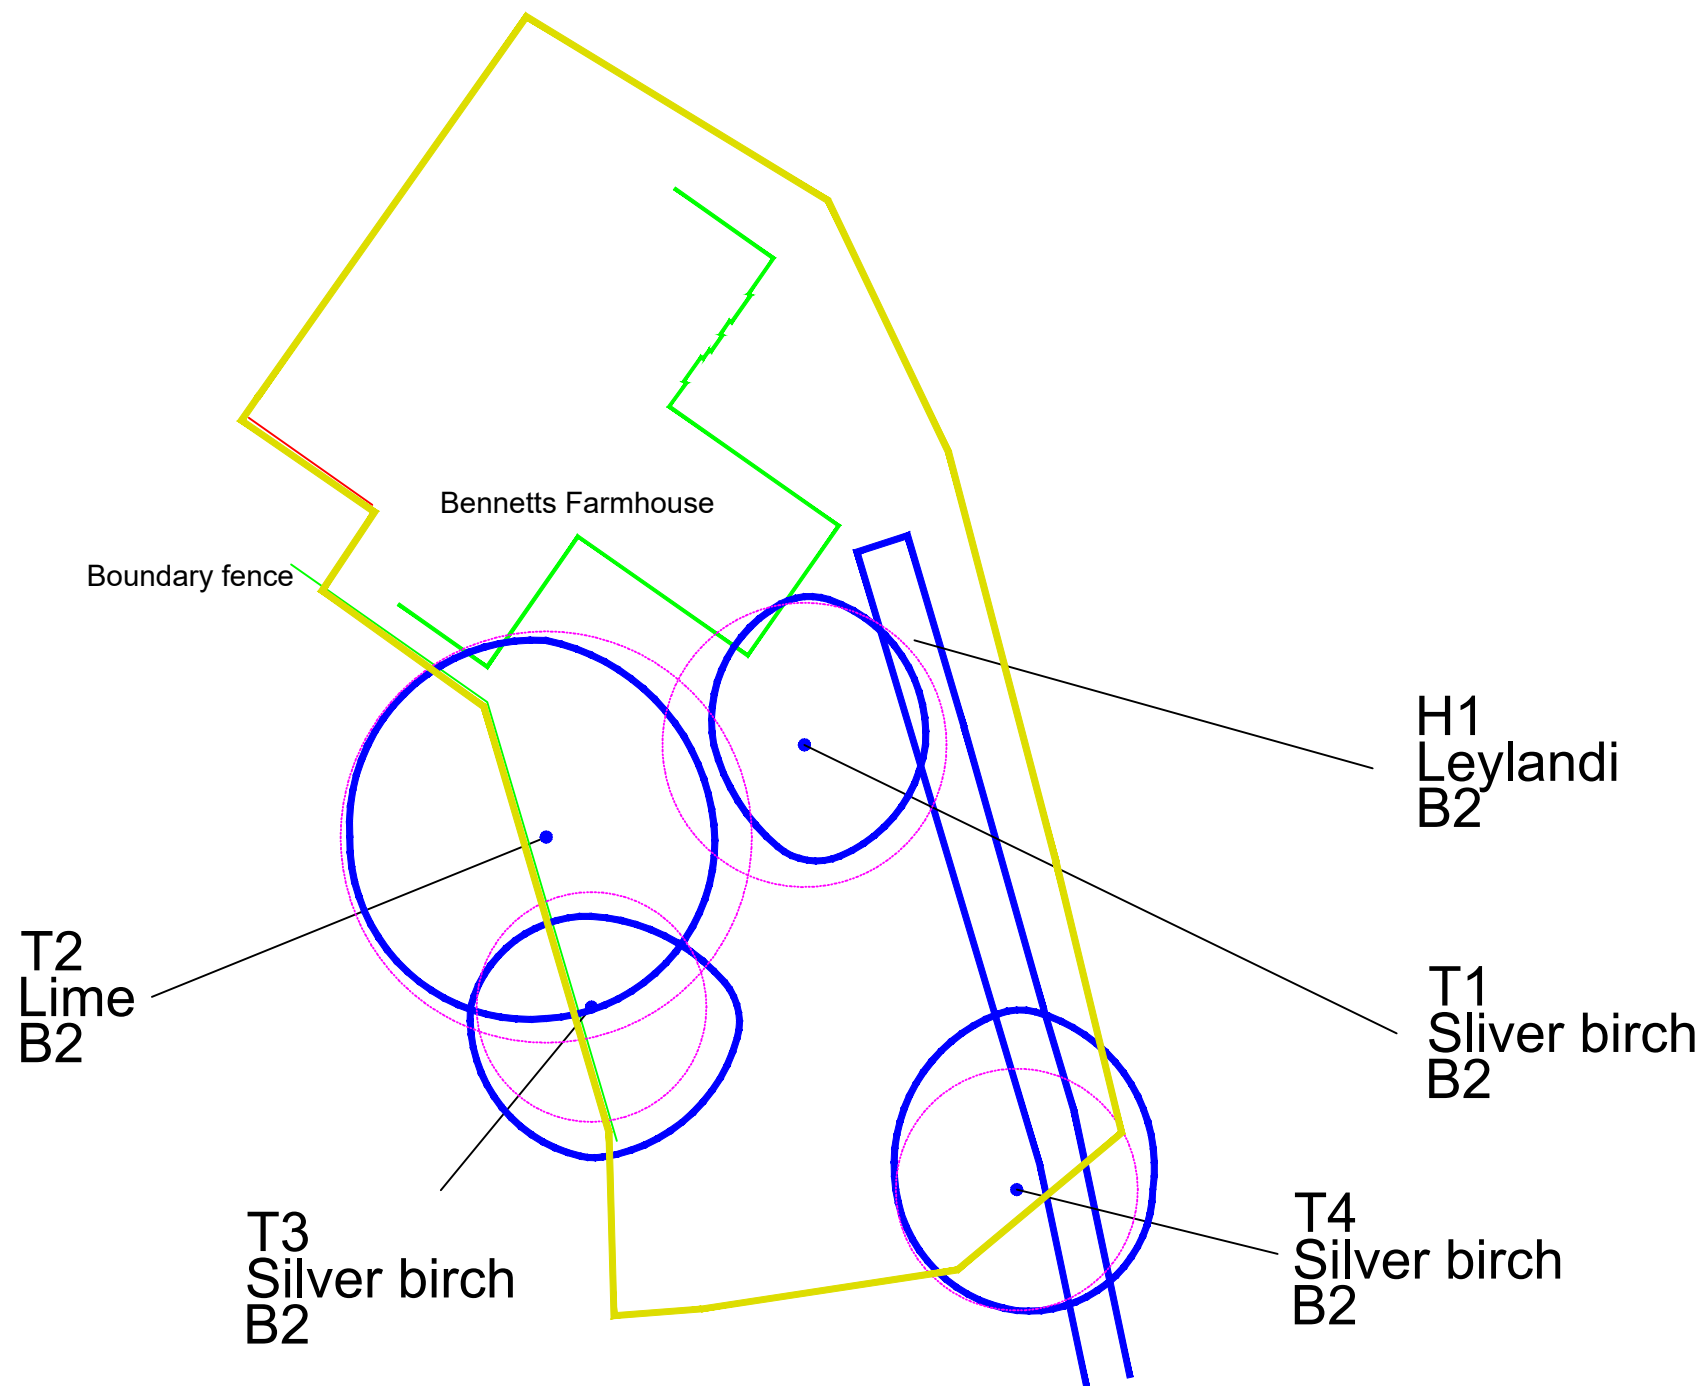
TITLE:  
Tree Constraints Plan

4.3.1 The trees have received previous pruning including crown lifting and reductions. The hedgerow (H1) has been regularly maintained on both the sides and top.

4.3.2 The Silver birch (T1) has an exposed basal cavity.

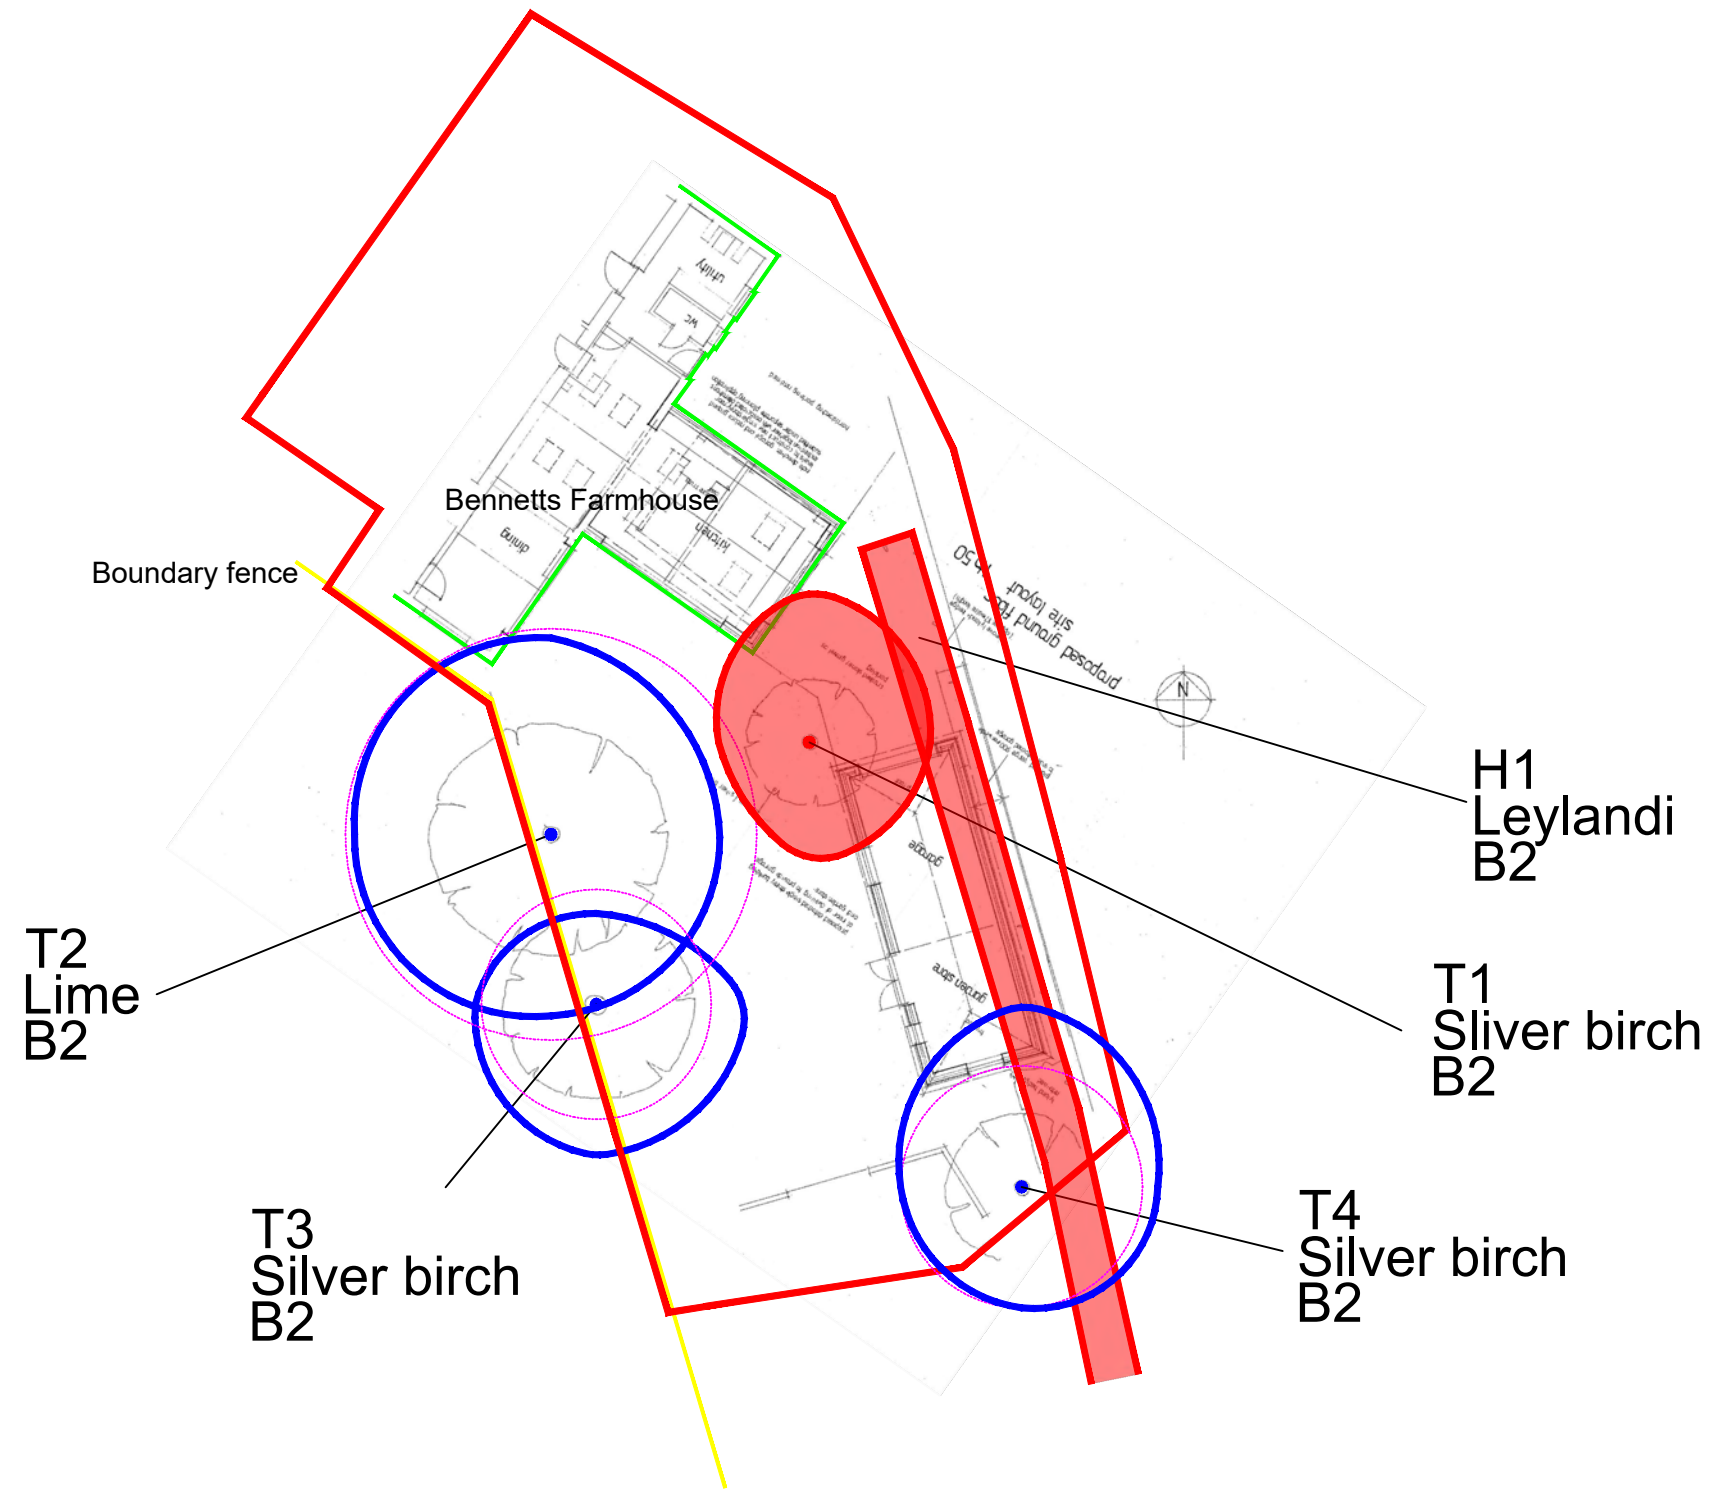
**Tree Retention & Removal Plan**

5.2.1 One Category B tree (T1) would be removed to facilitate the proposed layout. It should be noted that this tree has a basal cavity and is in close proximity to the existing dwelling and it has a limited safe useful life expectancy.

5.2.2 One Category B hedge (H1) would be removed to facilitate the proposed layout. The hedge comprises of Leyland Cypress which is frequently planted in residential areas and has limited ecological value. It is proposed to replace the hedge with one comprising of native species which will be of higher ecological value once it has become established.

5.9.1 The Leyland Cypress hedge is to be replaced with a mixed native hedgerow. The following species would be suitable for the replacement hedgerow: Beech (*Fagus sylvatica*), Blackthorn (*Prunus spinosa*), Hawthorn (*Crataegus monogyna*), Field maple (*Acer campestre*), Hawthorn (*Crataegus monogyna*), Hazel (*Corylus avellana*), Holly (*Ilex aquifolium*), Hornbeam (*Carpinus betulus*) and Yew (*Taxus baccata*).
