DESIGN, ACCESS & HERITAGE STATEMENT

Peverells, Tye Green, Glemsford, Suffolk CO10 7RQ (Ref:
53781)

January 2024

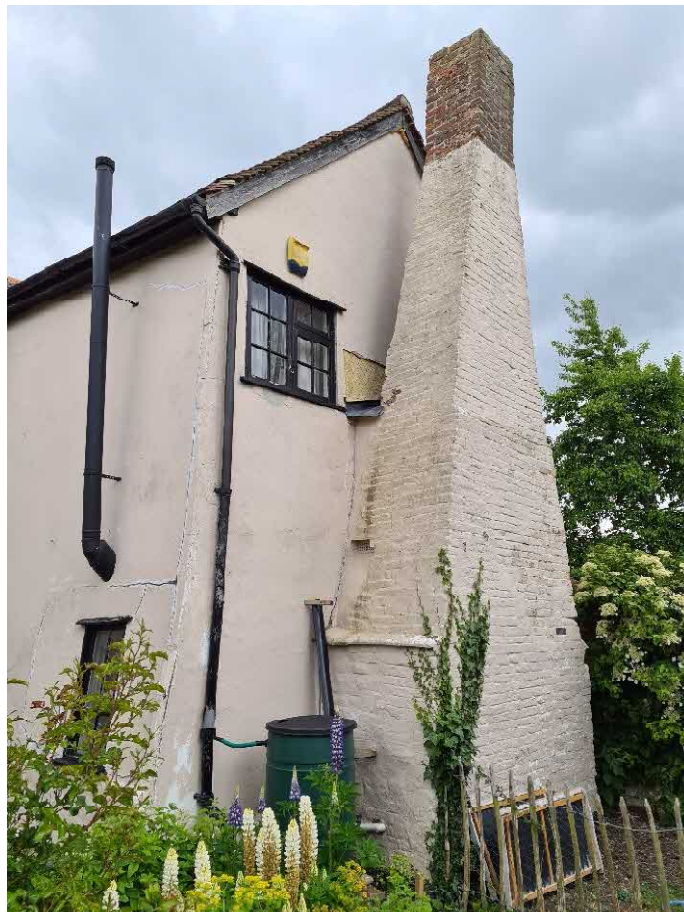
- 3.6 The rear chimney stack is largely constructed with modern brickwork laid in lime-based mortar and sand and cement pointing (see figures 3 & 4 below). There are some older bricks to the base of the stack, but these will be left untouched. The majority of the brickwork has been decorated with a modern impervious painted finish. The top 1.2m of the stack has been left in fair-faced brickwork to match the other chimney stacks.

Fig 3: View of rear chimney stack

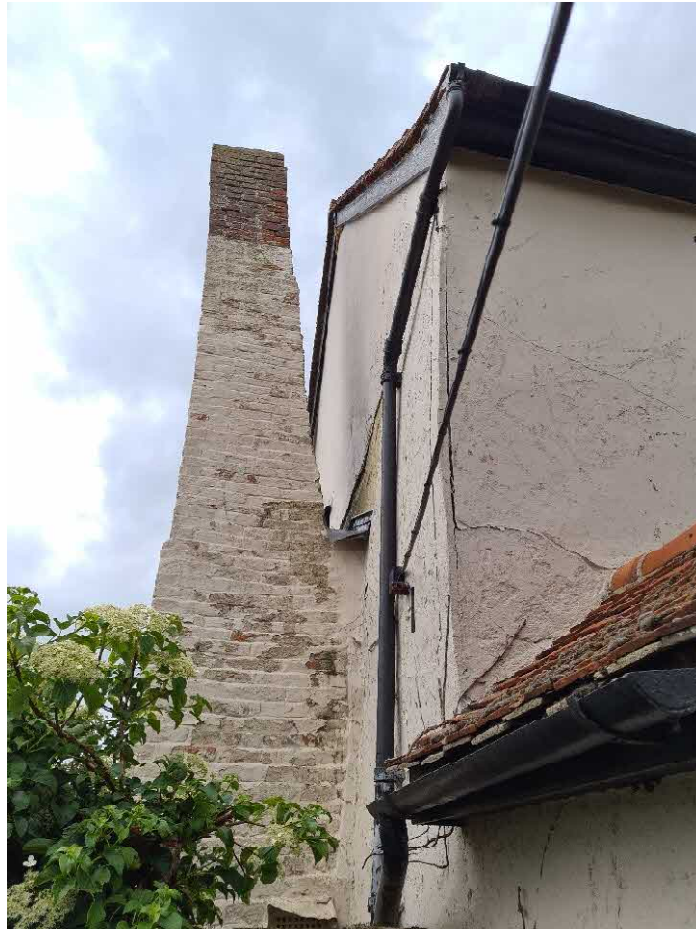
- 3.7 The stack is constructed with a wide base up to approximately 1.65m where a lead capped splayed brick detail is present. The stack continues upwards from a width of approximately 2.15m and tapers at the top to 0.5m. The stack is attached to the rear elevation for approximately 3.4m where a lead back gutter has been formed to weather this detail. The upper stack is independent from the rear elevation.

Fig 4: View of side elevation of rear chimney stack

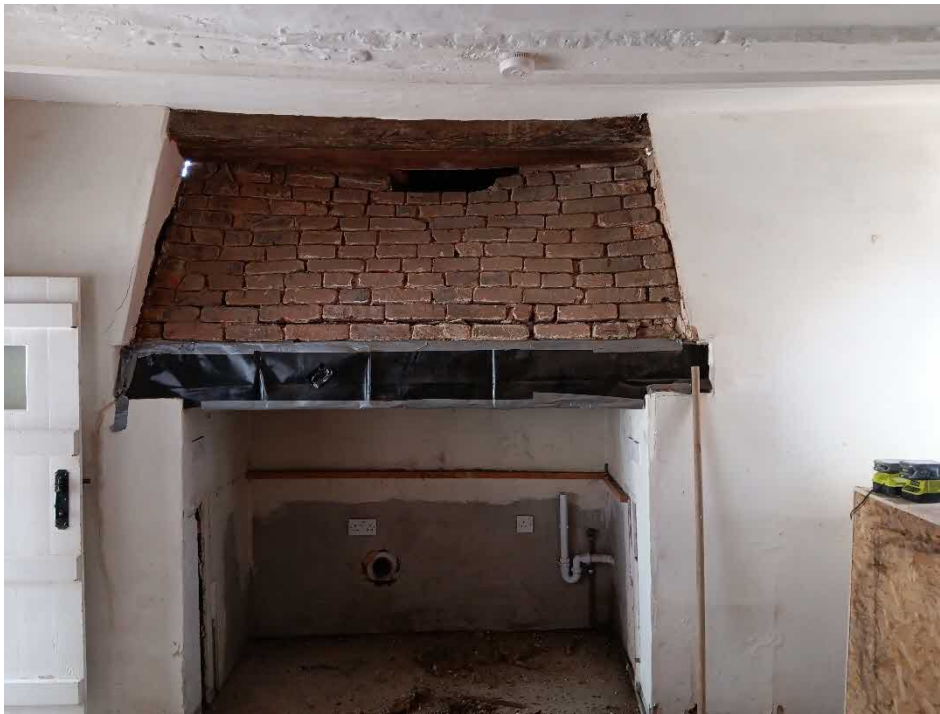
- 3.9 The brickwork hood above the timber bressummer over the fireplace has been constructed in modern bricks laid in a lime-based mortar. The brickwork has been constructed on an incline from the face of the bressummer back to the external face of the rear elevation.
- 3.10 Internally comprises of exposed timber framed elements with a mixture of lath and plaster infill panels and modern boarded finishes.
- 4.0 PROPOSALS
- 4.1 The works are limited to the demolition and re-construction of the rear chimney stack and the re-construction of the brick hood to the fireplace to the southeast cross wing only (see figure 5 and 6 below).
- 4.2 Due to the immediate safety risk to the occupants the upper 4m of the stack has been removed, by hand, and bricks stored on site to mitigate the risk of damage/injury.

Fig 5: Defective brickwork above fireplace

- 4.4 The brickwork hood above the timber bressummer to the fireplace is to be carefully taken down (by hand), bricks stacked on site and left ready for re-use.

- 4.5 The stack will be re-built using the salvaged bricks laid in a lime mortar to match existing dimensions and details. Any bricks that are unable to be reused will be substituted for matching handmade clay bricks from Bulmer Brick & Co or similar.

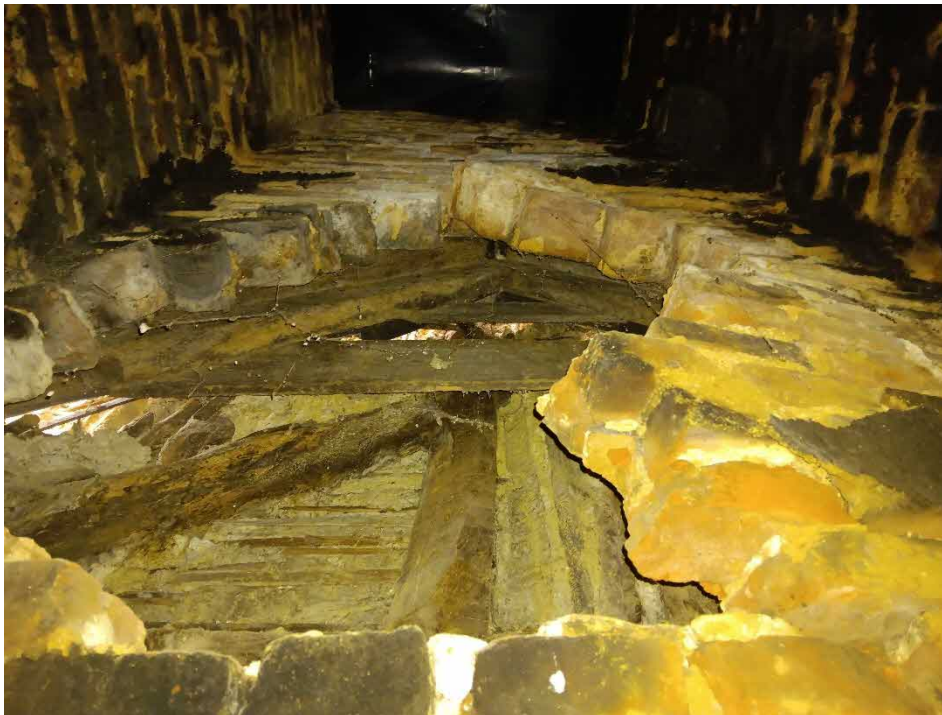
Fig 6: Missing bricks above brick hood below

At first floor level, below the leaded back gutter and above the lintel of the kitchen fire place the brickwork of the inside face of the chimney had collapsed and loose bricks were noted to be laying on the asbesdos sheet that had been used to seal up the chimney in the kitchen

- 4.3 The works will include carefully taking down, by hand, the upper 4m (approx.) of brickwork to the. This part of the stack is independent from the rear gable elevation. All bricks to be cleaned and stacked on site and left ready for re-use.
