**WILD ORCHIDS, HARCOMBE ROAD,  
REYMONDS HILL.**

## Arboricultural Survey Report

**Report by:** Steve Russell BSc (Hons).    **Date:** 18<sup>th</sup> January 2024.

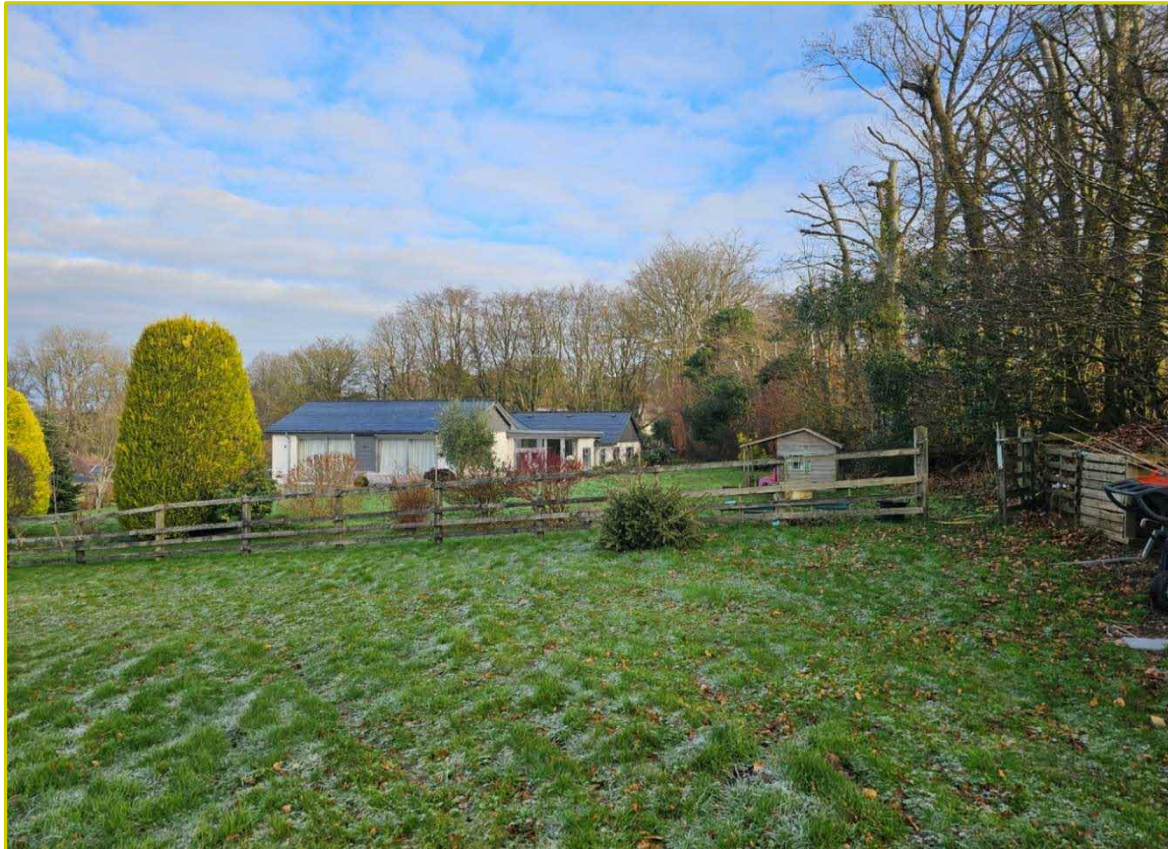
Photo 1 - View from the paddock looking north towards the property.

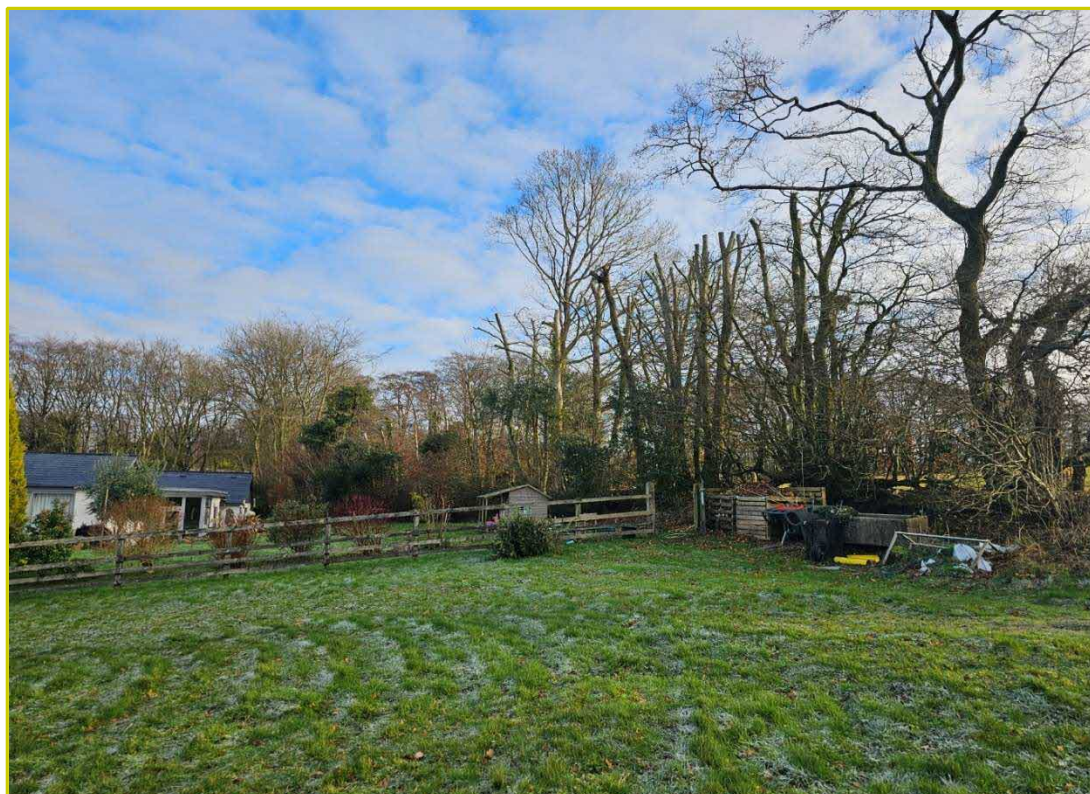
The hedge has not had any management in some time until recently when the majority of the Beech trees have been topped, although in parts it has been trimmed back to form a cut hedge. The Oak to the southern end of the surveyed hedge has clearly been regularly pruned back from the power cables by the Electricity company. There is a further Oak which has been retained with its full canopy.

Photo 2 - View looking north showing Beech hedge bank and Oak.

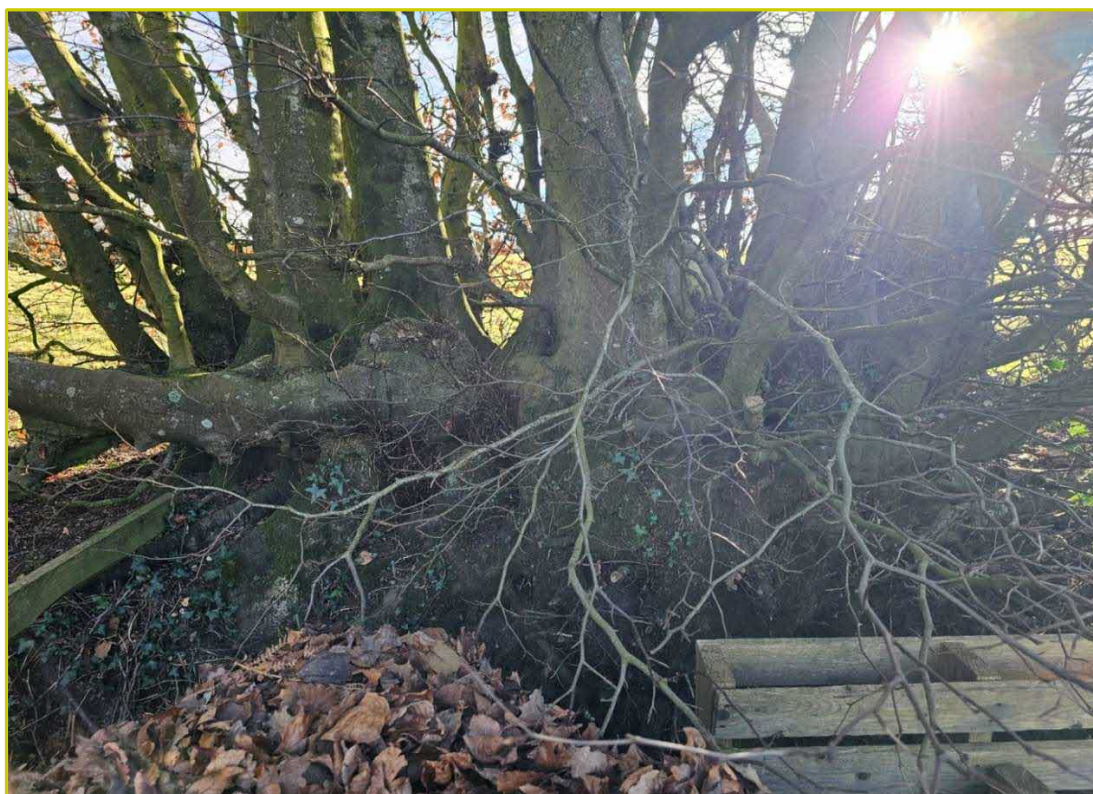
The site consists of an area of garden to the south of the house, it is laid to lawn with a line of managed shrubs and small trees. The boundary to the south and west is a fence with paddock beyond. To the southeast of the property is a boundary hedge with trees, this is a typical hedge bank with mainly Beech, some Oak and some Holly understorey. The Beech have been cut/coppiced/laid in the past and many of the stems have regenerated from the old laid/coppice.

Photo 3 - Old Beech Coppice.

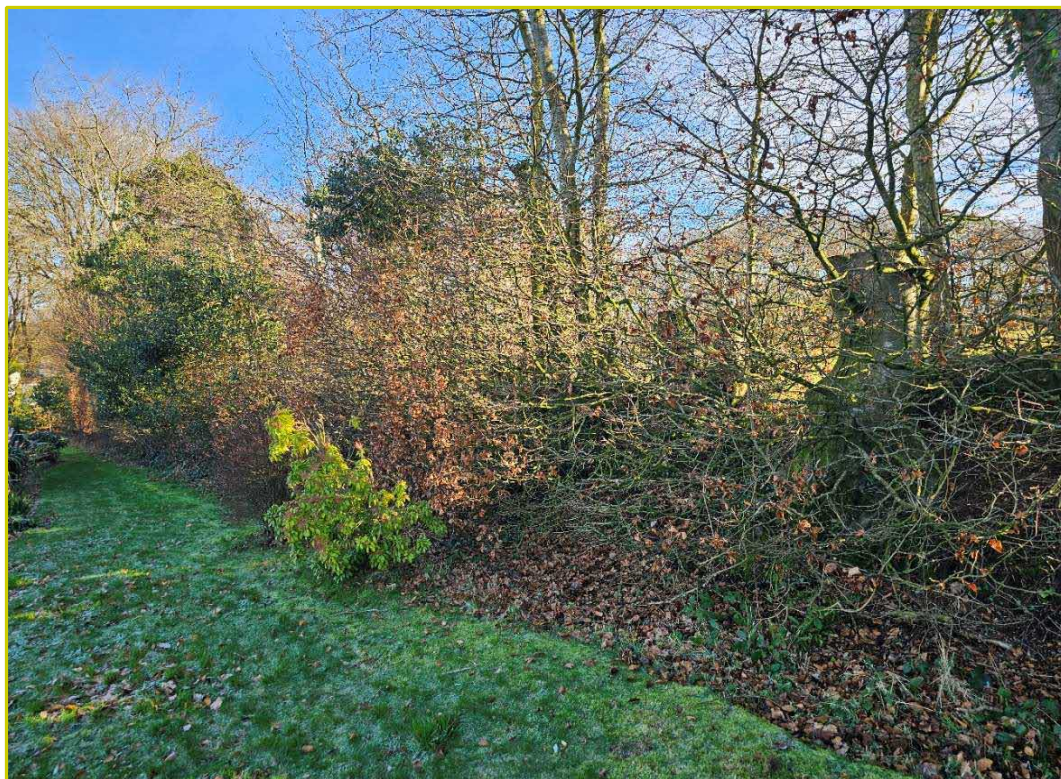
Photo 4 - Beech hedge bank showing partially trimmed back hedge line.

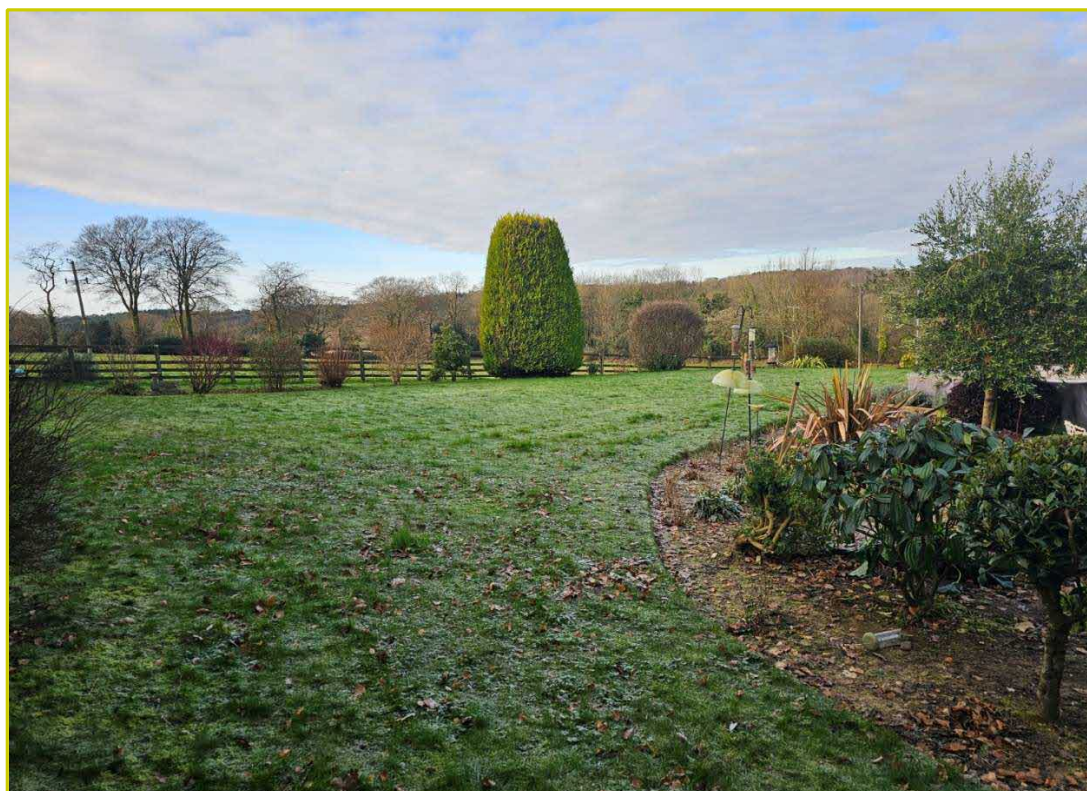
Photo 5 - Small trees and shrubs in garden.

The current pool proposal will have no impact on the RPAs of the Beech bank hedge and Oaks, the RPAs can be protected with Protection Fencing during the construction of the pool. A number of the smaller trees and shrubs will be directly impacted by the proposals, however other than the Cypress most could be moved successfully and located elsewhere in the garden if desired/required.

The proposed layout takes account of the main tree constraints detailed in this report. There will be a need for protection fencing of the hedge line and the need to remove/move a number of smaller trees and shrubs within the garden Demonstration at this stage that trees are fully protected may result in the local authority not requiring a full Arboricultural Method Statement at a future date.
