December 2023

Kerris Manor  
Farmhouse, Kerris,  
Cornwall  
Heritage Impact Assessment

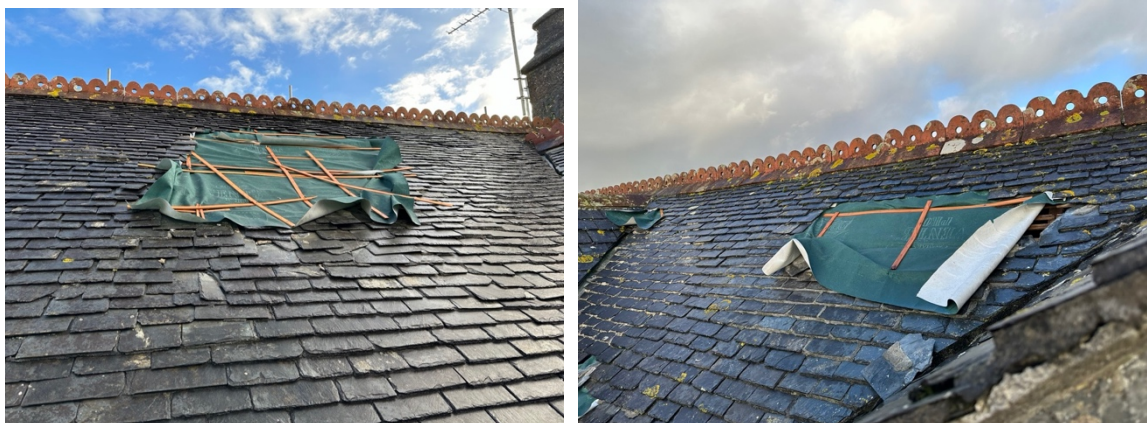
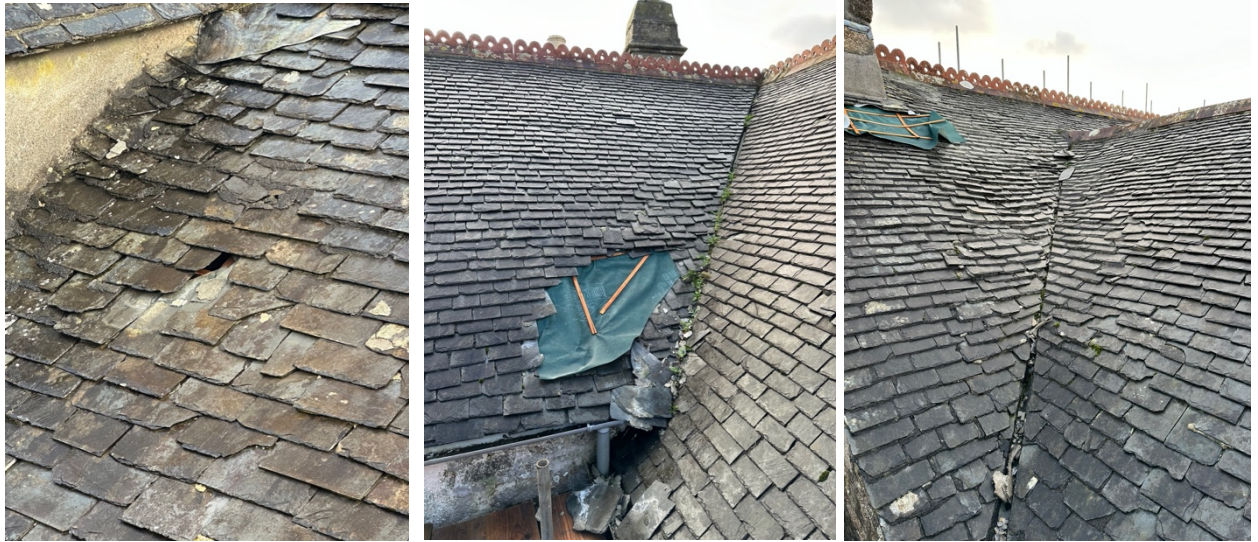
Figures 3-7 Recent roof damage following autumn storms

- 2.17 As can be seen from the photographs, damage is not just in particular areas, but also adhoc, and often in relatively inaccessible parts of the roof – making the task of repairing it difficult and increasing the regular risk of water penetration and internal damage.

- 4.3 The photographs in the first part of this report highlight the issue – representing damage from one storm and also showing where ad hoc slipped slates further increases the risk of water ingress.

- 4.2 The roof has been professionally inspected to understand the extent of damage and the prognosis for its future. Through a combination of weather, a failure of the slates themselves as well as the timber pegs that hold them, on-going damage is now increasing in regularity has led to the conclusion that the roof covering needs to be entirely overhauled.

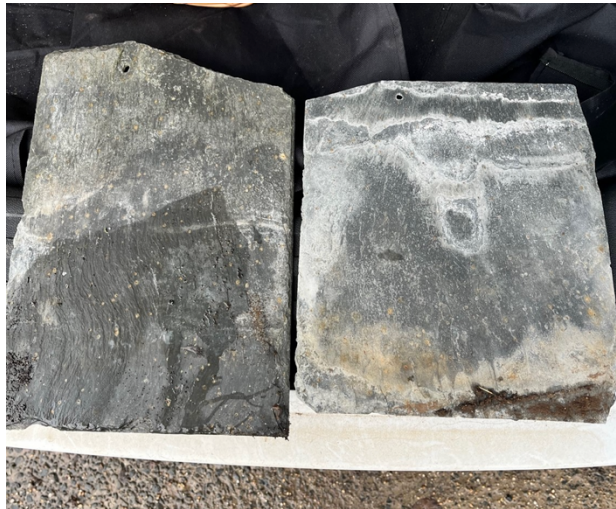
- 4.11 The following image is a comparison of a slate from the roof of Kerris Manor and from one of the barns – showing that they ensure a good quality match.
