# Gloucester Asbestos, Stroud Road, Gloucester

Drainage Strategy Technical Note  
December 2023

**Project Description:** Condition and Connectivity

**Project Date:** 12/10/2023

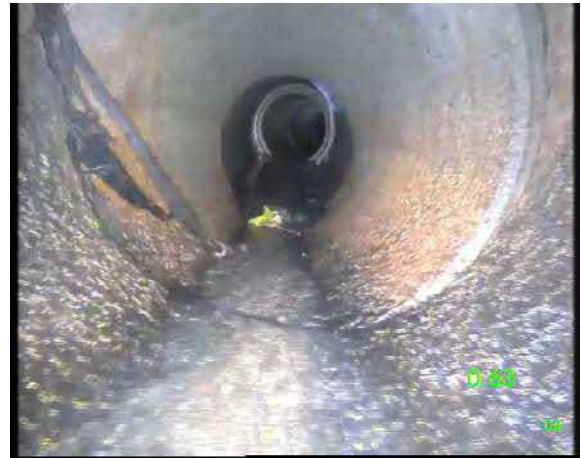
SMH1X\_885ab768-8c54-405c-b348-cd1dca354b3f\_20231019\_215407\_864.jpg, 00:00:20, 0.63 m  
Roots, fine at joint

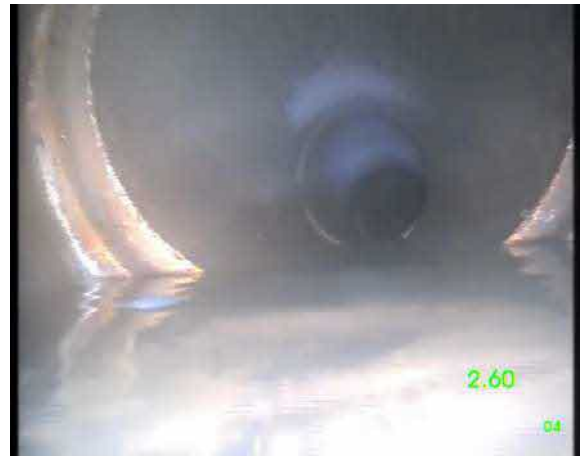
SMH1X\_8a35c796-c733-40ce-ab8b-f39d3adb1ead\_20231019\_215447\_341.jpg, 00:00:34, 2.60 m  
Joint displaced, medium

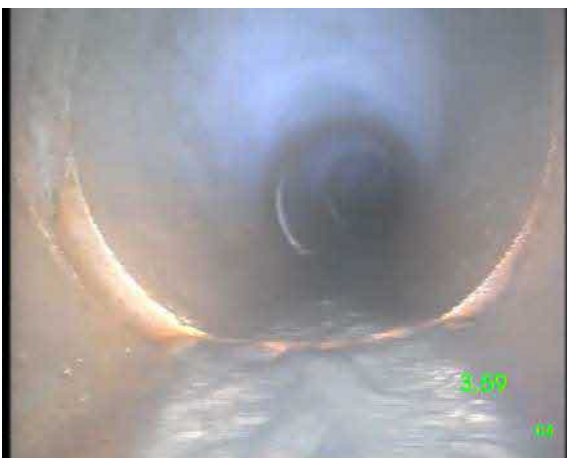
SMH1X\_bec6f80d-dce7-4835-89f9-17849e65ee8d\_20231019\_215505\_428.jpg, 00:00:40, 3.59 m  
Open joint, medium

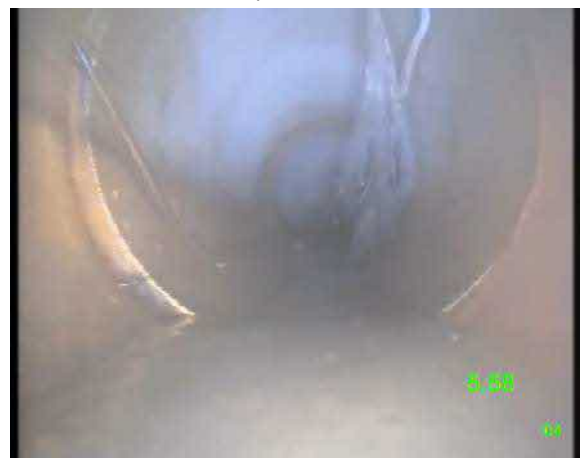
SMH1X\_c18a7041-9d22-4cdb-b142-e95d9b6b8000\_20231019\_215525\_810.jpg, 00:00:52, 5.58 m  
Roots, fine at joint

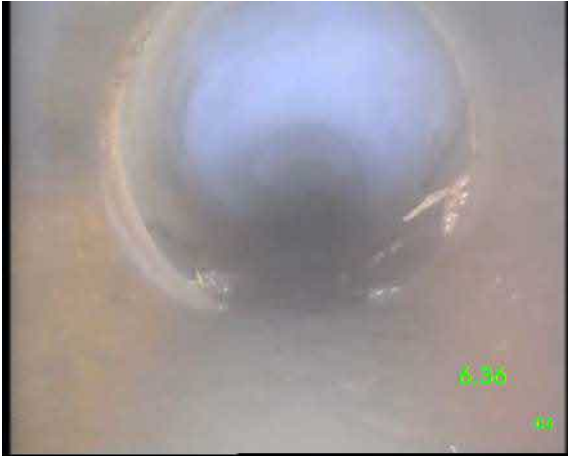
SMH1X\_e1206aec-17cc-426f-8ea0-5966a2ee4935\_20231019\_215540\_650.jpg, 00:00:58, 6.41 m  
Joint displaced, medium

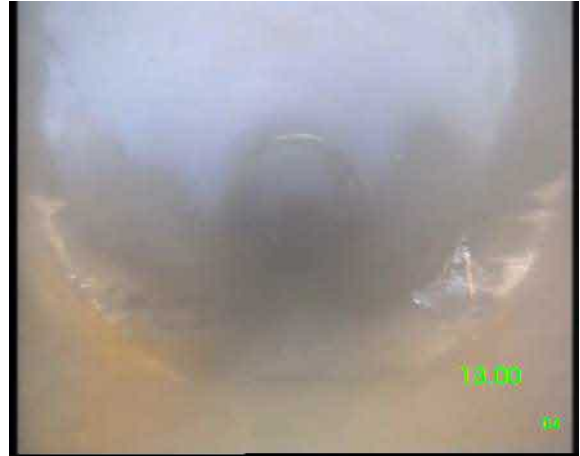
SMH1X\_ea7c40a2-d2a6-43ca-905d-944eba992b6c\_20231019\_215615\_174.jpg, 00:01:39, 13.05 m  
Roots, fine at joint

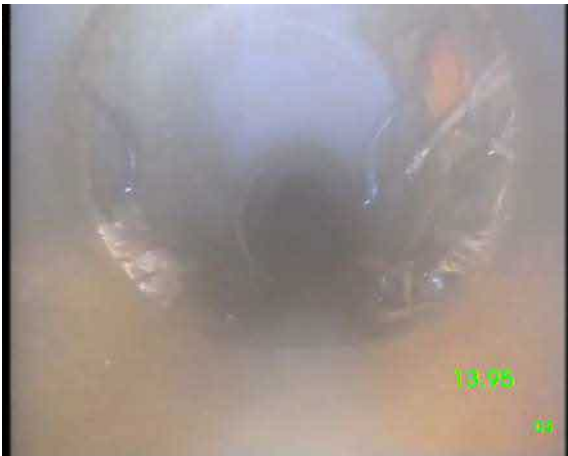
Scale:	1:193	Position [m]	Code	Observation	MPEG	Photo	Grade	
		13.95	RMJ	Roots, mass at joint, 25% cross-sectional area loss	00:01:44	SMH1X_1 2570131-3 300-499d-	5

SMH1X\_12570131-3300-499d-a56e-1378067cbf55\_20231019\_215628\_599.jpg, 00:01:44, 13.95 m  
Roots, mass at joint, 25% cross-sectional area loss

Sections 1 and 2 - Attend site with a Jet Vac unit, clean and clear the pipework and re-survey and report findings with further recommendations.

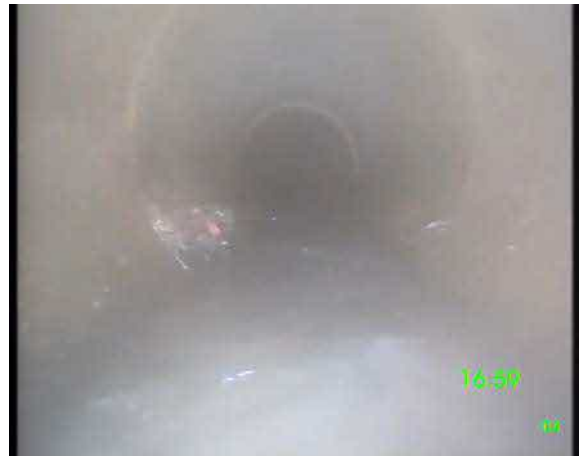
SMH1X\_07097504-8e01-4bd2-a716-56a4448125cf\_20231019\_215657\_698.jpg, 00:02:00, 16.59 m  
Roots, fine at joint

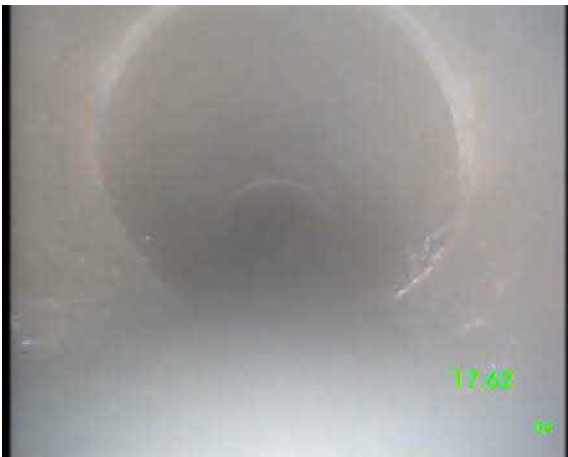
SMH1X\_c29a90ee-f258-47c6-a05d-786affb5dbc7\_20231019\_215707\_301.jpg, 00:02:06, 17.62 m  
Roots, fine at joint

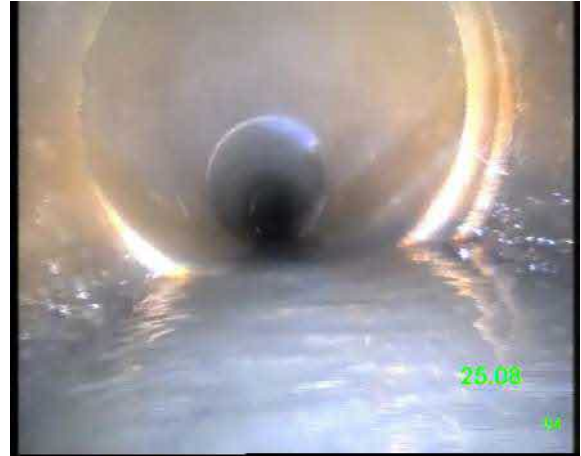
SMH1X\_e10e47b0-9b97-4679-b11a-c3080e9dbed7\_20231019\_215813\_462.jpg, 00:02:50, 25.08 m  
Joint displaced, medium

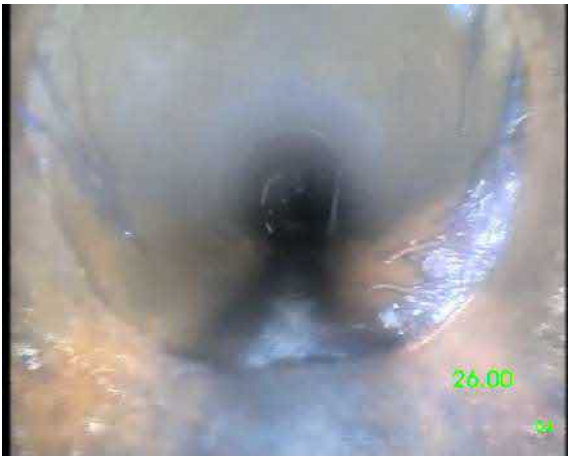
SMH1X\_0ea55e5c-d473-4f04-abbb-7345b45689fe\_20231019\_215823\_264.jpg, 00:02:56, 26.00 m  
Roots, fine at joint

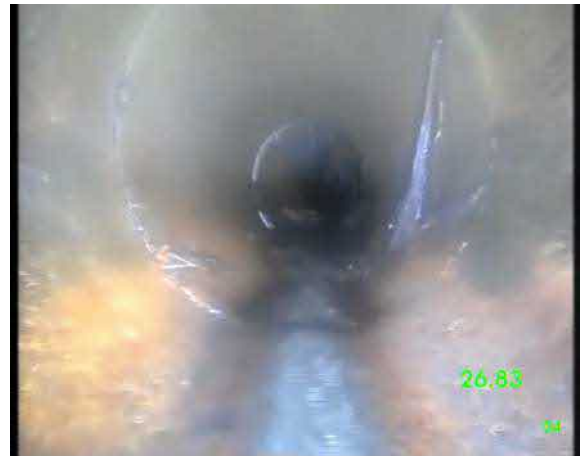
SMH1X\_d305c559-ddb9-492d-b870-5d4fdb75086b\_20231019\_215832\_566.jpg, 00:03:01, 26.87 m  
Roots, fine at joint

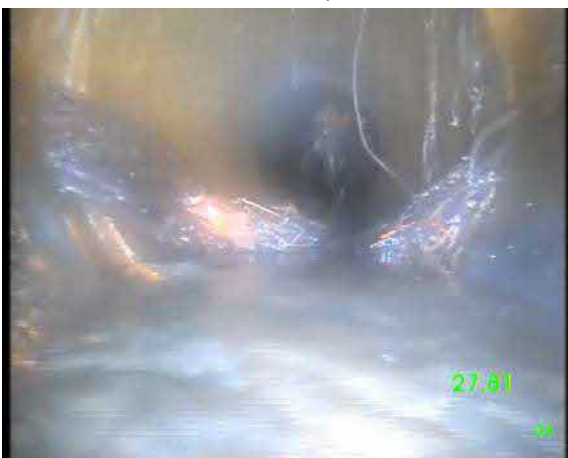
SMH1X\_39e3fe2e-2cf7-4c61-a331-9cc1021f688a\_20231019\_215853\_268.jpg, 00:03:07, 27.81 m  
Roots, mass at joint, 30% cross-sectional area loss

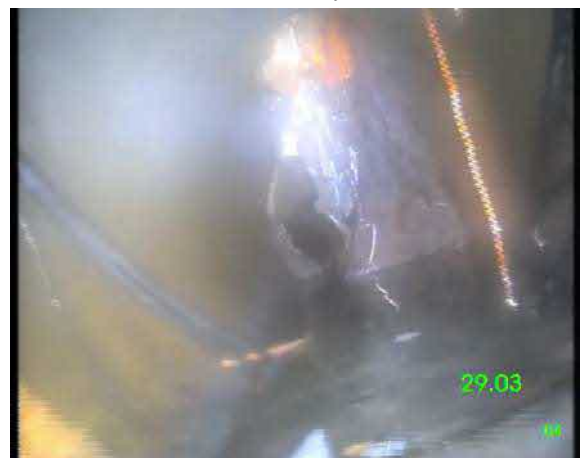
27.81	WL	Water level, 20% of the vertical dimension	00:03:07			
		29.03	WL	Water level, 25% of the vertical dimension	00:03:14			
		29.06	CXBI	Connection defective, blocked and intruding at 12 o'clock, 150mm dia, intrusion: 25%	00:03:14	SMH1X_7f 7a1bf8-93 4b-4edd-a	4

SMH1X\_7f7a1bf8-934b-4edd-a8df-ee5f6865581c\_20231019\_215926\_148.jpg, 00:03:14, 29.06 m  
Connection defective, blocked and intruding at 12 o'clock,

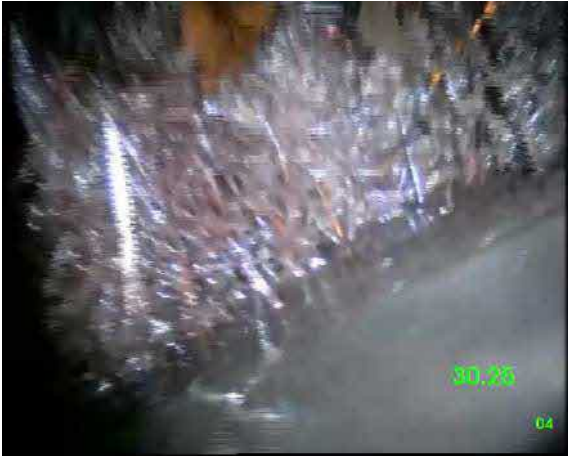
SMH1X\_c5a0ea96-cb5c-4a7b-a4e3-b509a4127004\_20231019\_215949\_612.jpg, 00:03:30, 30.25 m  
Roots, mass, 60% cross-sectional area loss
